# Energy and Lighting Performance of Buildings in the Neighbourhood Ciudad de los Angeles, Before and After Refurbishing.

**Abstract:** *The Spanish Ministry of Economy and Competitiveness is funding the SHERIF Research Project, which falls under the INNPACTO program. This project aims to increase the rate of the existing building refurbishment from the energy efficiency point of view by designing a facade system that must be an economical, flexible and integrated solution<sup>1</sup>. Under this project has been performing several tasks regarding the constructive characterization and energy evaluation of the thermal behaviour of facades on existing buildings<sup>2,3,4</sup>. In order to perform the latter task, in which this article will focus, has been developing a survey of various buildings in the neighbourhood Ciudad de los Angeles, which has as main objective the comparison between the actual energy and light behaviour of different buildings, prior and posterior to any refurbishment works have been undertaken. The evaluation of the actual performance of buildings before and after being refurbished is aimed to determine the impact of the work developed as well as learn from t

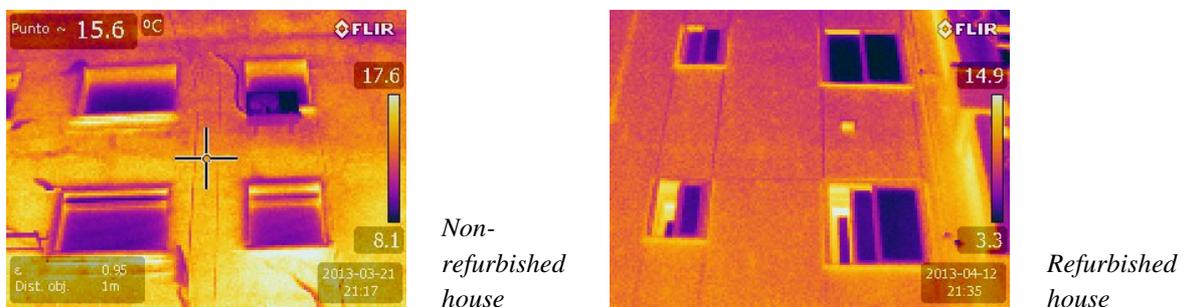
Fig. 2. Infrared outdoor images on facade typology A1.

The main difference found between the two infrared images is the discontinuity of colours. This indicates that there are discontinuities in the thermal behaviour of the facade. As, we can see in the non-refurbished building (left-hand side), specifically in the lower right window, how the predominant yellow colour indicates that the heating system was turned on inside the house, and these heat flow is being lost through the facade. By contrast, in the image on the right-hand side, the facade has a homogeneous behaviour (continuity of colours). Only vertical lines are observed, which correspond to the union of the facade panels without a difference in the hue observed.

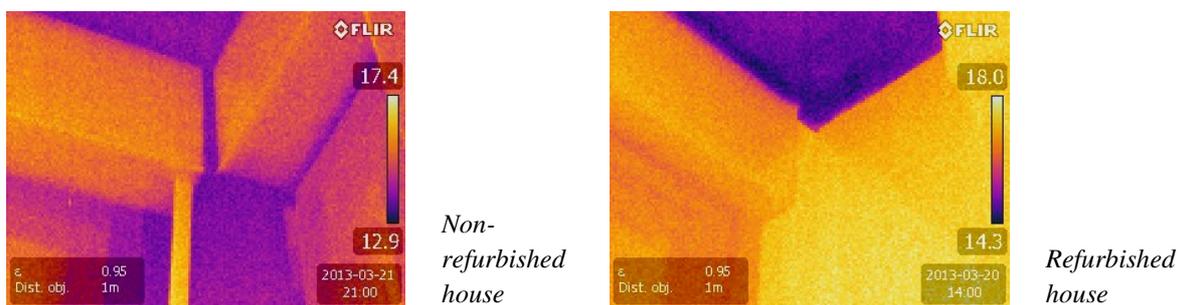
Fig. 3. Interior Infrared indoor images on facade typology A1.

In the infrared image (left-hand side) it is possible to see a common problem in this kind of buildings, where the shutter boxes represent both an important loss of heat and infiltrations as well, because they are not insulated. However, in the right-hand side, there is no discontinuity in colour between the wall and the window.

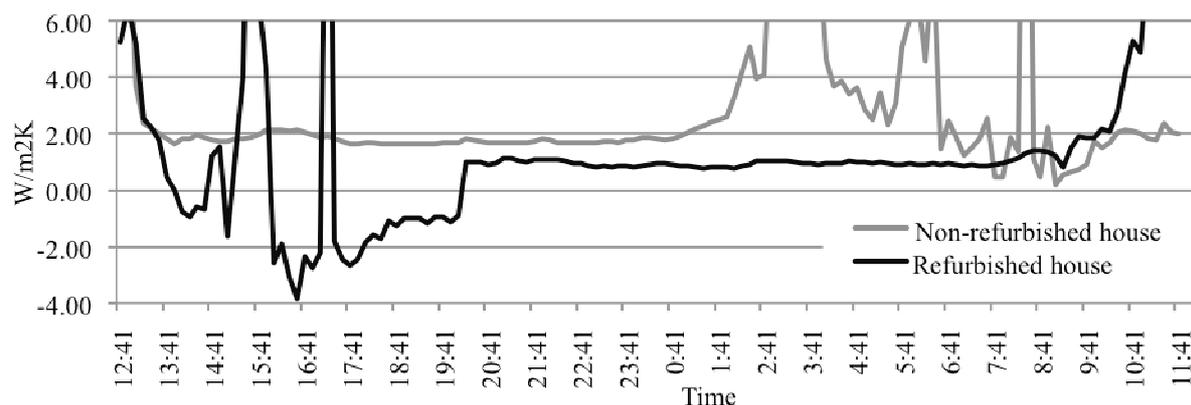
Fig. 4. U-value (W/m<sup>2</sup>K) measured for 23 hours on the facade typology A1.

A theoretical study has been made using mathematical calculations. Also "in situ" measurements have been performed in homes for 23 hours, collecting information every 10 min<sup>8</sup>. Measurements of 15 dwellings were performed on different days. In the theoretical study, the thermal transmittance was 1.65 kWh/m<sup>2</sup> corresponding to the non-refurbished building. In refurbished building the thermal transmittance was 0.55 kWh/m<sup>2</sup>. In the "in situ"

study the thermal transmittance was 1.67 kWh/m<sup>2</sup> in the non-refurbished building. While, in the refurbished building, the thermal transmittance value was 0.95 kWh/m<sup>2</sup>. Both theoretical and in situ measured data showed a large difference between the thermal behaviour of the refurbished and non-refurbished facades. According to the thermal transmittance measured "in situ", it can be concluded that the thermal behaviour of the opaque part of the facade improved by 77% after refurbished.

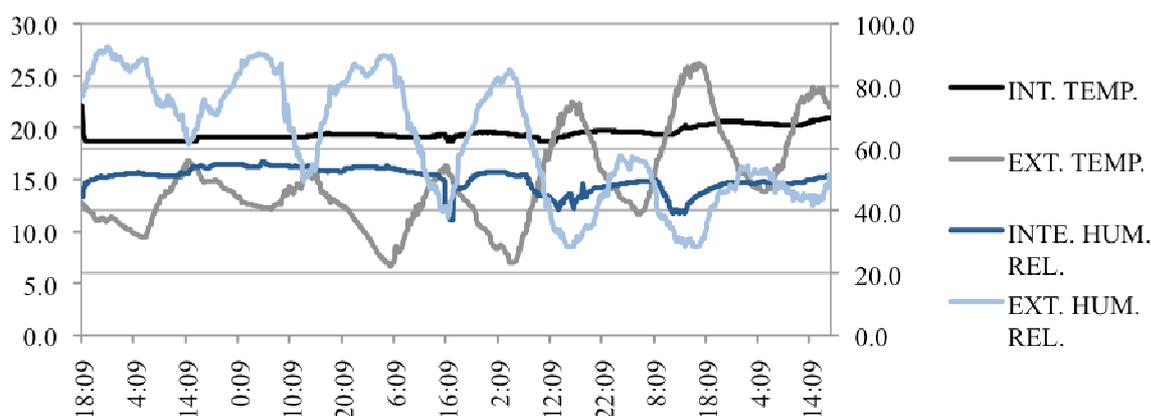
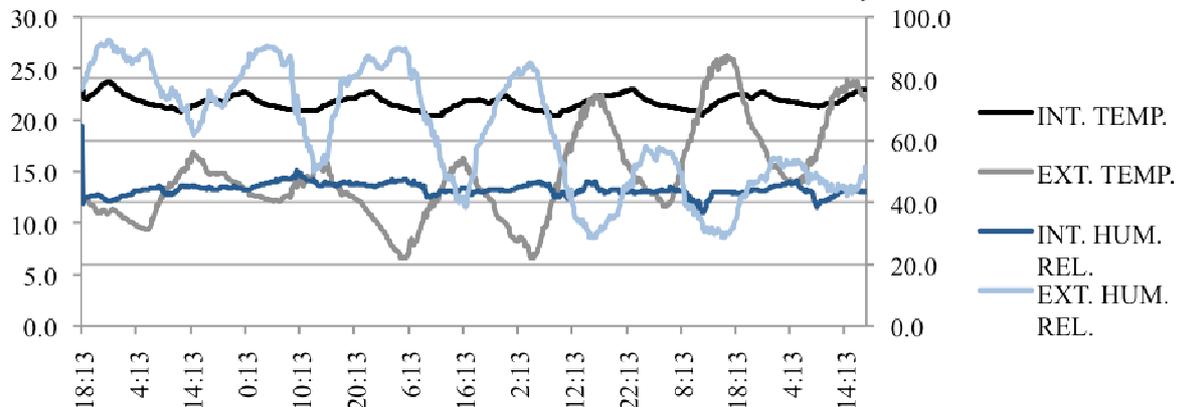
Fig. 5. Temperature and humidity Measured in typology A1.

Figure 5 shows the indoor temperature and humidity measured between 9 and 17 of April in the A1 building typology. In this case, the user's behaviour (switching on and off the heating, opening and closing the windows for ventilation, etc.) will be one of the most important influences on this data. One of the differences that could be observed was that the average air temperature in the non-refurbished house was 19.5 °C while in the refurbished house was 21.7 °C. The temperature in the non-refurbish house was quite constant, possibly because the measuring instrument was placed in a room that is not often used by the occupants.

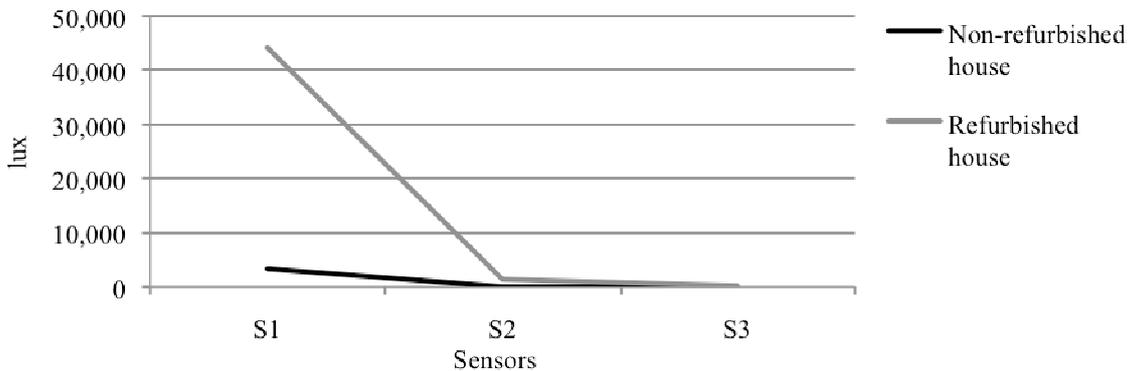
Fig. 6. Illuminance taken in the typology A1 at 3 o'clock.

Figure 6 shows the illuminance of each dwelling decreasing drastically in the second sensor (S2), which created a glare area between the first and second sensor. Also, it shows that the illuminance on the third sensor (S3) for both cases fails to get 300 lux, the minimum value to make any activity that does not require visual effort.
