# Construction of a high anchored wall at highway EX-A1 (Spain)

A. Gómez<sup>1</sup>, A. Soriano<sup>2</sup>, E. Carrera<sup>3</sup> and A. Soriano-Martínez<sup>4</sup>

**ABSTRACT** Highway EX-A1, near the Spain-Portugal border, crosses a Tertiary formation of weak marly rocks that are affected by high tectonic stresses that had created a good number of failure planes within the rock. During the past geologic times, some large landslides had taken place. They are now covered by Quaternary soils. The design of high cuts in this type of rock formation is somewhat troublesome. The paper indicates one of the solutions that have been implemented to stabilize one of the main highway cuts.

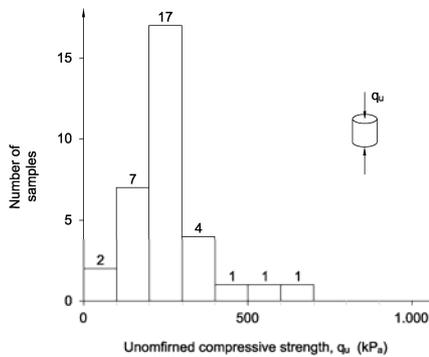
Figure 1.- Compressive strength of the soft marls

Examination of the relation between the depth of the sample and the  $q_u$  value indicates no a clear correlation.

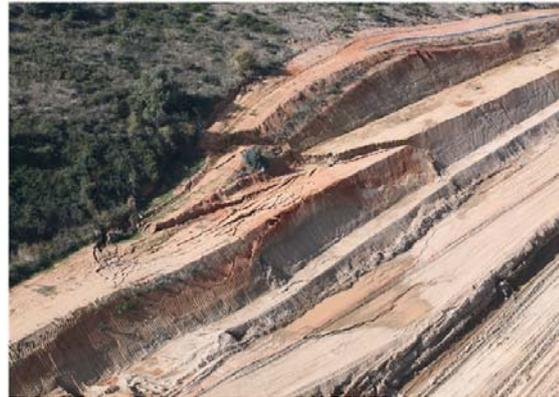
The excavation of this cut resulted unstable. A clear scarp appeared behind the upper part of the slope and the vertical movement of the sliding mass amounted to more than 1 m near the crest of the slide. The picture included in Figure 2 was taken a few months after the failure.

Figure 2.- Observed failure during construction

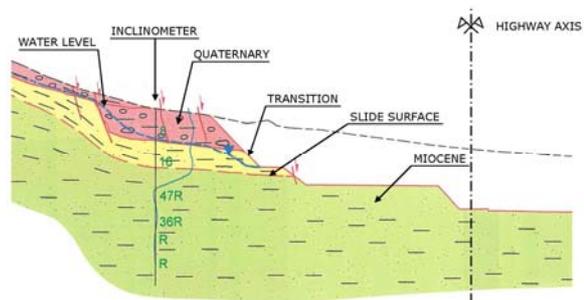
A scheme of the possible failure surfaces is indicated in Figure 3.

Figure 3.- Scheme of the observed failure surfaces. Geotechnical report after sliding. Translated from the original drawing made by Rodríguez Ortiz and Rodríguez Jurado, 2010

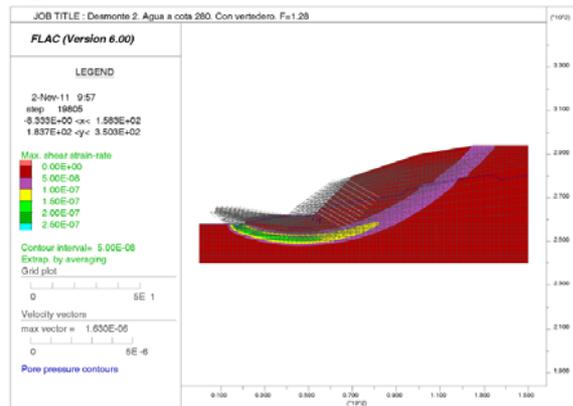
The type of expected failure, in case the ground strength is lower than that used for calculation is indicated in Figure 5. This particular situation corresponds to the phase of construction immediately before the placement of the final fill and with a water table situated at the medium expected level. For this situation, which is the more critical during construction, the resulting factor of safety, for the highest reasonable water table, is  $F = 1.1$ . For long term condition the expected factor of safety being  $F \geq 1.3$ .

Figure 5.- Type of failure for a particular design situation

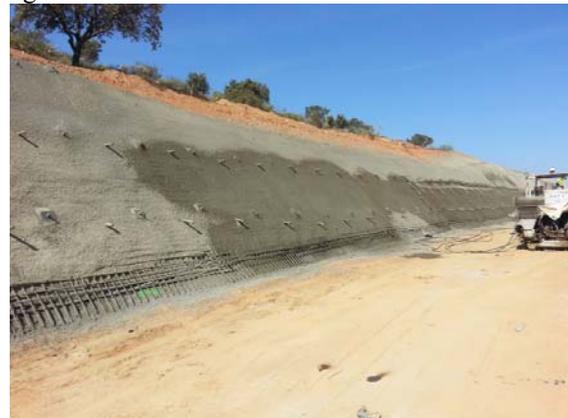
The photograph included as Figure 7 shows a view of the wall when it had a height of 4 m; that its two wall strips, each one 2 m high.

At this situation, when only the upper 4 m of the wall were finished, the excavation near the toe of the cut was initiated in order to reach the final explanation level for the highway. This was aimed to advance the general construction schedule. But this excavation reactivate the sliding of the ground between the anchored wall and the future highway as indicated in Figure 8.

Figure 7.- Anchored wall wader execution

- Increase the length of the anchors of the two lower rows of the wall from 12 m to 16 m.
- Substitution of the concrete wall that was to be built at the toe of the cut by a second anchored wall 4 m high built with the same procedure as the main anchored wall.

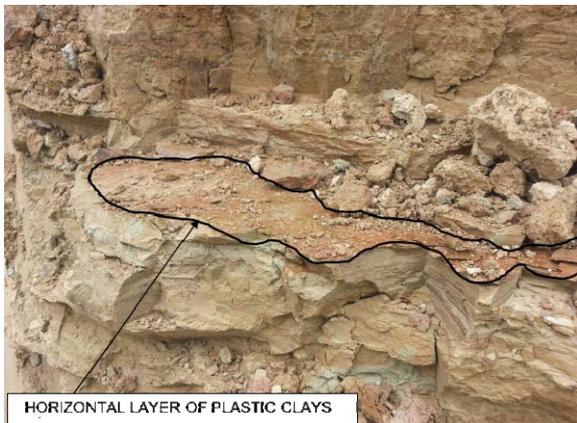
During the construction of the lower part of the main wall and during the construction of the lower anchored wall, the structure of the soft Miocene marls was examined. Figure 9 indicates a fine layered clayey stratum near a separation surface (old sliding plane) where a few millimeters thick layer of clays exist and is thought to be the cause of the initial slide of this excavation as well as the second slide that took place during the execution of the solution, front of the upper anchored wall.

Figure 9.- Detail of a fossil sliding plane

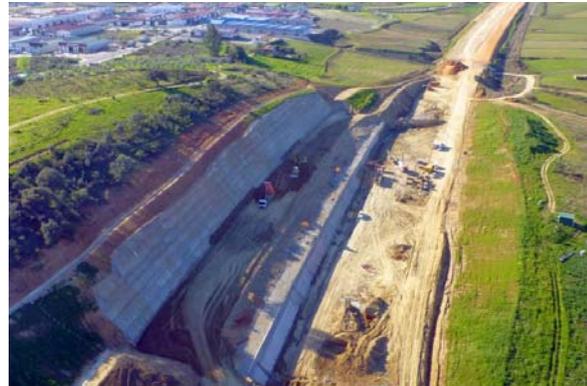
Excavations were completed with no other major incidents. Figure 10 includes a view of the situation of the walls (upper and lower anchored walls) when all excavations were finished and the final fill placement is under execution.

Figure 10.- View of upper and lower anchored walls

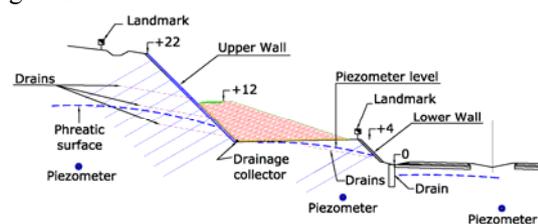
Data of most interest in order to assess the stability of the cut were thought to be the movements of the anchored walls and the piezometric elevation of groundwater. In order to obtain this information, landmarks were placed along the crest of the upper and lower walls, at 20 m intervals. Some piezometers were placed within the marls, as indicated in Figure 11.

All piezometers used for this particular cut (a total of nine units) indicate pore-pressures much lower than those that could be obtained by other observations. Drains placed at the toe of the upper wall, as well as those of the lower wall, were draining some small flow of water. These observed facts indicate that the piezometric level, at the central section of the cut, should be at a position similar to the one indicated in Figure 11.

Figure 11.- Scheme of the observation of movements and pore pressures

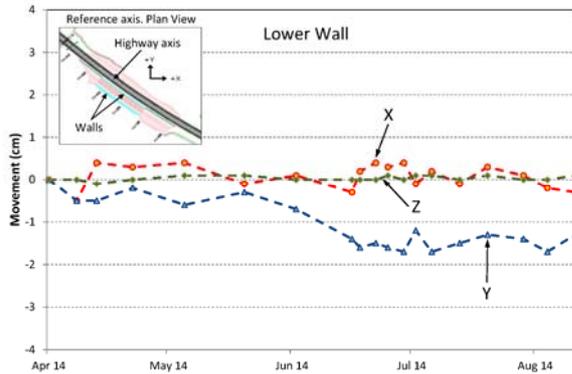
During the month of June 2014 and due to the final transitory excavations needed to prepare the highway platform, some movement took place at the crest of both walls as indicated in Figure 12, for the central section of the lower wall. For other sections movements were quite similar. The maximum observed movements are quite low and mainly due to the final excavation process.

**Figure 12.-** Observed movements at the central section of the lower anchored wall
