# Failures of harbour walls at Malaga and Barcelona

José María del Campo · Vicente Negro

**Abstract** The paper describes the failure of harbour walls which occurred at Malaga on 4th July 2004 and at Barcelona on 1st January 2007, associated with an inadequate consideration of the ground conditions in the light of the marine environment. At Malaga, there was an existing breakwater hence the new harbour was protected from the effect of the waves while at Barcelona, the construction of the quay wall proceeded at a faster rate than the breakwater. In both cases the wharf backfill was placed rapidly on the soft muds, progressing from the inland side. The paper discusses the importance of an overview including the ground investigation, engineering design, construction method and speed of construction.

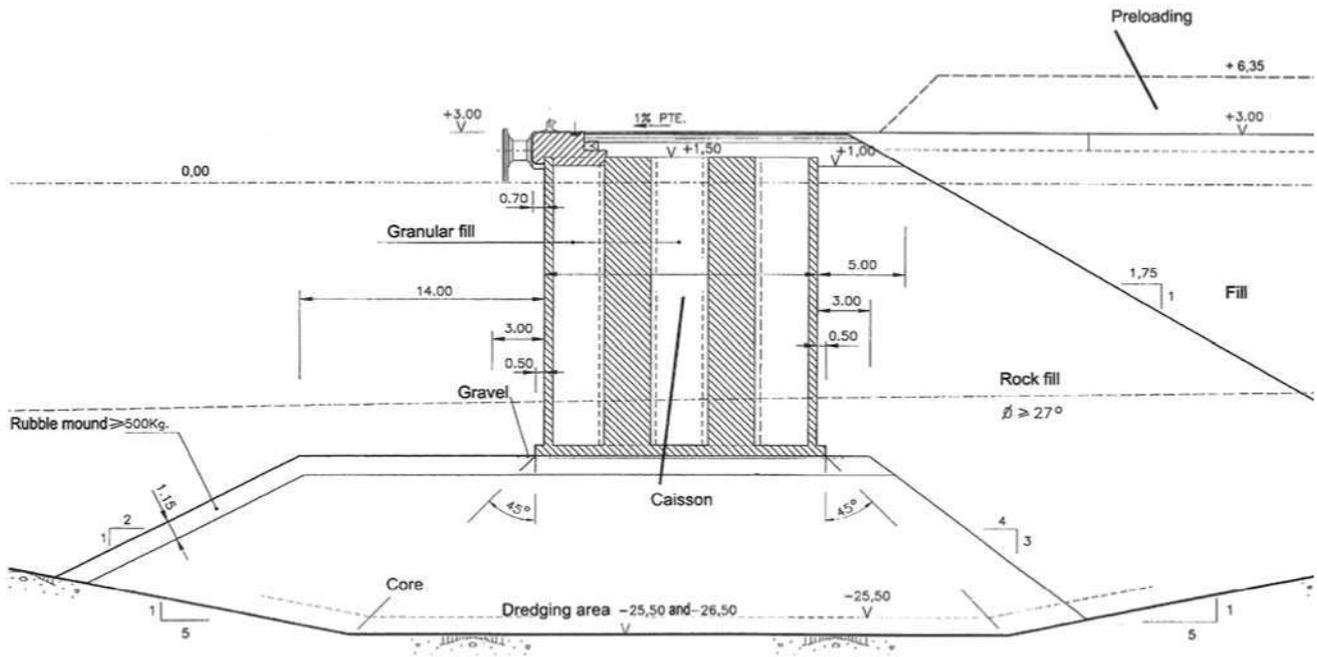
Following dredging the structure was founded on an 8 m thick concrete strip which extended from 15 to 22 m bsl. The silty mud dredged had a low  $\phi'$  of ca. 10°. The dredged slope was 1:5 (11°) on the exposed side and 1:7 (8°) on the landward side.

In order to operate the Terminal on the concession system, the wharf fill was consolidated by loading in 3 m lifts on the landward side. A standard cross section for the quay is shown in Fig. 1 and the geotechnical profile in Fig. 2.

Fig. 1 Standard cross section of the Malaga quay

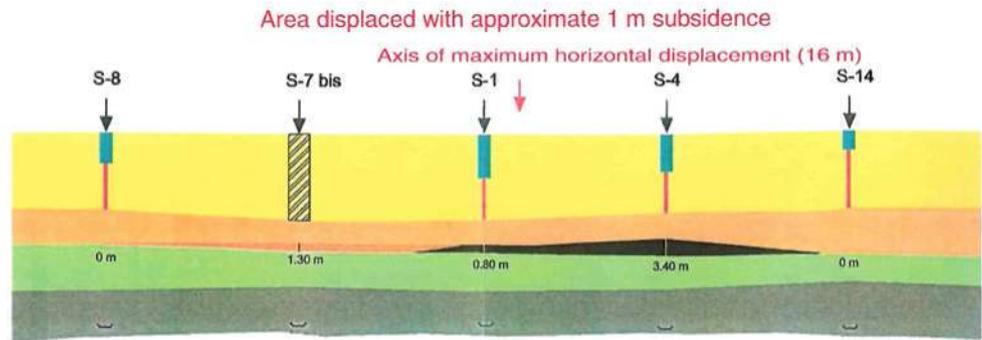
Longitudinal profile along the line of boreholes over the caissons (Profile 1)

Fig. 2 Longitudinal profiles along the quay's alignment

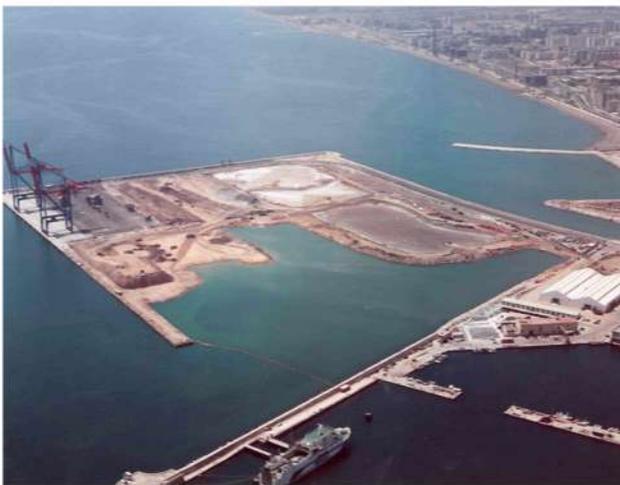
The first part of the construction was finished in July 2004 and began operating, although ground improvement and consolidation continued (see Fig. 3). Much of the fill beneath the wharf was placed on mud which had not been fully appreciated at investigation/initial construction stage. As a consequence, five of the central caissons slid outwards, causing the quay wall to fail (Fig. 4). Possible contributory causes include: insufficient dredging of the soft material beneath the wharf area; too rapid a placement of the fill and an inadequate thickness of the support strip. As a consequence of the limited appreciation of the ground conditions at both investigation and construction stages, the project was delayed by more than 12 months for the

Fig. 3 Malaga quay in the construction phase

demolition and replacement of the structural elements (caissons) and foundations.

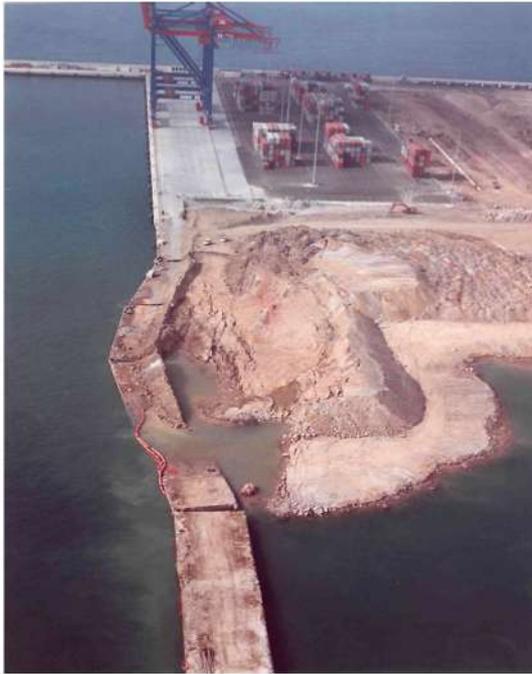
Fig. 4 Deep central core sliding phase

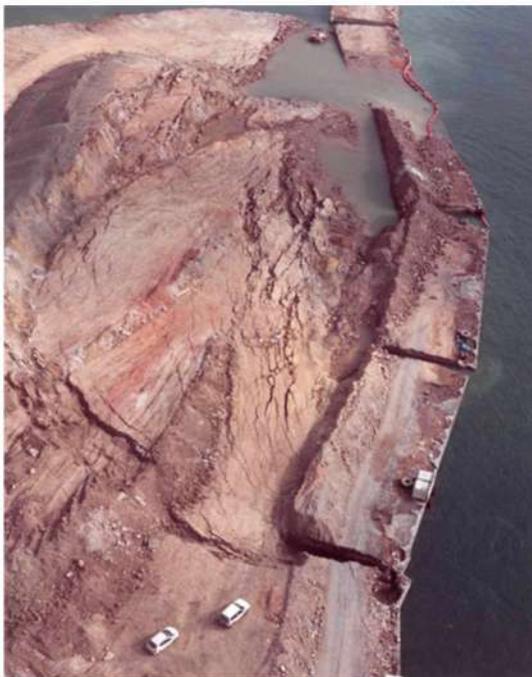
Fig. 5 Collapse of the second phase of the Terminal. East-west aerial view

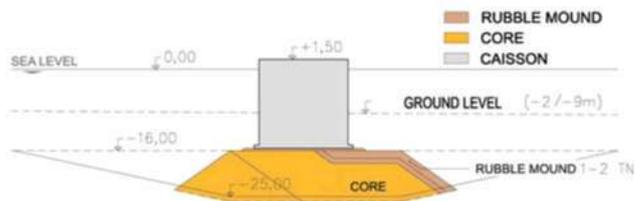
The Prat Quay is a 1,500 m long construction with two sections (I and II) protected by the south extension to the Barcelona breakwater (Figs. 5, 6, 7). Prat I was built after mud dredging from 16 to 25 m bsl and the placement of a 9 m thick rock fill blanket. The wall itself consisted of four caissons on granular foundations. During the construction of the second phase, the work was protected by the extension to the sloping breakwater. Following dredging to 24 m bsl, the 11.5 m wide caisson was placed on a 8 m thick rock blanket at a level of 16.5 m bsl (Negro et al. 2008) (Fig. 8).

Fig. 7 Typical Prat Quay cross section, first phase (breakwater behaviour)

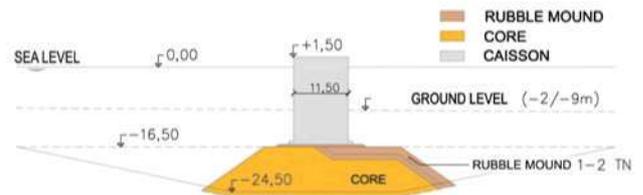
Fig. 8 Typical Prat Quay cross section, second phase (dock behaviour)

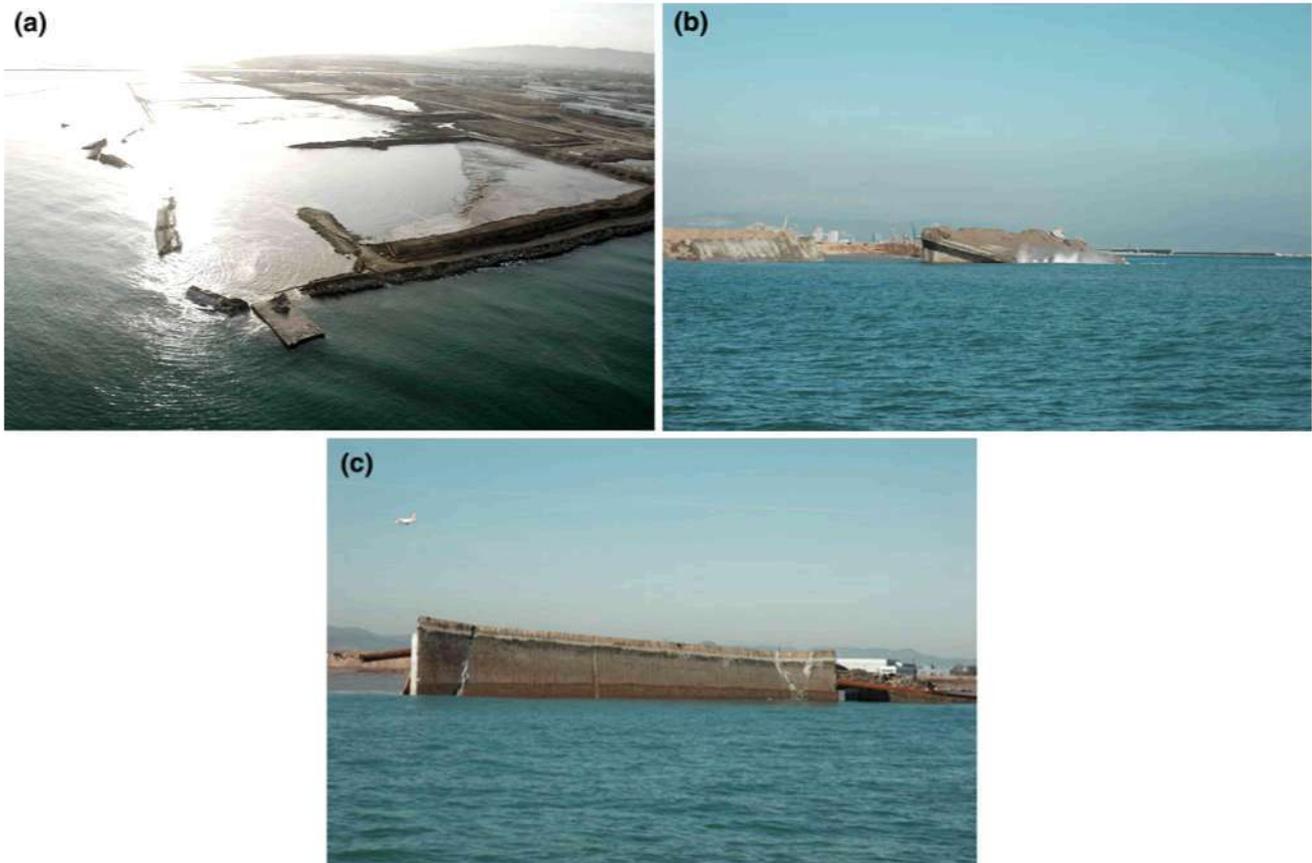
**Fig. 9** a State of Prat Quay after the collapse. b State of the caissons after the quay slid. c State of the caissons after the quay slid

8. The caisson acted as a dam, hence the pressures were higher than anticipated at design stage.
9. The tidal environment, as well as the variable pressure imposed on the structure by waves, was difficult to model.
10. The balance of effective and neutral stresses may cause ground liquefaction and siphoning.

With these limitations, the quay was prone to sliding as a consequence of only a slight environmental, geotechnical or structural disturbance and it collapsed on 1 January 2007. (Fig. 9a–c).

After debris removal, blasting and caisson refloating, repair works were undertaken during 2008 and 2009 and it is hoped the Terminal will come into service in 2010.
