Structural Deterioration and Failure of the Laminated Wooden Roof of a Covered Swimming Pool

Javier Pinilla-Melo ^{1,*}

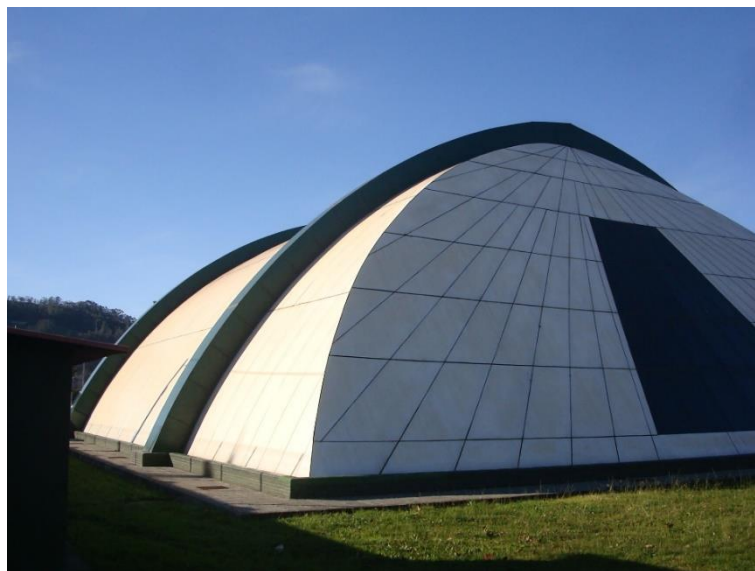
Figure 1. Exterior of the indoor swimming pool.

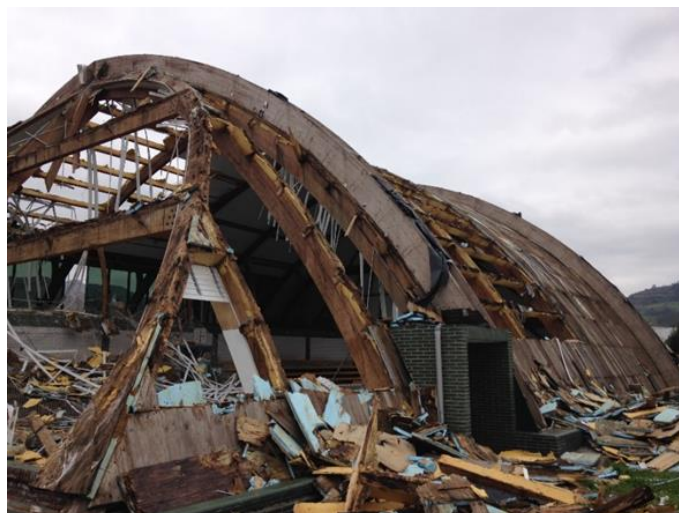
Figure 2. Building demolition.

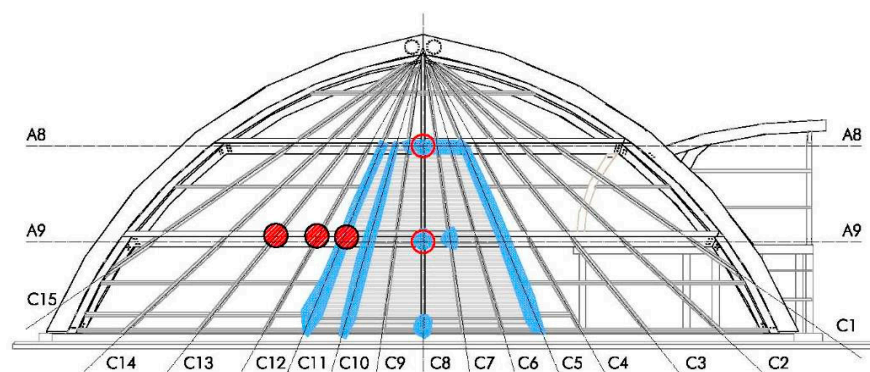
Figure 3. Plan and section with the location of damage (blue—soft rot fungi; red—breakage of connections).

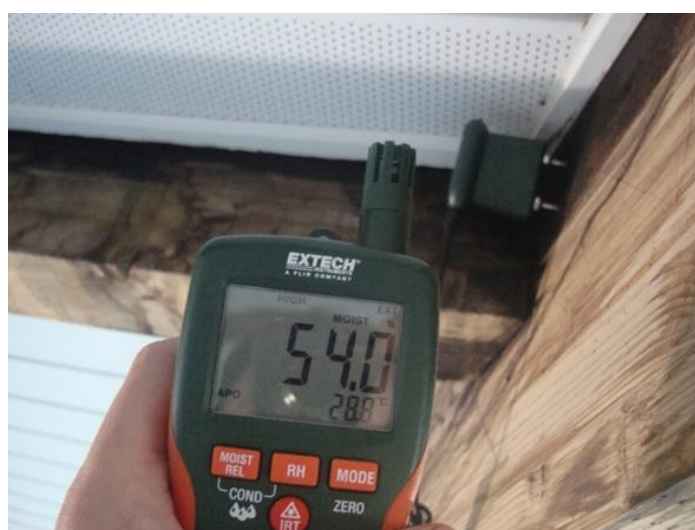
Figure 4. Measurement of wood temperature and moisture content with a needle thermo-hygrometer.

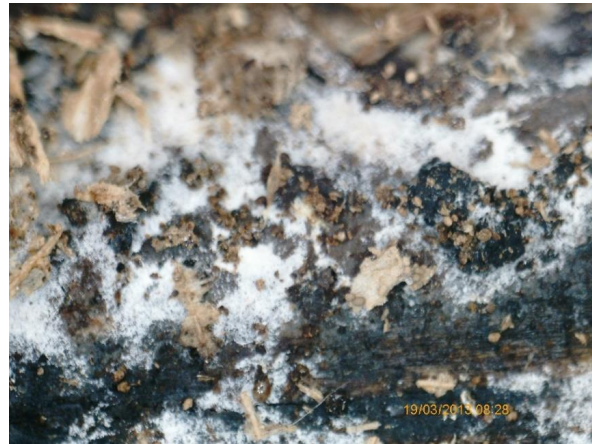
Figure 6. Microscopy of soft rot fungi.

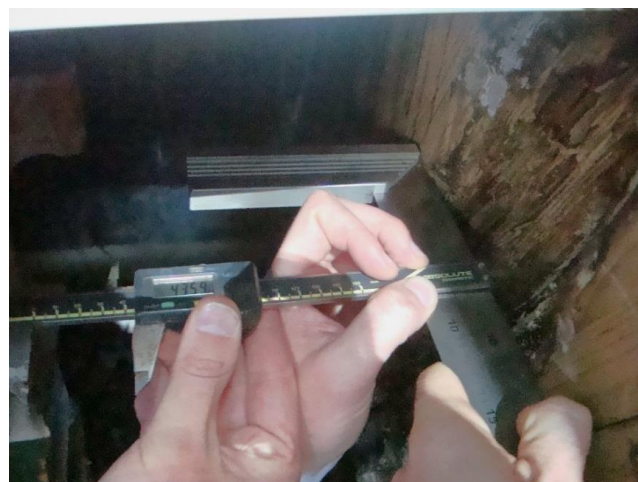
Figure 7. Measurement of sectional loss due to wood rot using a digital caliper.

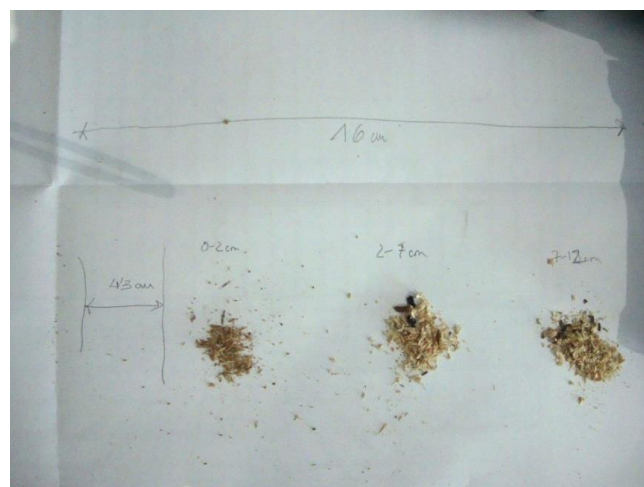
Figure 8. Sawdust extracted from a 16 cm hole drilled at the base of the arch. The depth of each extraction from the 4.3 cm sectional loss is indicated.

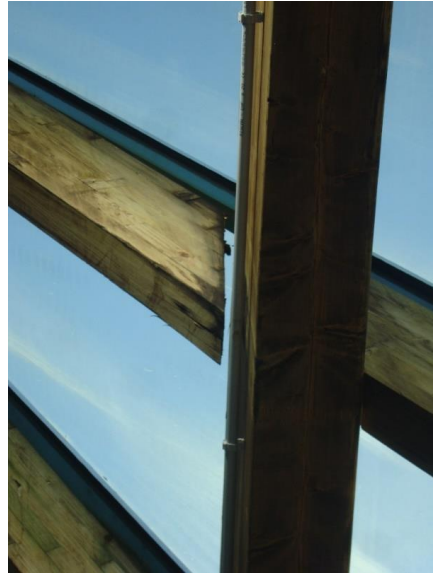
Figure 9. Breakage of fixings between the pair and beam.

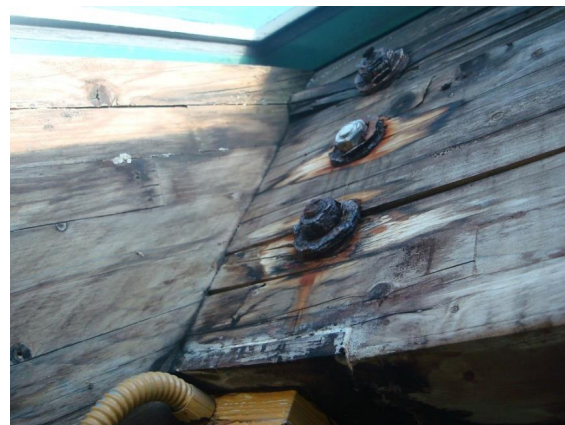
Figure 10. Corrosion of nuts, washers, and threaded rods in beam connections.

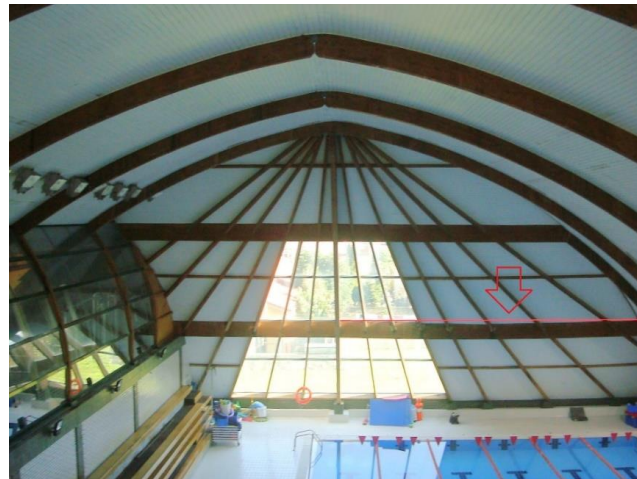
Figure 11. Deflection of a horizontal beam in the inclined façade.

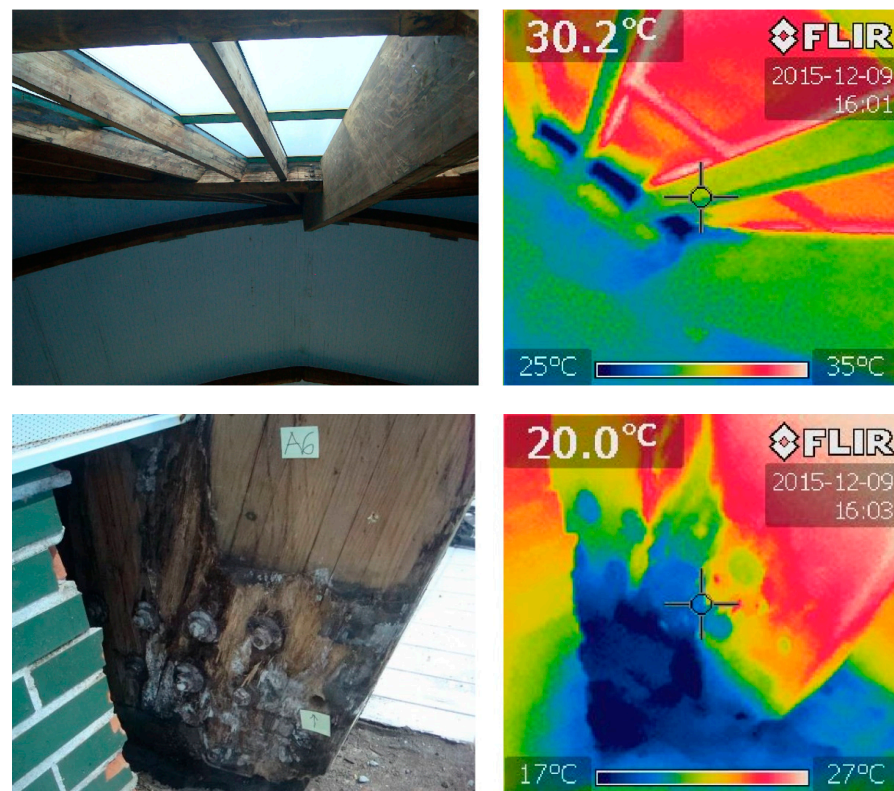
Figure 12. Thermal camera images of the toral rafter's foundation and A6 arch support. An RGB image is presented on the right.

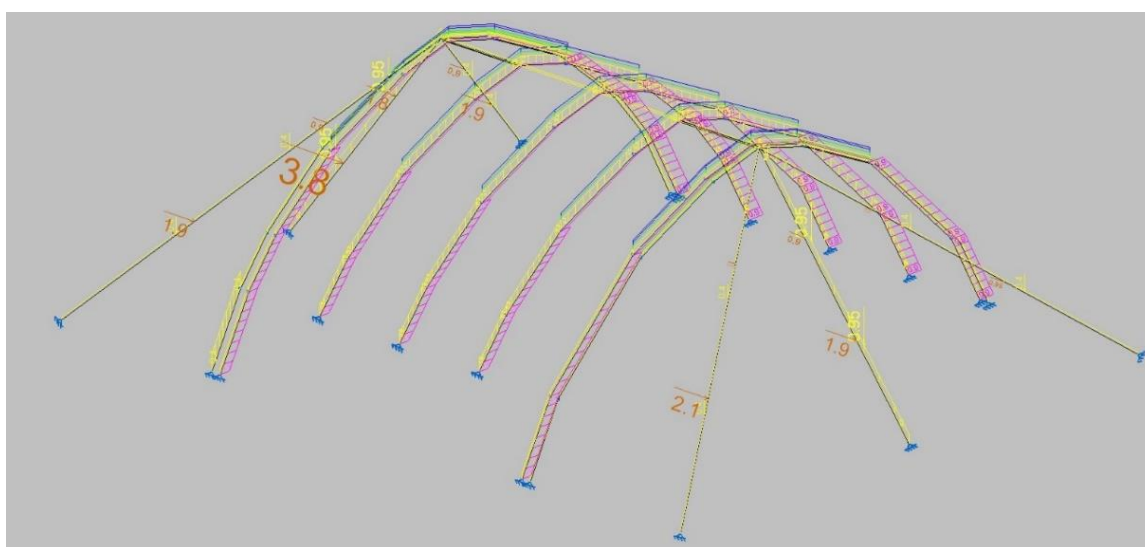
Figure 13. Loads (yellow: permanent; magenta: longitudinal wind; orange: transversal wind; green: maintenance; blue: snow).

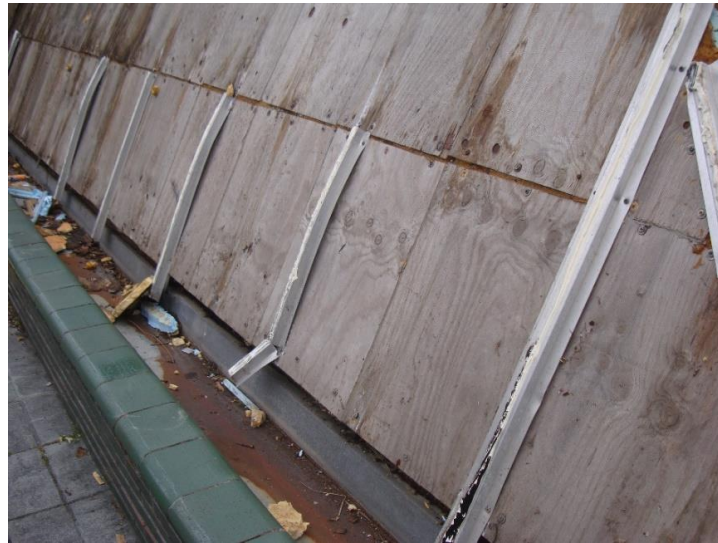
Figure 14. Aluminum omega profiles screwed to the wooden sandwich panel. Image taken during the demolition process.

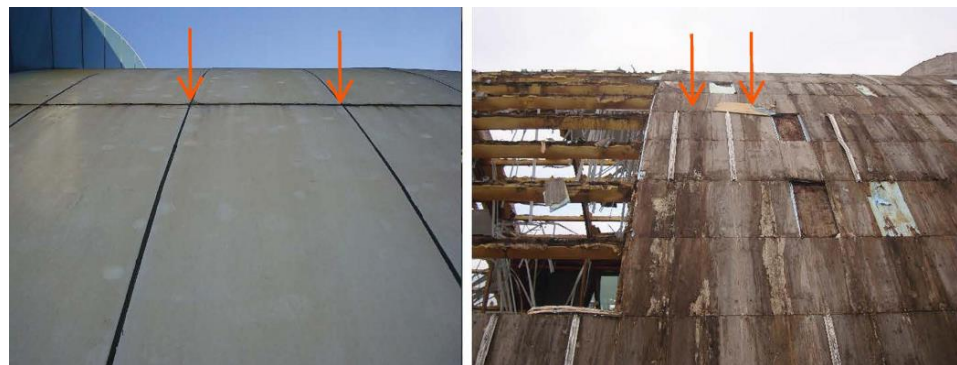
Figure 16. Left of the image: composite roof panels before demolition. Right of the image: the wooden sandwich panel during the demolition process. Red arrows indicate areas of water seepage through the composite roof panels.

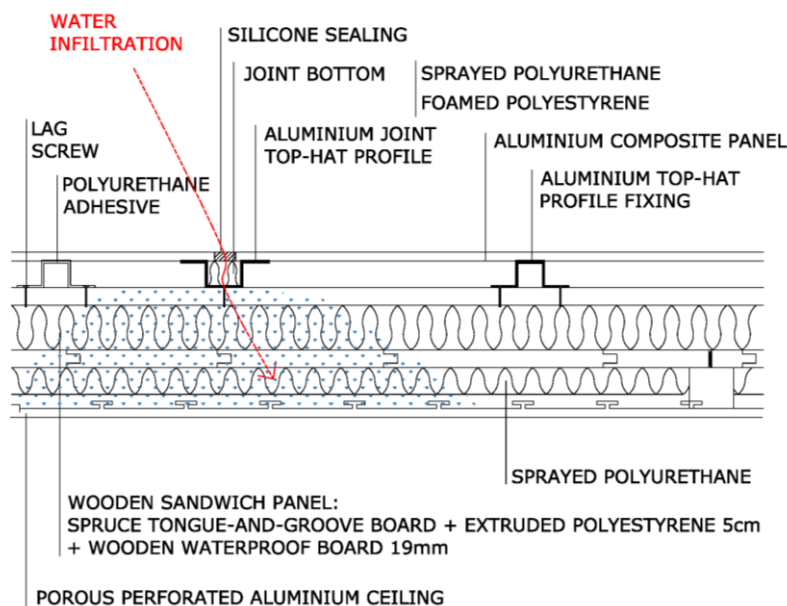
Figure 18. Longitudinal constructive section of the roof with indications indicating its constructive elements and water seepage points.
