# Preliminary Geospatial and In Situ Reconnaissance of the 8 September 2023 Moroccan Atlas Earthquake Damage

**Abstract:** This research investigates the post-earthquake performances of structures in four rural villages in the Moroccan Atlas, emphasizing common construction system characteristics and design flaws that render buildings susceptible to seismic events. Village selection was based on a prior multispectral satellite-image study, proving effective for planning high-impact, post-earthquake field campaigns. The significance of this research resides in on-site data collection, facilitating the physical assessment of earthquake-induced damage and identification of inherent vulnerabilities in construction systems. The constructions in the study area exhibited structural design deficiencies, inadequate construction techniques, and urban modifiers, leading to damage extensively documented in the literature, as well as less-documented unique damage. Predominant seismic-design shortcomings in the study area included subpar material quality, insufficient earthquake-resistant design, and unskilled labor. In situ data were complemented by a global geospatial approach using different

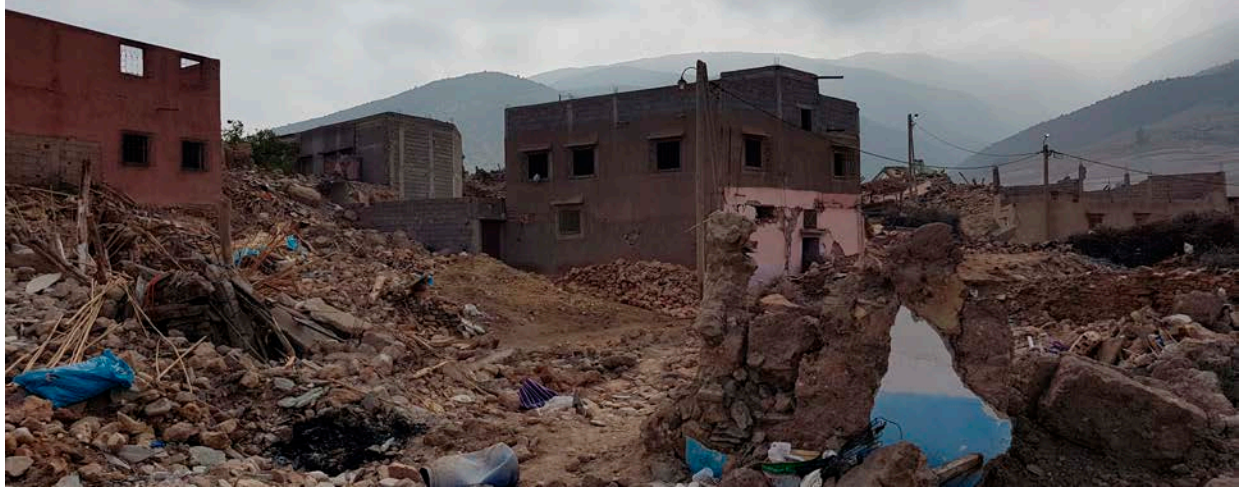
In accordance with the EMS manual [31], the structures in Tafeghaghte, primarily composed of stone masonry with non-anchored one-way wooden floorings, are categorized as Class A vulnerability. Most of these buildings had collapsed (grade 5), whereas confined masonry constructions suffered less damage (grade 2 to 4), suggesting an intensity of approximately IX in this area (Figure 7). In contrast, in the analyzed area of Talat N'Yaaqoub there were numerous constructions with confined masonry walls made of concrete blocks with beam and block floorings, classified as Class C vulnerability [31]. A less-vulnerable construction system recommended by Moroccan seismic regulations and other guidelines

**Figure 7.** Evaluation of damage along a street in Tafeghaghte subsequent to the 8 September 2023 earthquake. Stone masonry structures have predominantly collapsed, while confined masonry systems or confined mixed systems mostly display damage ranging from grade 2 to 4 [31].

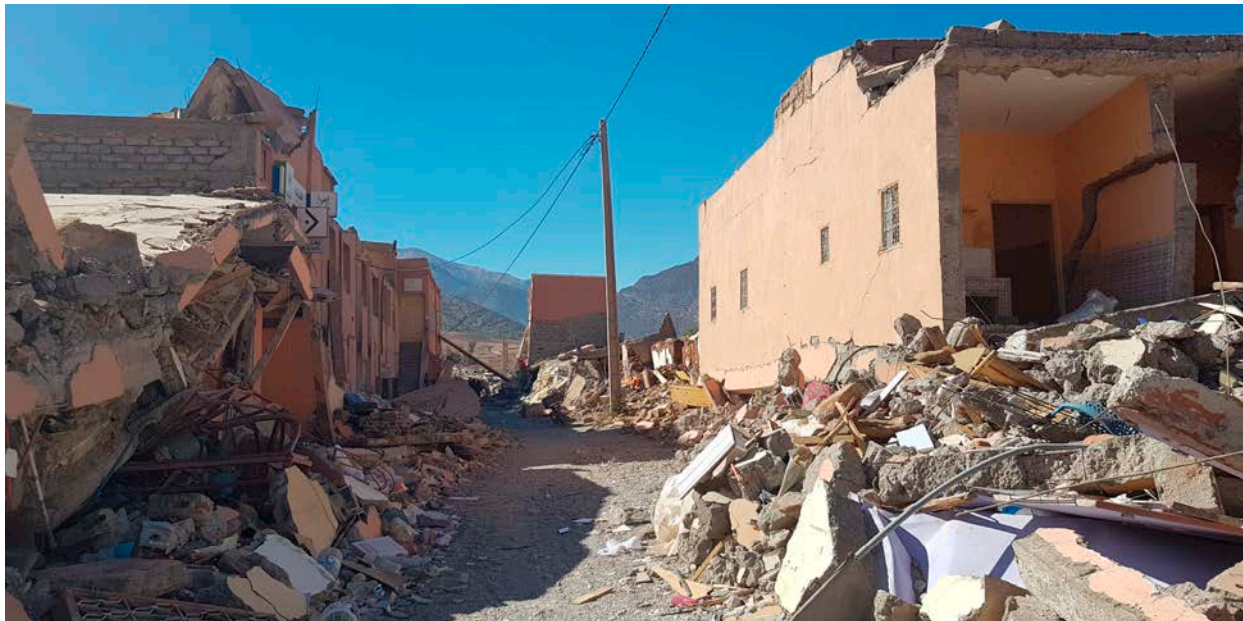
in regions with high seismic-threat [13,32] suffered damage ranging from Grade 3 to 5 in many buildings. The macroseismic intensity in this zone is estimated to fall within Grade X, according to the damage observed to the constructions (Figure 8).

**Figure 8.** Assessment of damage in a street of Talat N'Yaaqoub following the 8 September 2023 earthquake. Confined masonry structures exhibit extensive destruction, with buildings suffering grade 3 or higher damage, and numerous collapses recorded at grade 5 [31].

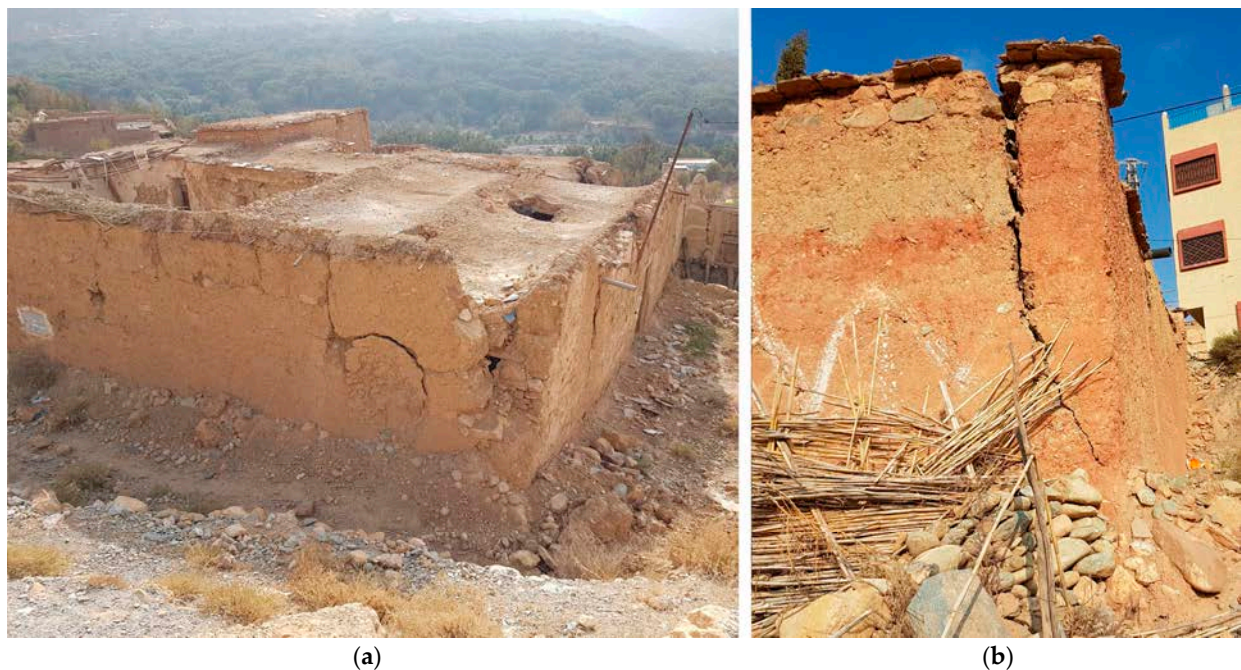
Single and two- or three-story residential houses comprise load-bearing earth walls ranging in thickness from 50 to 60 cm. Over time, the material tends to lose cohesion. The floor slabs are typically heavy, consisting of wooden beams covered with straw and compacted earth. There is often a lack of diaphragms, inadequate support, and an absence of anchoring of floor and roof elements to walls, leading to highly flexible floor systems and deficient roof structures (Figure 10). Moreover, due to the lack of cohesion, characteristic of this material, perpendicular walls present a lack of box behavior. The vulnerability of this type of construction is not included within the classification provided by the EMS-98; however, its main features make these buildings more vulnerable than those considered the most vulnerable in this scale, those in Class A. Therefore, it would be reasonable to consider them as not classified (equal or inferior to class A).

**Figure 10.** Out-of-plane failure of an exterior wall on a rammed-earth building with a floor constructed from wood, straw, and mud. These images highlight insufficient connectivity observed between the perpendicular walls and the floor diaphragms. Image (a) displays damage to the corner and a portion of the parapet and image (b) illustrates an out-of-plane failure of a wall. The buildings were situated in the central area of Adassil.

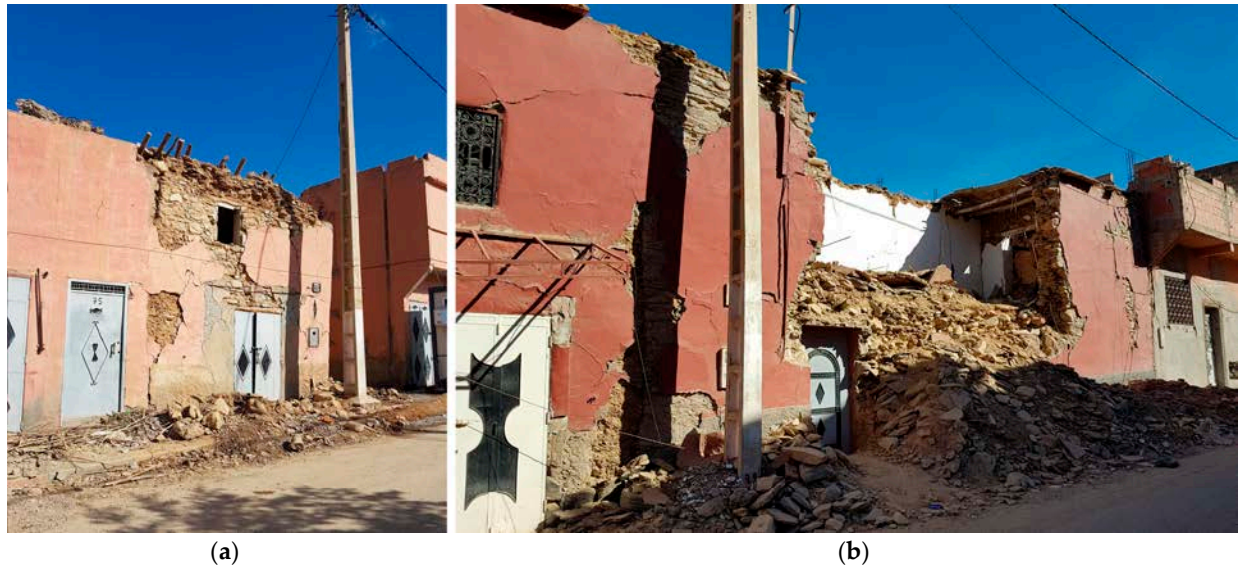
**Figure 11.** Impact of the 8 September 2023 earthquake on a stone masonry building with wooden log slab in Amizmiz. Image (a) illustrates the inward collapse of the roof, attributed to inadequate support, leading to the subsequent collapse of the upper part of the wall. Image (b) shows the crumbling of the walls.

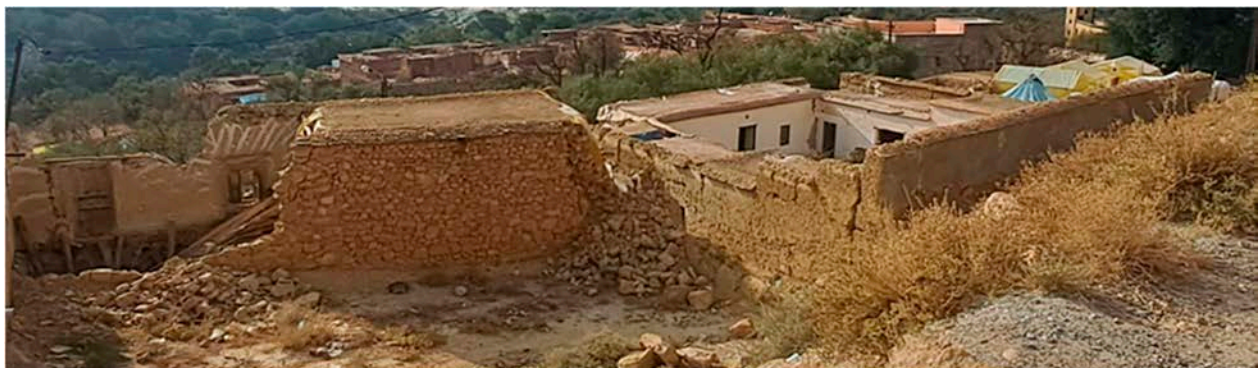
**Figure 12.** Impact of the 8 September 2023 earthquake on a traditional building in Adassil with a floor made of wood, straw, and mud. The observed damage includes the disintegration of sections of the stone masonry walls of the house and failure characterized by perpendicular bending at the corners of the rammed-earth dwelling.

The most prevalent failure mode identified in traditional structures was the partial or complete overturning of walls out-of-plane, as depicted in Figure 12. This failure pattern is commonly associated with inadequate connections between perpendicular walls or floors [35,36]. In stone masonry, such failure is frequently witnessed in instances of wall collapse caused by weak mud mortar, inadequately integrated multi-leaf stone wall construction, and insufficiently supported floors [37].

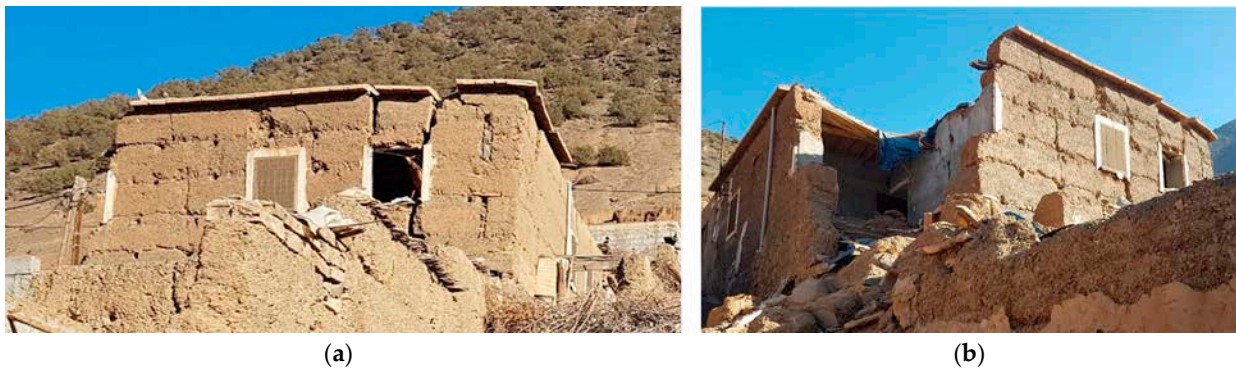
In the context of isolated or corner buildings, particularly those constructed with rammed earth, corner failure was also observed. This type of failure was more prone to occur in scenarios where nearby openings (Figure 13) or structural designs contributed to an accumulation of stress at the corners. In the case of construction systems using earth, observed specifically in the study of Adassil, the rammed-earth buildings with a quadrangular shape and a central patio exacerbated the concentration of stress at re-entrant corners, as illustrated in Figures 10 and 12. This behavior was also observed in stone masonry, where the concentration of stress in tension and the irregular shape of the building was the cause of the observed damage (Figure 14).

**Figure 13.** Damage assessment of a traditional rammed-earth building depicting various stages of damage. The corner failure is exacerbated by the presence of window openings. (a) Partial corner failure, (b) Total corner failure.

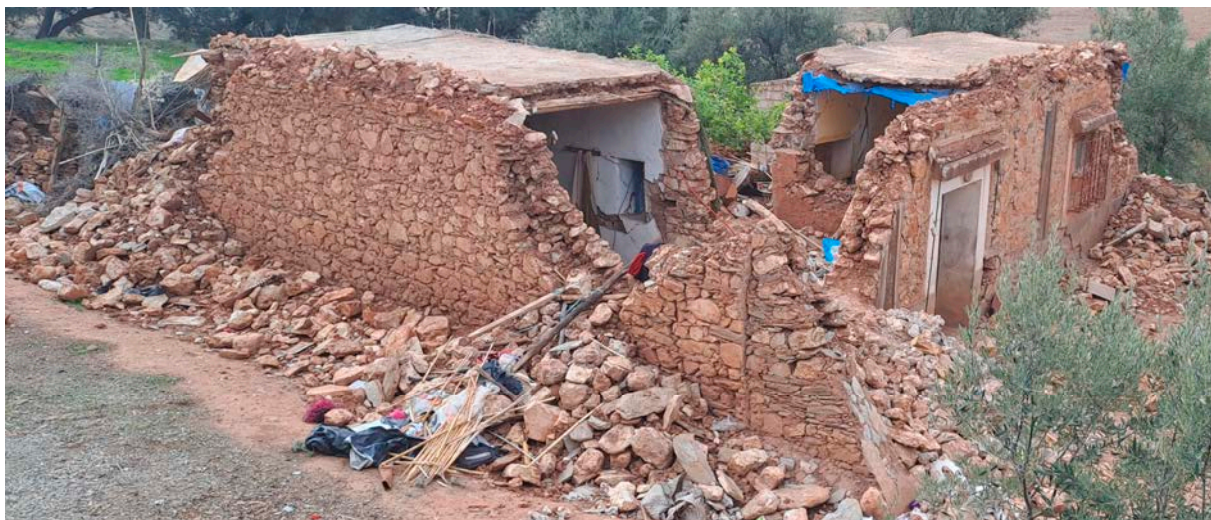
**Figure 14.** Damage observed in an L-shaped masonry residential structure. The damage at the corner is evident, attributed to concentration of stress in this specific area. Residential dwelling in the vicinity of Tafeghaghate.

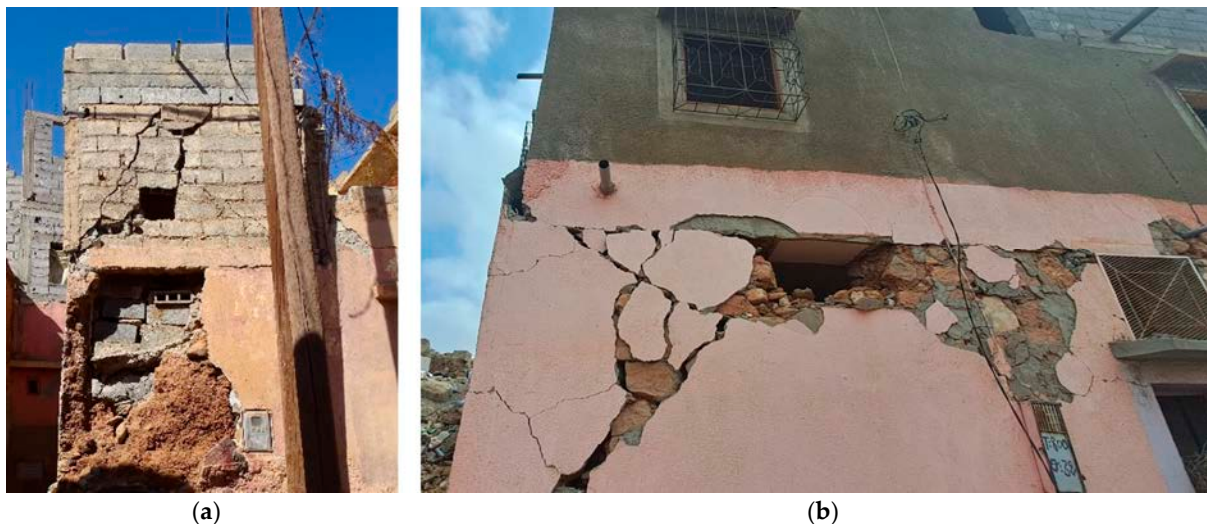
situation arose because the dwellings had grown vertically over time, adding more stories according to the residents' needs but using different construction systems (Figure 15). The brittleness and limited ductility of the stories built using traditional materials determined the behavior of the whole building. The difference in rigidity between the construction elements was decisive in the seismic response of the buildings. Furthermore, the difficulty involved in adequately connecting the two construction systems underlies the fact that many buildings presented damage resulting from sliding between lower walls and upper floors of differing materials (Figure 15b). Additionally, the positioning of these dwellings within the aggregate might influence their seismic response [38–40].

**Figure 15.** Traditional ground-floor buildings with upper floors constructed using reinforced masonry. Image (a) shows evident inadequate connections between traditional and modern construction elements. Image (b) illustrates the lack of connection, combined with varying stiffness among the floors, resulting in the manifestation of horizontal cracks. Location: Amizmiz and Tafeghaghat.

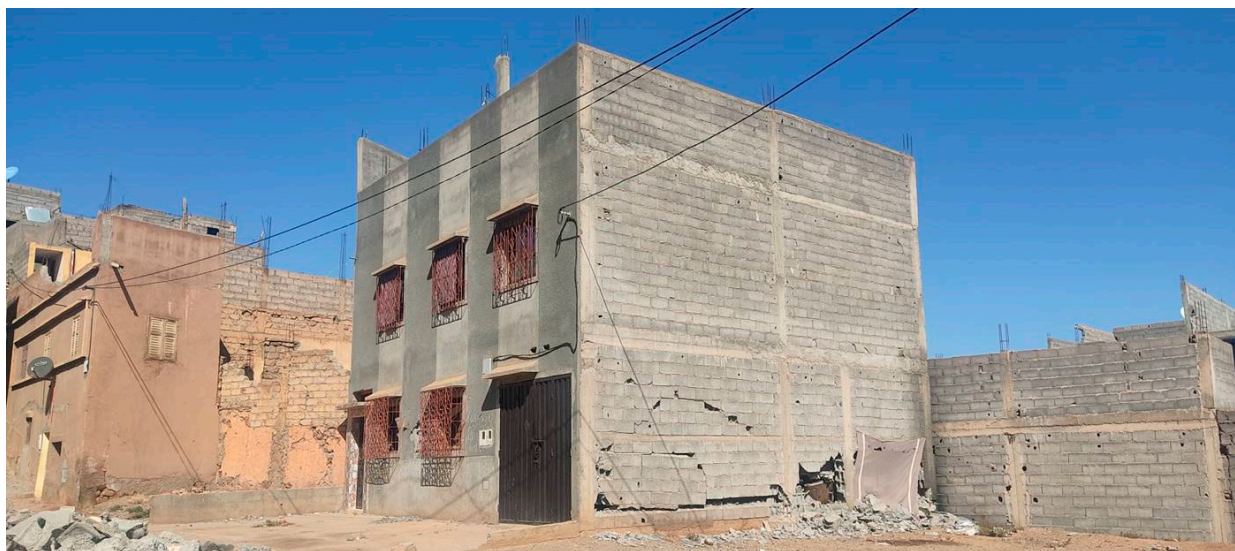
similar or different characteristics. In this regard, it is common to find starter bars at the top of columns to facilitate the anchorage of RC elements of future upper stories (see Figure 16).

**Figure 16.** Several buildings with starter bars at the top of columns to facilitate the anchorage of RC elements of future upper stories (Amizmiz).

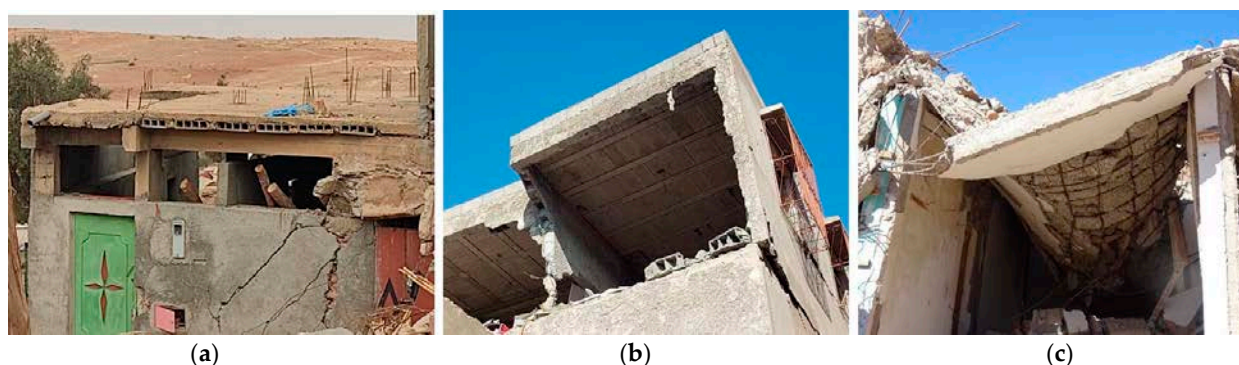
Furthermore, with regard to structure, the horizontal elements were mainly composed of RC joists and concrete hollow blocks with a reinforced or unreinforced compression deck layer (Figure 17a,b). In these cases, a diaphragmatic effect of floor systems is unlikely, due to the low quality of the components and the weak connection between horizontal and vertical elements. Nonetheless, exceptionally, a few cases were identified of reinforced concrete slabs with extremely high ductility in comparison with the vertical structures (Figure 17c).

**Figure 17.** Several buildings with starter bars at the top of columns to facilitate the anchorage of RC elements of future upper stories. (a) Tafeghaghte, (b) Amizmiz, (c) Talat N'Yaquod.

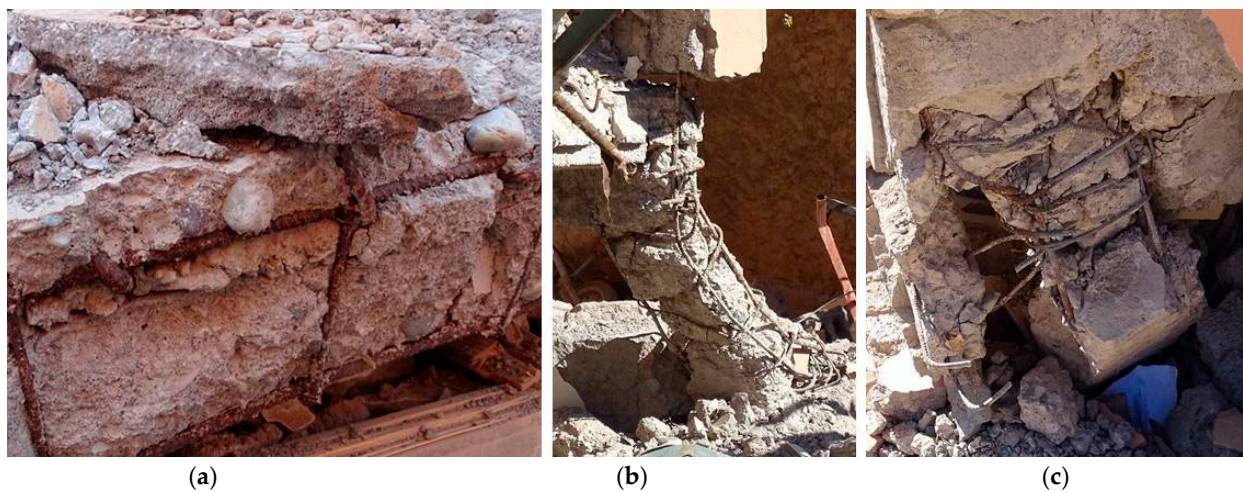
The compression strength of the concrete is one of the most important parameters for seismic behavior in both reinforced-concrete and confined masonry typologies. For this reason, some of the current building codes (EC8 and ACI-318) stipulate a minimum threshold of 20 MPa. In this regard, the RPS 2000 version 2011 establishes a minimum concrete compression strength of 22 MPa. Despite this legal requirement, the visual inspection of constructions revealed that the concrete quality was deficient in several aspects: visible porosity and cavities, discontinuous granulometry and the employment of large rounded aggregates (Figure 18). This low resistance and lack of cohesion of the material was also evidenced by its fragile rupture when exerting manual pressure. Furthermore, in some cases, the steel reinforcing bars were flat, unribbed, or with minimal ribs, which also contributed to poor overall behavior due to the extremely low adherence (see Figure 19). Only in a very small number of cases was corrosion of the steel reinforcement bars detected.

**Figure 18.** Low-quality reinforced concrete due to visible porosity and cavity/holes, discontinuous granulometry, and the employment of large rounded aggregates in structural elements pertaining to different buildings (Talat N'Yaquod) (a–c).

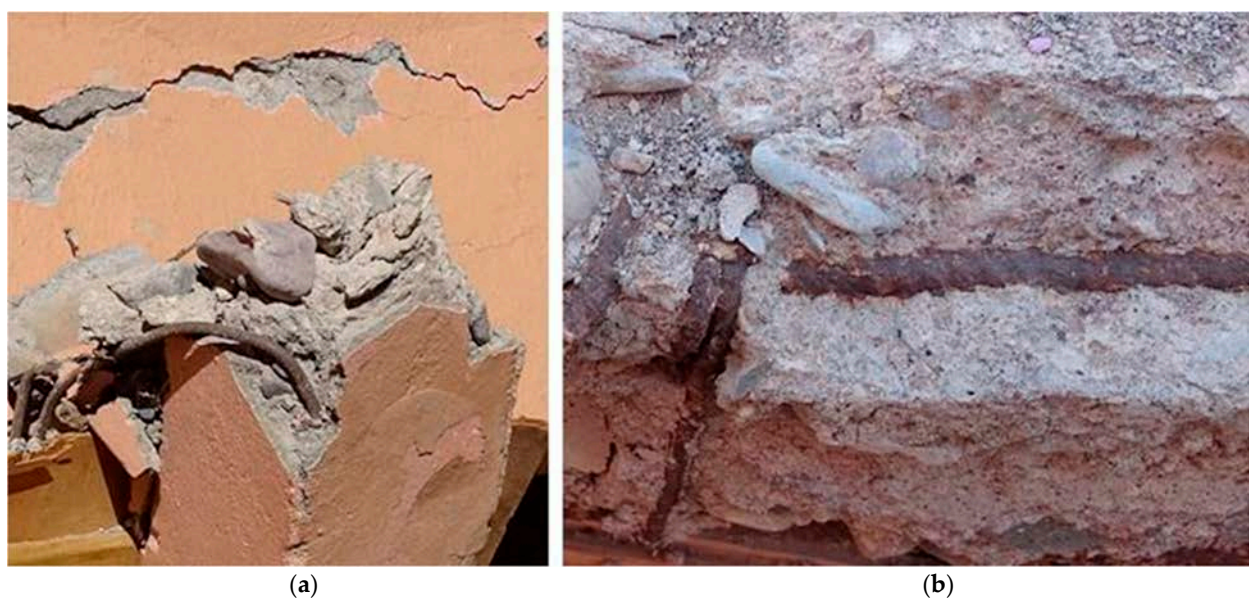
**Figure 19.** Deficiencies in steel bar reinforcement in concrete elements: (a) smooth bars; (b) presence of corrosion and minimal transversal ribs in longitudinal reinforcement (Talat N'Yaquod).

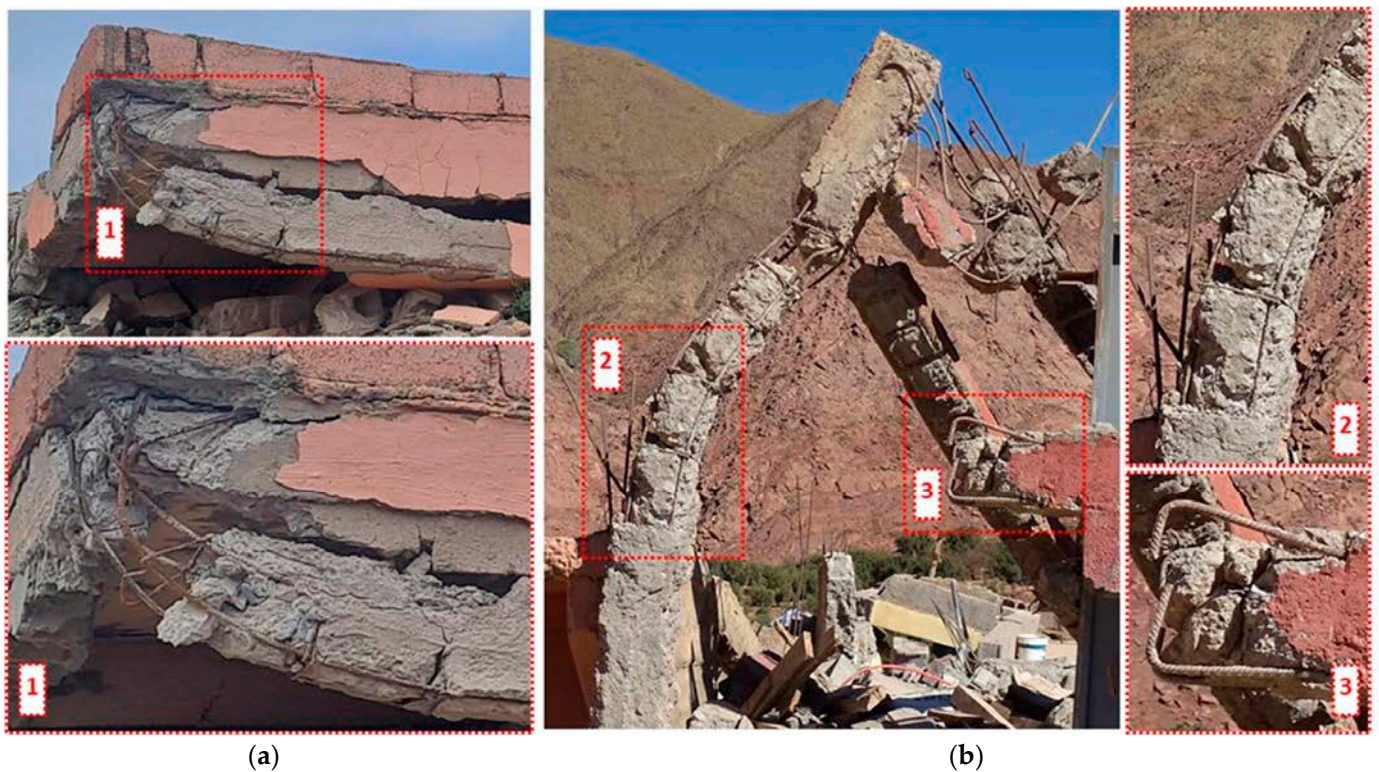
Furthermore, the dimensions of the transversal sections of the columns and the steel stirrups were identified as being insufficient for both confined-masonry and RC frame constructions, given the damage observed, such as fragile failure (Figure 20). Additionally, the abovementioned dimensions were below those established in the RPS 2000 version 2011, which in turn are below those established in the EC8 and ACI-318 codes. Specifically, the steel stirrups were not only insufficient in number and sometimes inexistent, but also excessively distanced (Figure 20, details 1 and 2), in several cases exceeding 25 cm. In addition, widespread use of stirrups with hooks at  $90^\circ$  at their ends and reduced development length was detected, resulting in these elements opening more easily under the earthquake load. In this regard, reference regulations for RC with special requirements for seismic zones, such as ACI 318 [42], state that the hooks should have an angle of  $135^\circ$  and that the minimum length should be six times the diameter of the bar and longer than 75 mm (Figure 20, detail 1). Similarly, it was observed that overlapping of the longitudinal steel bar reinforcements was frequently carried out in areas of greatest demand, for example, near the beam–column joints. Moreover, it was found that the development length of the longitudinal steel reinforcement was insufficient at the junction of beams with end columns (Figure 20, detail 3).

**Figure 20.** Deficiencies in RC elements that lead to low-ductility sections and fragile failure. Details 1 and 2: fragile failure in the support at the floor–support–system joint due to low-quality concrete, excessive distance between steel stirrups at a critical point, and non-earthquake-proof hooks ( $<135^\circ$  or length less than  $6\phi$  or 75 mm) in the joint. Detail 3: short development length and deficient anchoring of steel for longitudinal reinforcement of the beam where it connects with the column. (a) Amizmiz; (b) Talat N’Yaquod.

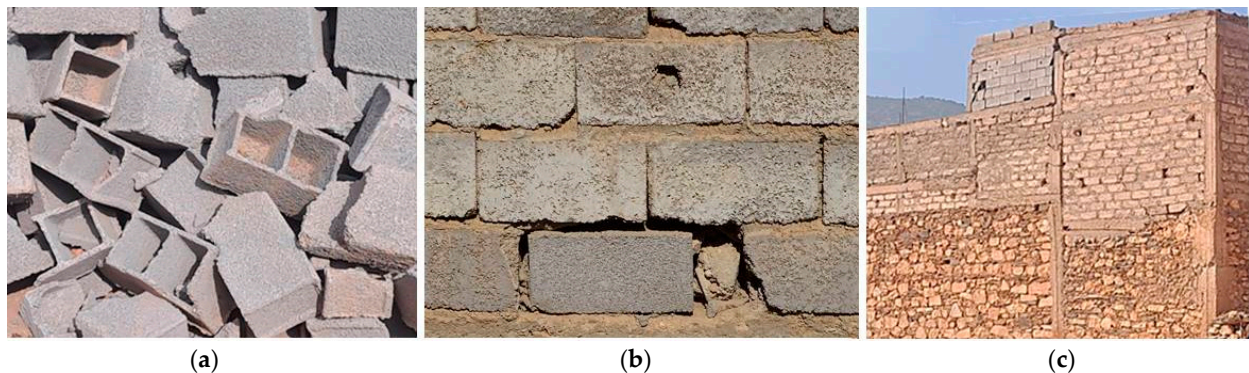
Firstly, as regards the specific constitution of the shear-resistant masonry walls, the confining reinforced concrete components presented the deficiencies detailed above. The masonry components, however, were predominantly made from hollow cement–mortar pieces with low resistance to compression, easily identifiable in a visual inspection. As shown in Figure 21a, the components present very low cell thickness, around 1 cm, which considerably decreases their transversal section. Moreover, the cement–mortar joints between pieces are sometimes much thicker on their horizontal faces (Figure 21b), non-uniform, and highly variable in thickness. These factors, in part, account for the generalized poor performance of masonry buildings, which presented extreme damage and numerous complete collapses. Similarly, some of the mixed structures observed combined cement–mortar hollow-block masonry walls of very dissimilar characteristics or these elements combined with solid blocks of mortar or hollow pieces of fired clay or natural stone, or, in some cases, even a combination of various of these materials (Figure 21c). The effect of the combination of different confined materials on the structural behavior of the buildings has proven to be highly significant. Figure 22 shows the highly dissimilar results for the different materials combined in the same construction: the parts of the wall constructed of concrete blocks withstood the earthquake, whereas the stone parts collapsed.

**Figure 21.** (a) Cement–mortar blocks (Tafeghaghte). (b) Bed joints (Amizmiz). (c) Different types of masonry of highly dissimilar quality in the same wall (Tafeghaghte).

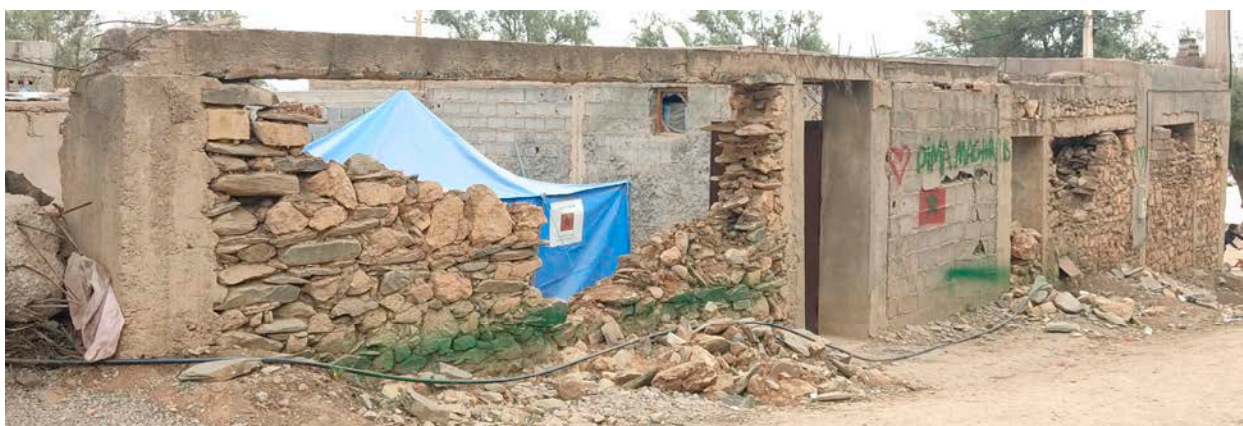
**Figure 22.** Comparison of damage for different infill materials in the same wall (Tafeghaghte).

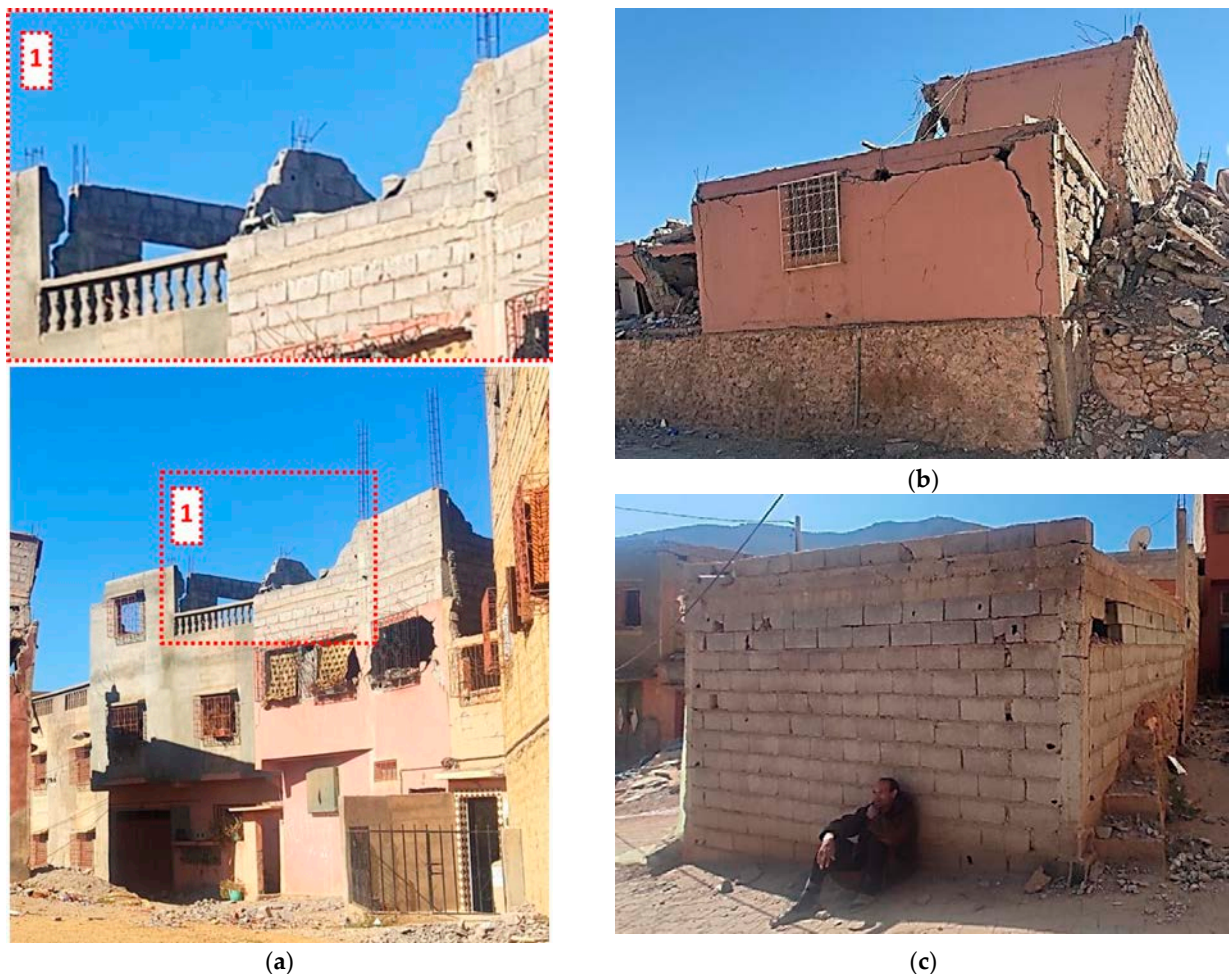
Similarly, low-quality connections between vertical elements and low-quality materials were identified as factors causing out-of-plane failure of walls (Figure 23). Mention should be given to cases of some buildings combining RC frames and masonry walls presenting out-of-plane failure of infill walls. This occurred either due to inefficient connection (Figure 23c) or inadequate sequencing during the execution of the different components: reinforced concrete beams and columns were erected before the block walls, leading to poorer structural behavior than would be the case in a confined masonry structure with the same quantity of materials (Figure 23c). Moreover, some buildings presented confining beams and columns which were poorly bounded to extremely low-shear-strength hollow concrete blocks, which failed during the seismic event (Figure 23a).

**Figure 23.** Out-of-plane failures: (a) a confined masonry load-bearing wall and parapet wall because of the low-quality materials employed (Amizmiz). (b) Failure of a masonry wall with RC beams and columns due to the low shear strength of the masonry employed (Amizmiz). (c) Out-of-plane failure of a masonry wall with RC beams and columns due to inappropriate order of execution of components (Amizmiz). The structure does not behave as a confined masonry structure.

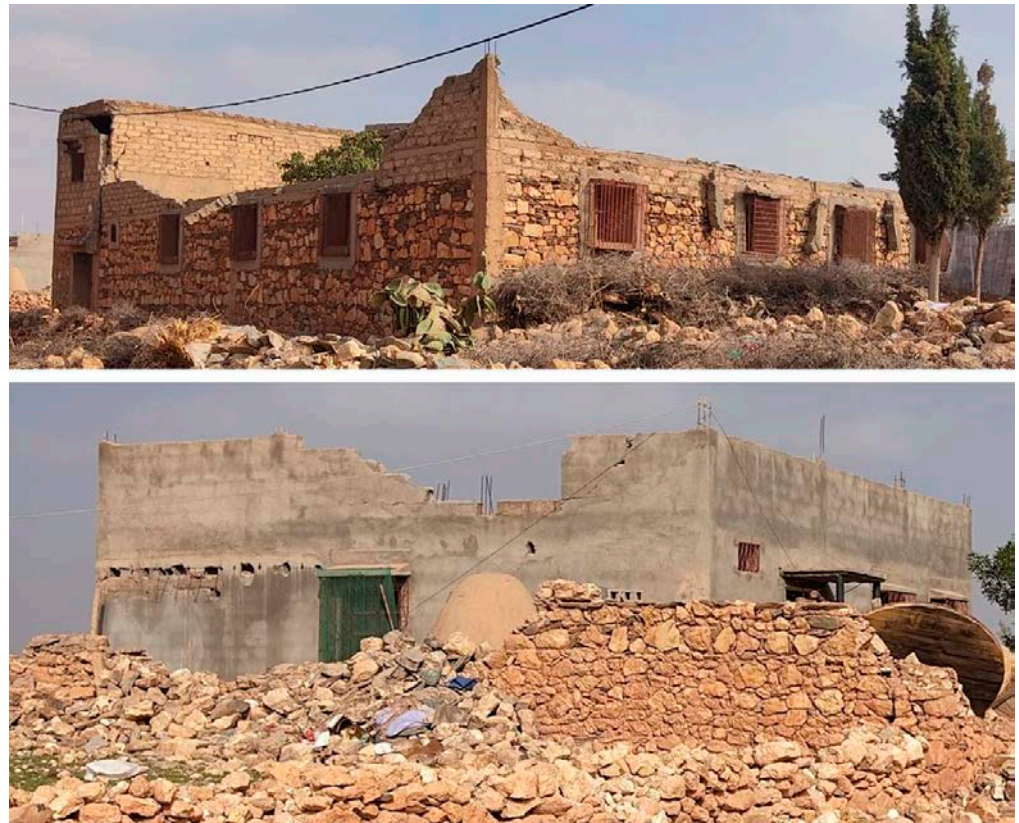
**Figure 24.** Out-of-plane failure of confined masonry parapet walls in two buildings with different structural wall material (Tafeghaghte) (both).

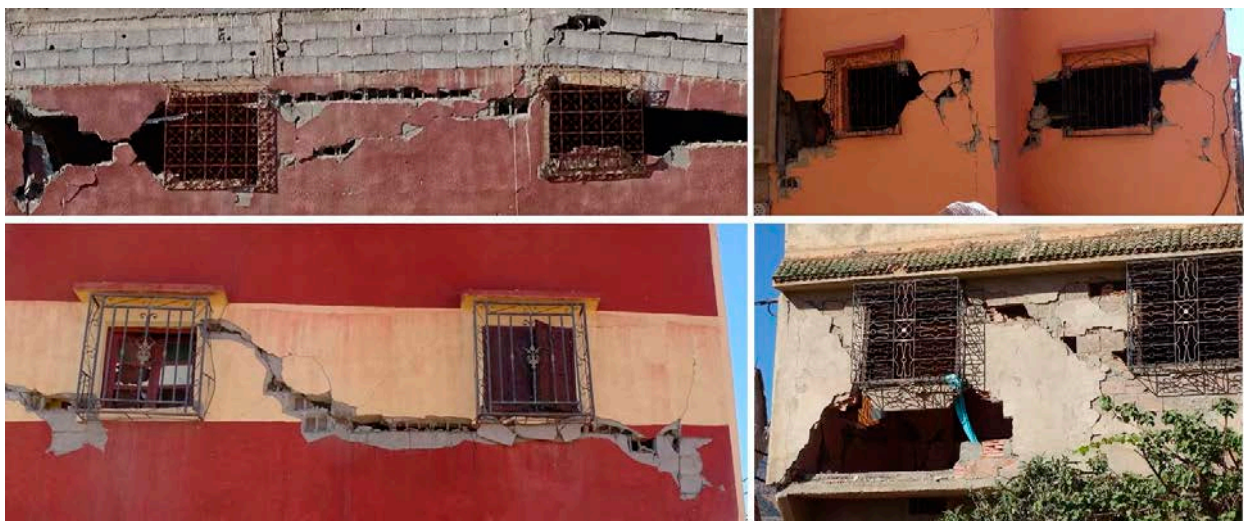
Finally, a key aspect of these structures that should not be ignored is the scarcity of confining elements found. Most buildings presented a lack of RC elements that confined the masonry in the door and window openings (Figure 25). This absence facilitated the openings acting as weak point determinant for the damage in the resistant walls.

**Figure 25.** Damage mainly due to the absence of reinforced-concrete confining elements in door and window openings (Amizmiz) (all).

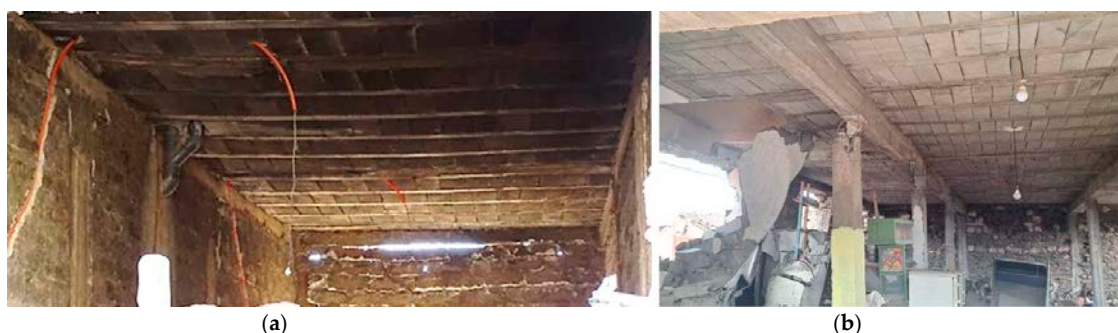
**Figure 26.** Buildings presenting a structural system which provides seismic resistance and stiffness mainly in only one of the two orthogonal directions. (a) Amizmiz; (b) Tafeghaghte.

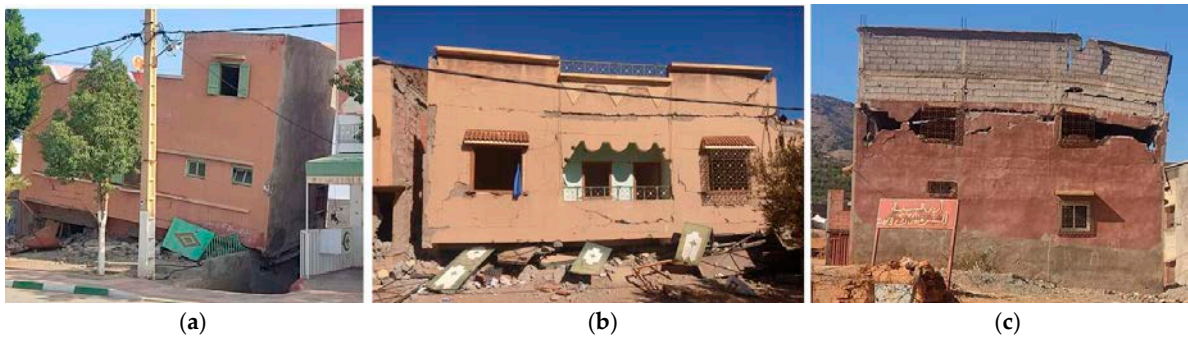
**Figure 27.** (a) Building in which the minor presence of shear-resistance walls on the ground floor resulted in a weak ground-story overturning failure (Amizmiz). (b) Building in which the excessive number of doors on the ground floor, which is characteristic of commercial buildings in the same road, causes a weak ground-story overturning failure (Talat N'Yaaqoud). (c) Building with major damage mainly concentrated in the intermediate story, due to window openings (Amizmiz).

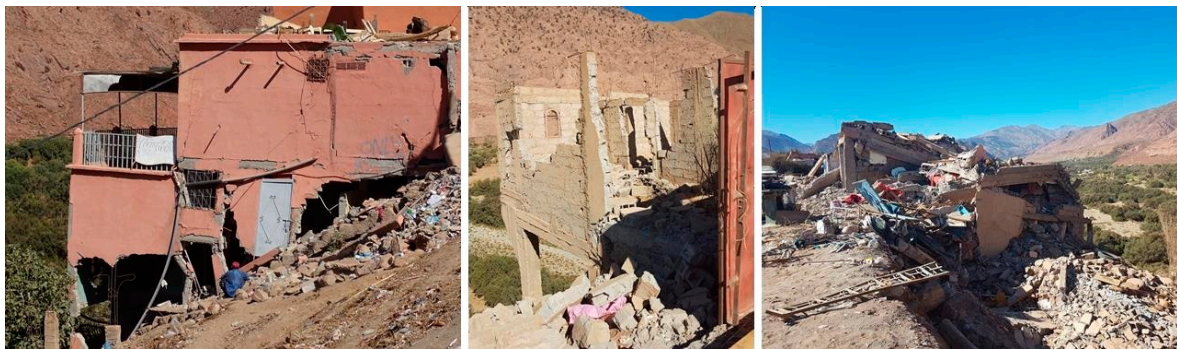
**Figure 28.** Buildings located on slopes and presenting very different column lengths (Talat N'Yaaqoud).

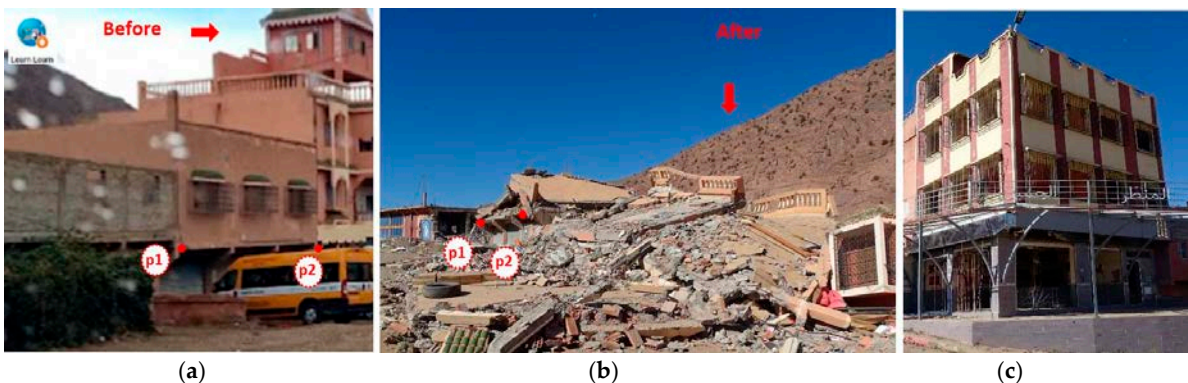
**Figure 29.** (a,b): state of a building before and after the earthquake (red dots). The building exhibited a high number of irregularities in height and plan, such as differences in stiffness and strength and balconies. p1 and p2 are inserted as reference points (Talat N'Yaaqoud). (Source photo before the earthquake: Google Maps, <https://www.google.es/maps/place/Talat+N%E2%80%99Yaaqoub,+Marruecos>, accessed on 18 January 2024). (c) Building with a marked height irregularity between the ground floor and the rest, along with columns displaced from the same vertical line. Possible torsional effects due to the presence of a much more rigid, blank dividing wall and the three very open façades facing the street (Amizmiz).

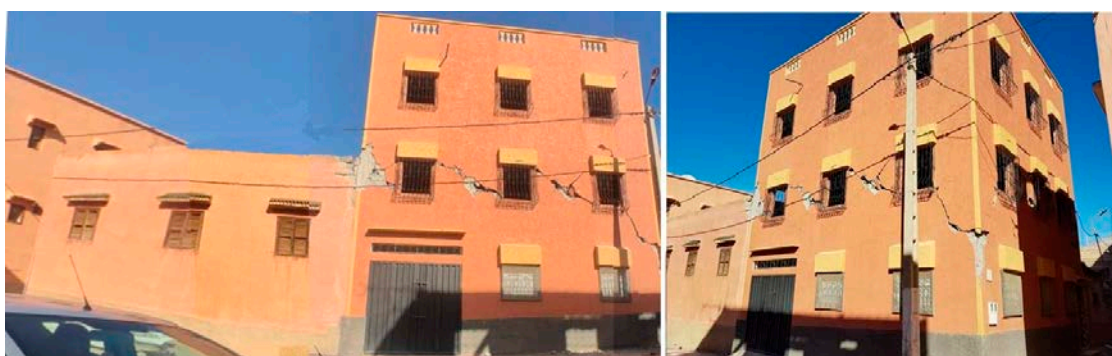
**Figure 30.** Building on a corner where a lower, more rigid adjacent construction has caused very noticeable pounding effects (Amizmiz).

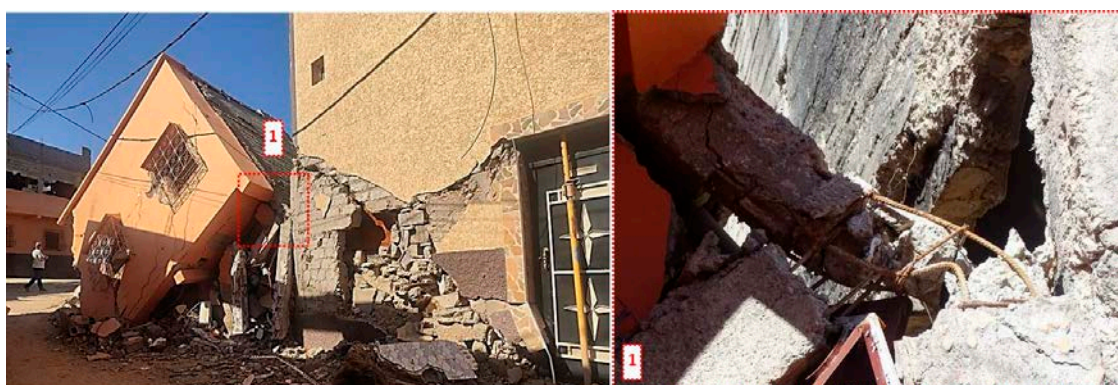
**Figure 31.** Building located on a corner, collapsed and overturned, presenting a possible weak-story deficiency and pounding effects from the adjacent building. Detail 1. Low resistance of the concrete and areas of low-longitudinal-reinforcement steel in the beam and the column. Short length of development and anchoring of steel for longitudinal reinforcement of the beam where it connects with the column. Absence in the beam of the recommended first closed confinement stirrup located no more than 50 mm from the face of the support element (ACI-318). Excessive distance between transversal reinforcement in a critical point of the column and absence of seismic hooks at the ends of the column stirrups (Amizmiz).
