Characterization, Analysis, and Investigation of the Provenance of the Stone Construction Materials of the Vera Cruz Church (Segovia, Spain)

Abstract: As part of the restoration project of the 13th century Vera Cruz Church (Segovia, Spain), a preliminary study of the stones used in its construction—dolostones of the Montejo de la Vega Fm of Santonian age (Upper Cretaceous)—and the possible location of the quarry of the provenance of these stones was carried out. For this purpose, a comparative analysis was performed between the currently active quarry of La Vera Cruz n° 88 and the historical quarry of Zamarramala. The samples were characterized using a multidisciplinary approach, combining X-ray diffraction (XRD), polarized optical microscopy (POM), and scanning electron microscopy with microanalysis (SEM-EDX). The combined mineralogical, chemical, and textural characterization provided valuable information on historical provenance. The results show a significant correlation between the dolostone samples obtained from the church and both quarries. The integral characterization confirms the suitability of the dolostones identified in the currently active quarry, Vera Cruz n° 88, fo

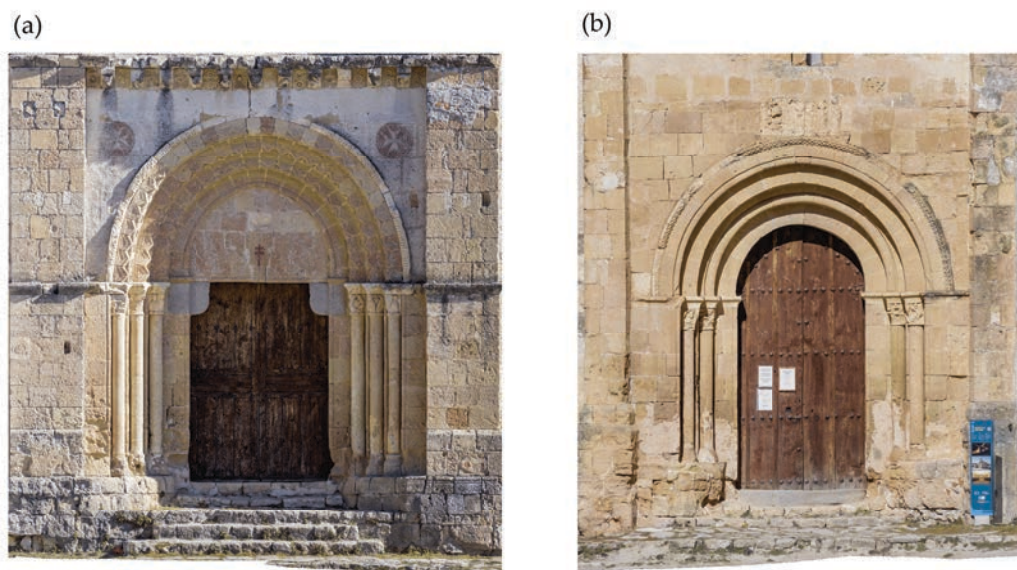
Figure 2. Church façades: (a) West doorway; (b) South doorway. Orthoimages: Luis-Javier Sánchez-Aparicio.

The south doorway (Figure 2b) is also flared but has only two pairs of semicircular archivolts. These are surmounted by a chequer molding as well. In this doorway, the work on the archivolts and capitals is simpler and the decoration is much less elaborate. Above this door is a bas-relief that was described in the report of the Royal Academy of Fine Arts of San Fernando. It had already deteriorated in 1919, but it was possible to identify a seated monarch or a judge in the act of administering justice on the left side, three standing women on the right, and a tree in the center [4]. This bas-relief is currently in a very advanced

state of deterioration (see also Section 1.4 Stone Weathering), which makes it impossible to recognize the iconography described in the report by the San Fernando Royal Academy of Fine Arts for the declaration of a “National Monument” in 1919.

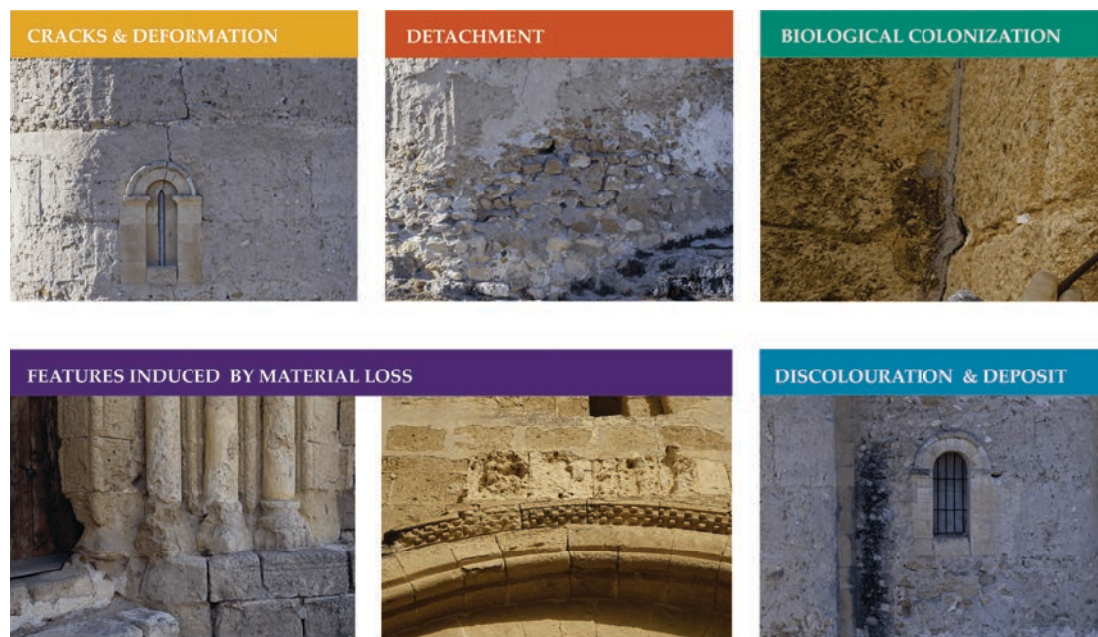
Fracture-type cracks are observed in the masonry and are particularly evident in the apses (west façade) and interior vaults. As a result of the accumulation of water and unfortunate interventions, detachments in the form of fragmentation can be seen in the base area and in the masonry.

The predominant alteration observed in the monument is material loss. There is pitting (unconnected cavities) in the contact zones between the granite steps and the dolostone on the south façade [22]. In addition, interconnected cavities in the form of alveolization are prevalent. Discoloration and deposits associated with damp conditions are particularly concentrated on the base and roof, giving rise to efflorescence and soiling.

Biological colonization of spores within dolostone pores causes cracking upon germination. Low intracrystalline porosity potentially hinders fungal penetration into the crystal, so they are located in spaces between dolomitic crystals. Fungi are predominantly associated with altered zones, both on the surface and in the interior [31]. In addition, plants are also found on the outer walls.

Figure 5. Stone weathering following ICOMOS terminology.

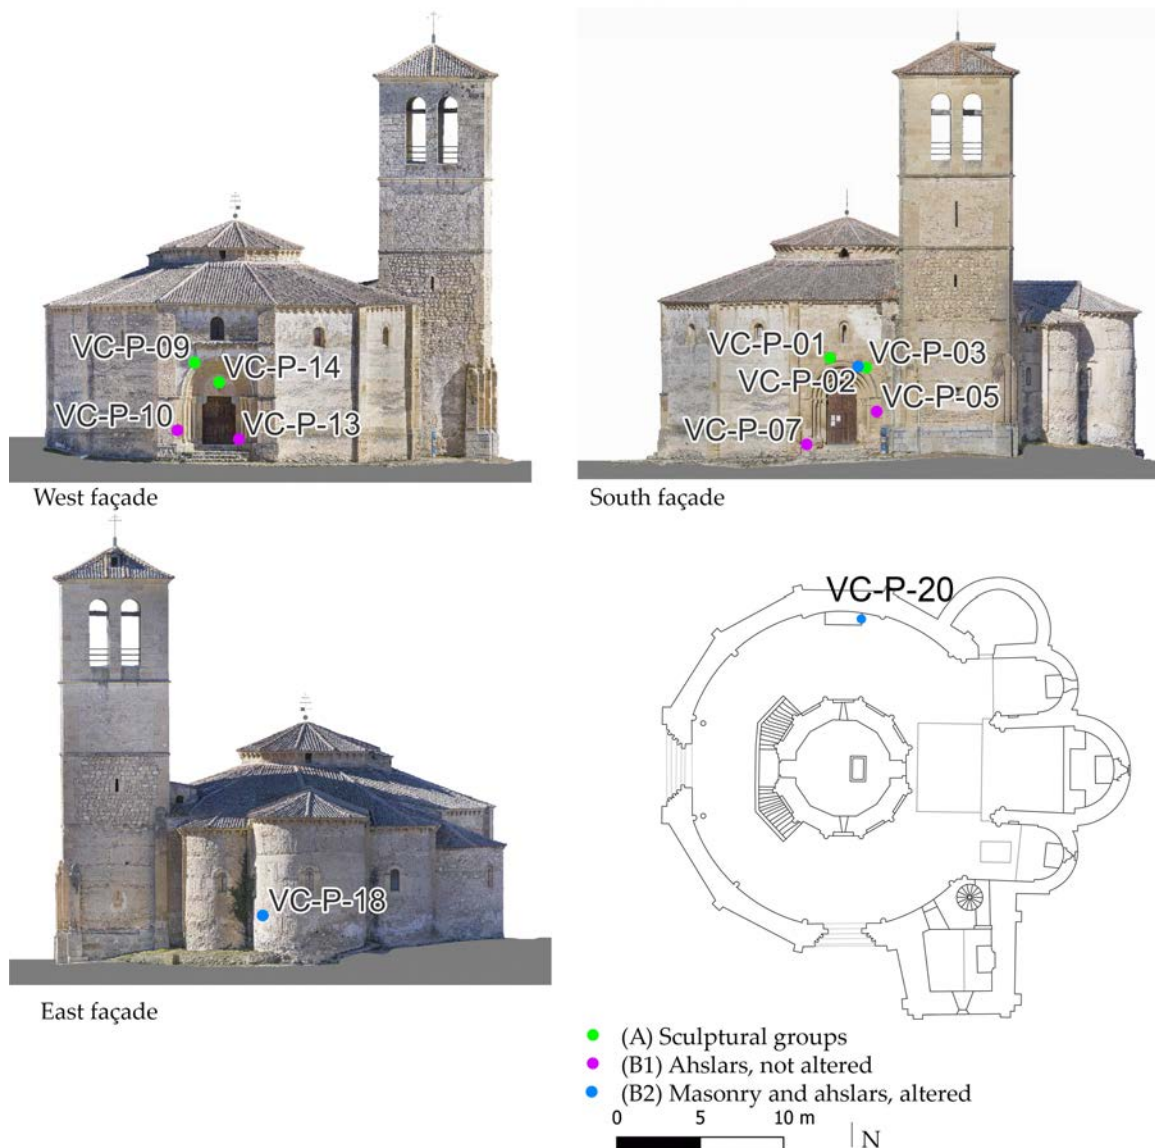
Figure 6. Location of samples in the outside of the building. East façade: VC-P-18 (Apse). South façade: VC-P-1 (sculptural ensemble on the door); VC-P-2 (decorations on the door); VC-P-3 (ashlar facing above the door); VC-P-5 (Impost); and VC-P-7 (Baseboard). West façade: VC-P-09 (decorations above the door); VC-P-10 (Ashlar on the baseboard); VC-P-13 (inner part of the ashlar on the baseboard); and VC-P-14 (Sculptural ensemble in the door). Interior: VC-P-20 (Altar). Orthoimages: Luis-Javier Sánchez-Aparicio. Layout: Diego Vicente Sánchez.

Based on their quartz content, the samples from the church are categorized into two groups. The first group (A) includes samples with a lower percentage of quartz (1%–4%), consisting of VC-P-1, VC-P-3, VC-P-9, and VC-P-14. These samples were taken from sculptural groups on the façade (see Figure 6).

The second group (B), made up of the remaining samples, has a quartz content from about 15% to 30%. These correspond to those taken from the ashlar. According to the sampling location and their visually appreciated decay, two different subgroups are established. The first subgroup (B1) includes stones taken from the upper parts, where there is minimum or no water accumulation, showing good conditions. These are VC-P-5, VC-P-7, VC-P-10, and VC-P-13. The second subgroup (B2) comprises samples taken from lower areas that are exposed to the effects of wind and water accumulation. VC-P-2, VC-P-18, and VC-P-20 show a higher degree of weathering.

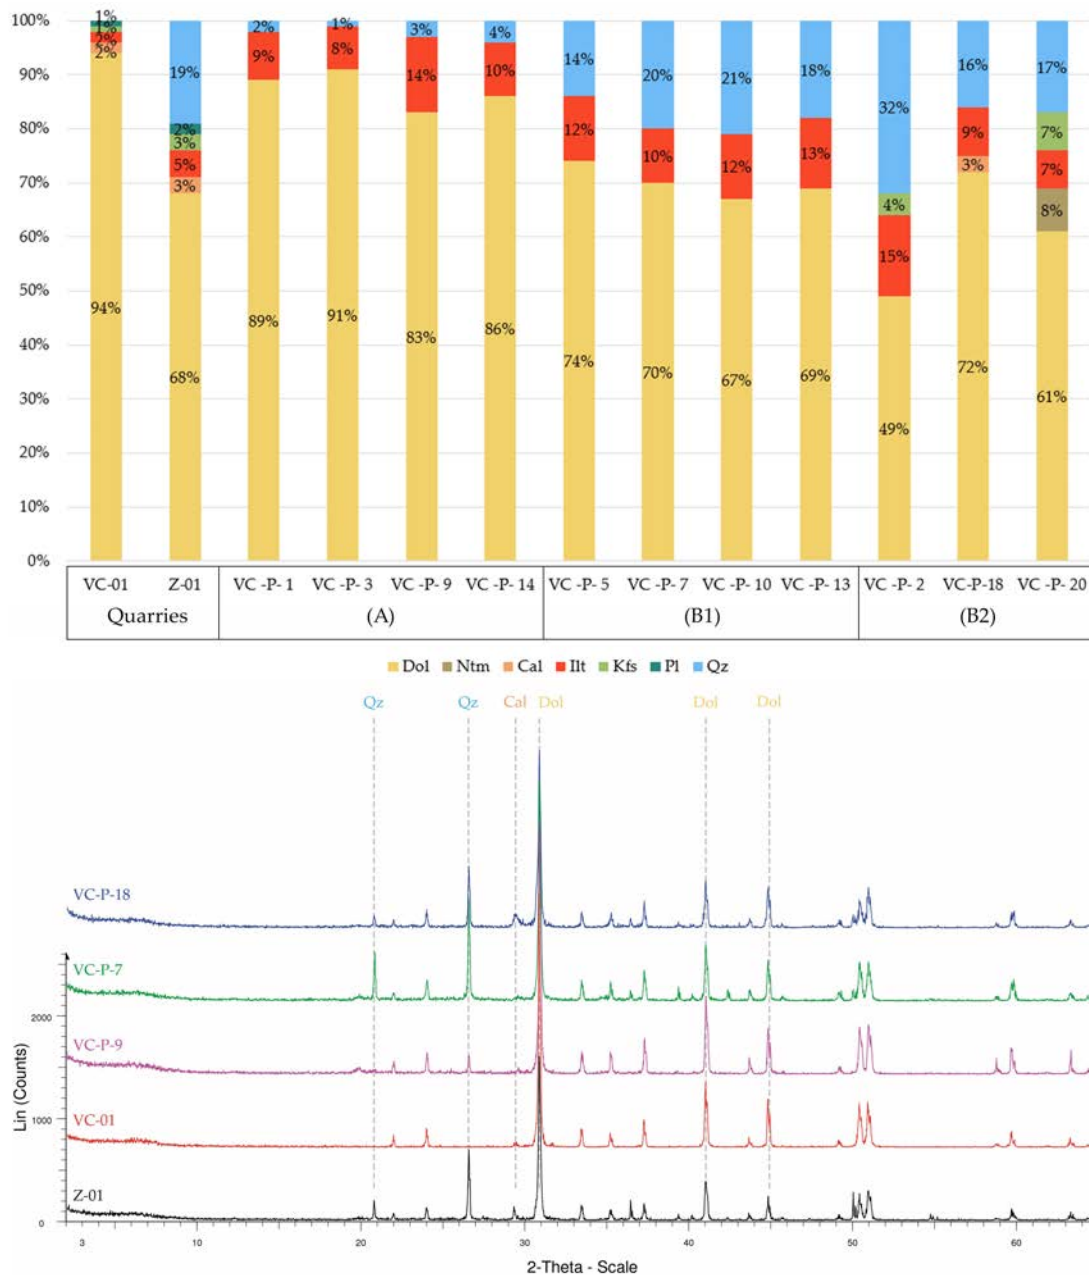
All samples have dolomite as the predominant crystalline phase, with percentages ranging from 49% to 91% in the church samples, 94% in the Vera Cruz quarry, and 68% in the Zamarramala quarry, with smaller proportions of quartz and clay minerals. All of them are classified as dolostones.

The dolostones from the nearby quarries differ in composition. For example, the sample from the active quarry of Vera Cruz is a dolostone of high purity (94%), with no quartz detectable by XRD, and with clay minerals, potassium feldspar, plagioclase, and calcite in proportions of less than 2%. The sample from the historical quarry of Zamarramala has a significantly lower dolomite content of 69%. It has 19% quartz and, as in the previous case, has the same accessory minerals in slightly higher percentages, up to 5%.

Samples of group A, with low quartz content, can be considered the most similar to the active quarry of Vera Cruz, although with slight compositional differences, such as the higher dolomite content of the quarry sample (94%) compared to the average value of these samples which is 87%.

Samples from subgroups B1 and B2, with a higher quartz content, are more similar to those from the historical quarry of Zamarramala, which has 19% quartz and 68% dolomite.

Figure 7. Mineralogical identification and quantification in %. XDR patterns of quarries and diffractogram of representative samples with identification of the principal peak phases. Abbreviations after Whitney and Evans [38] and Cardell Fernández [39]: Dol (Dolomite), Cal (Calcite), Ilt (Clay Minerals/Illite), Kfs (Potassium feldspar), Pl (Plagioclase), Qz (Quartz), Ntm (Nitromagnesite).

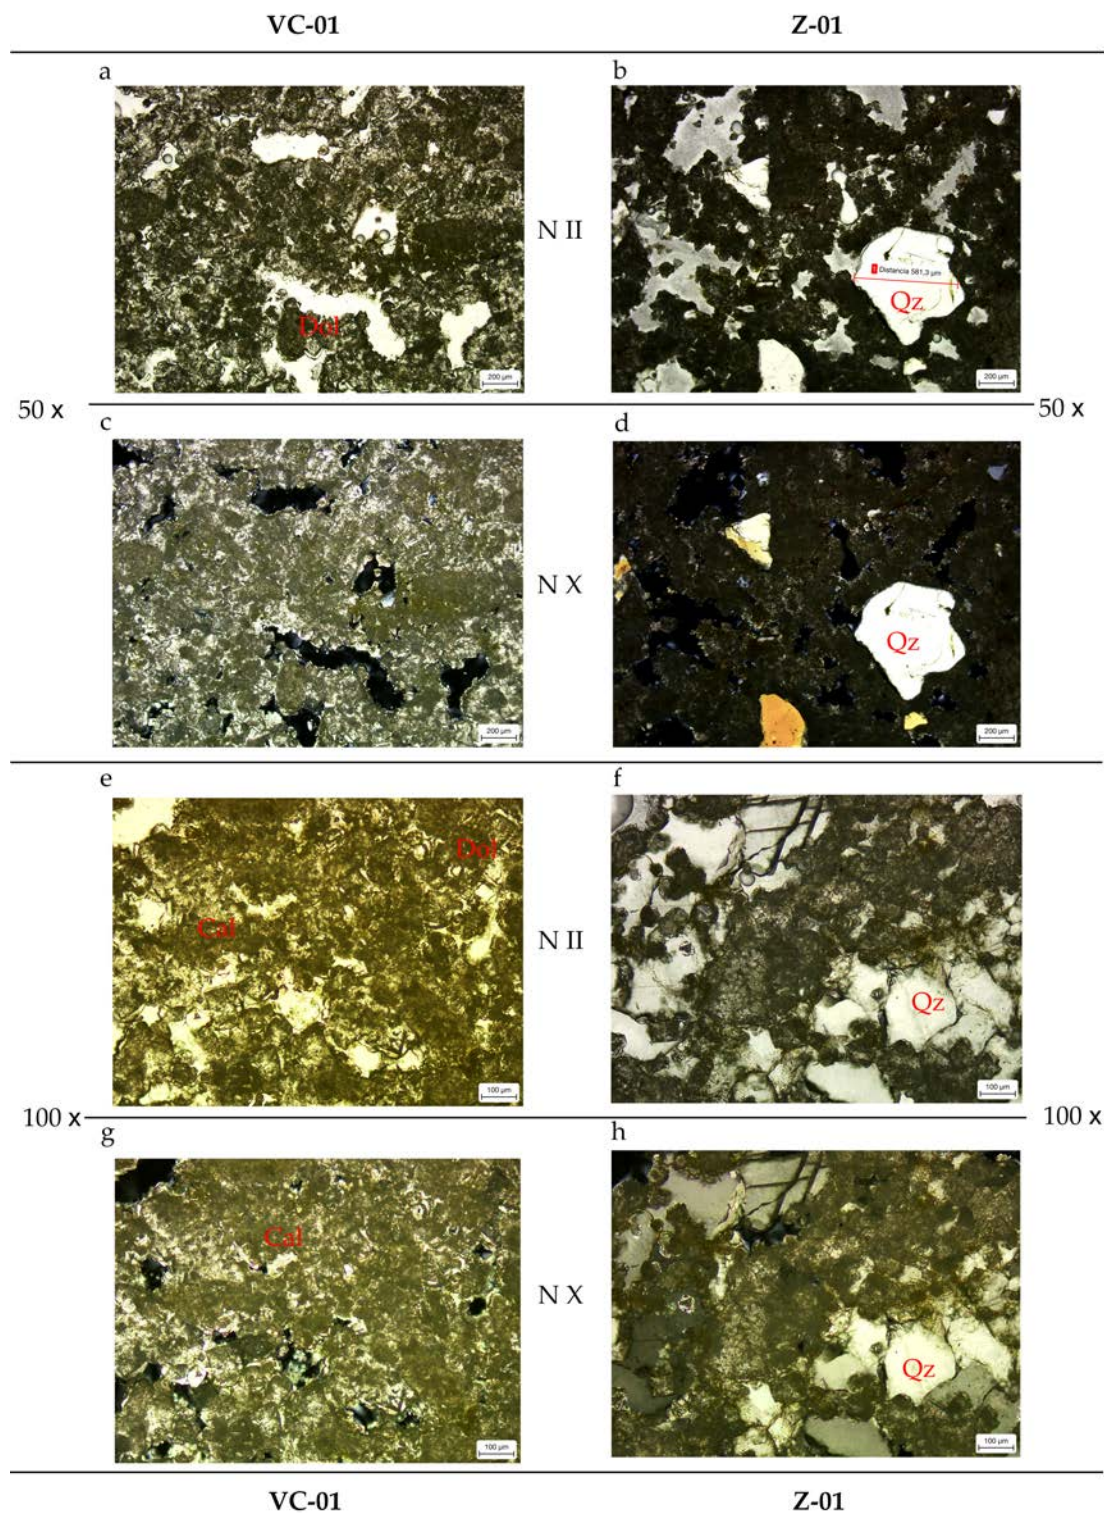
Figure 8. Representative thin section of the quarry’s samples VC-01 and Z-01. (a) VC-01, 50× magnification parallel nicols; (b) Z-01, 50× magnification parallel nicols; (c) VC-01, 50× magnification crossed nicols; (d) Z-01, 50× magnification crossed nicols; (e) VC-01, 100× magnification parallel nicols; (f) Z-01, 100× magnification parallel nicols; (g) VC-01, 100× magnification crossed nicols; and (h) Z-01, 100× magnification crossed nicols.

POM observations of VC-01 show a uniform matrix composed of recrystallized dolomite crystals (Figure 8a,c,e,g) with a euhedral morphology. The size of the dolomite grains is small (100 μm) in most of the sample. Calcite recrystallizations around the occluded intercrystalline porosity (Figure 8c,g) were observed, as well as the almost complete absence of detrital fragments, mainly quartz. In this sample (Figure 9a,c), the texture appears chaotic and altered, with high porosity. Crystals of dolomite within a clay matrix were identified with EDX analysis (Figure 9e,f). In addition, traces of biological alteration on the grains were found.

Sample Z-01 exhibits a larger grain size in POM with a remarkable presence of anhedral quartz grains up to 600 μm (Figure 8b,d,f,h). On SEM-EDX observation (Figure 9b,d), the

Stones from the Vera Cruz n° 88 quarry, the characteristics of which were studied in VC-01, would be suitable for the restoration efforts within the Vera Cruz Church.

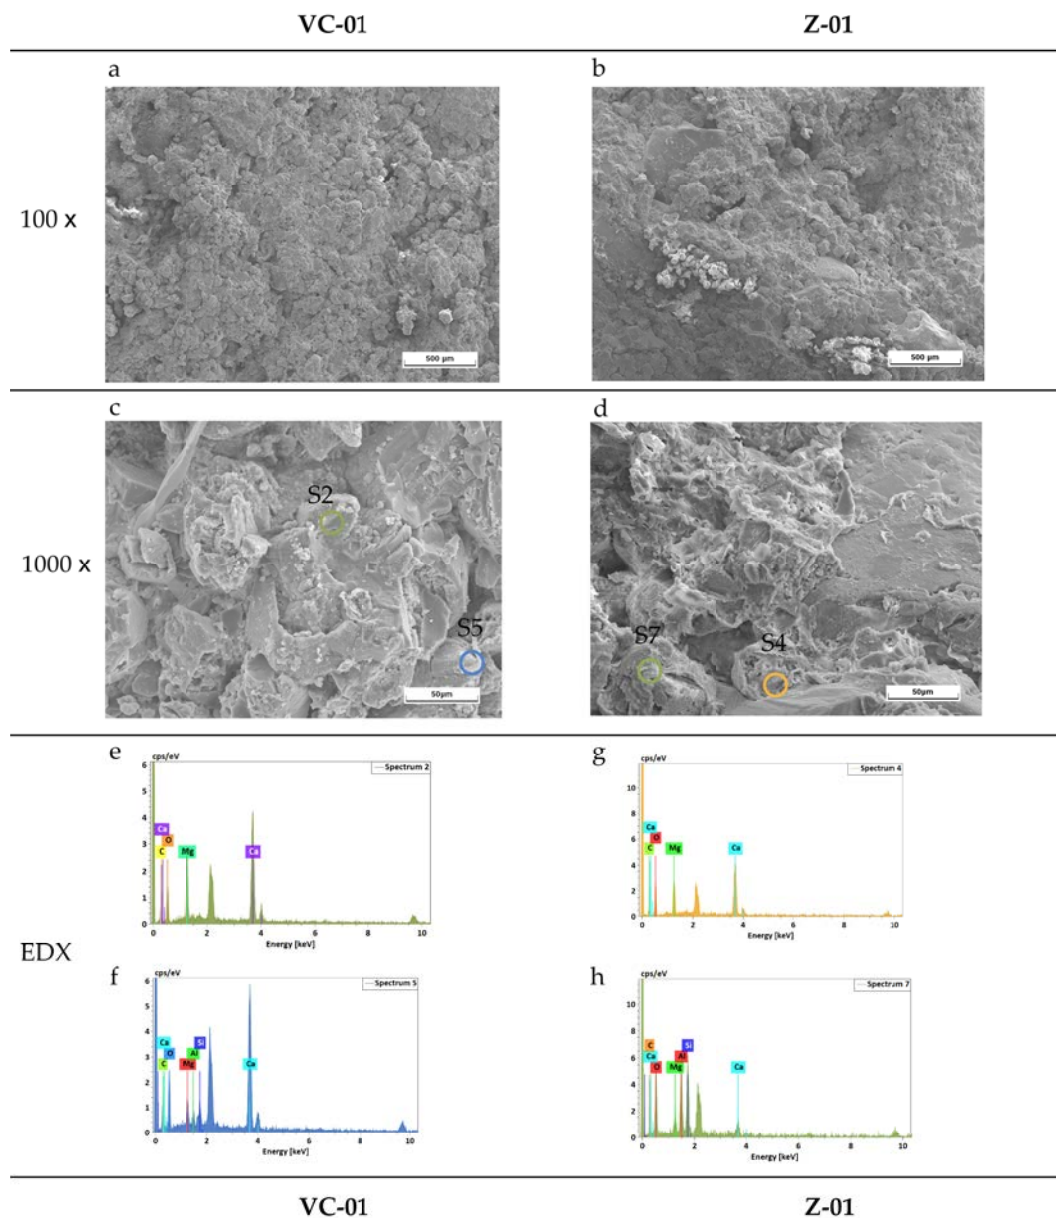
Figure 9. Scanning microscopy images, secondary electrons at 20 kV. (a) VC-01, 100× magnification; (b) Z-01, 100× magnification; (c) VC-01, 1000× magnification. S2 and S5: Spectrum 2 and 5 (e and f); (d) Z-01, 1000× magnification. S4 and S7: Spectrum 4 and 7 (g and h); (e) EDX analysis on VC-01, 1000×, SE. Spectrum 2 (S2): dolomite; (f) EDX analysis on VC-01, 1000×, SE. Spectrum 5 (S5): clay minerals; (g) EDX analysis on Z-01, 1000×, SE. Spectrum 4 (S4): dolomite and calcite; and (h) EDX analysis on Z-01, 1000×, SE. Spectrum 7 (S7): clay minerals.

sample shows low porosity and minimal surface alteration, characterized by two different quartz grain sizes: large and small ones. EDX analyses (Figure 9g,h) show chemical elements compatible with the presence of quartz, dolomite, clays, and calcite.

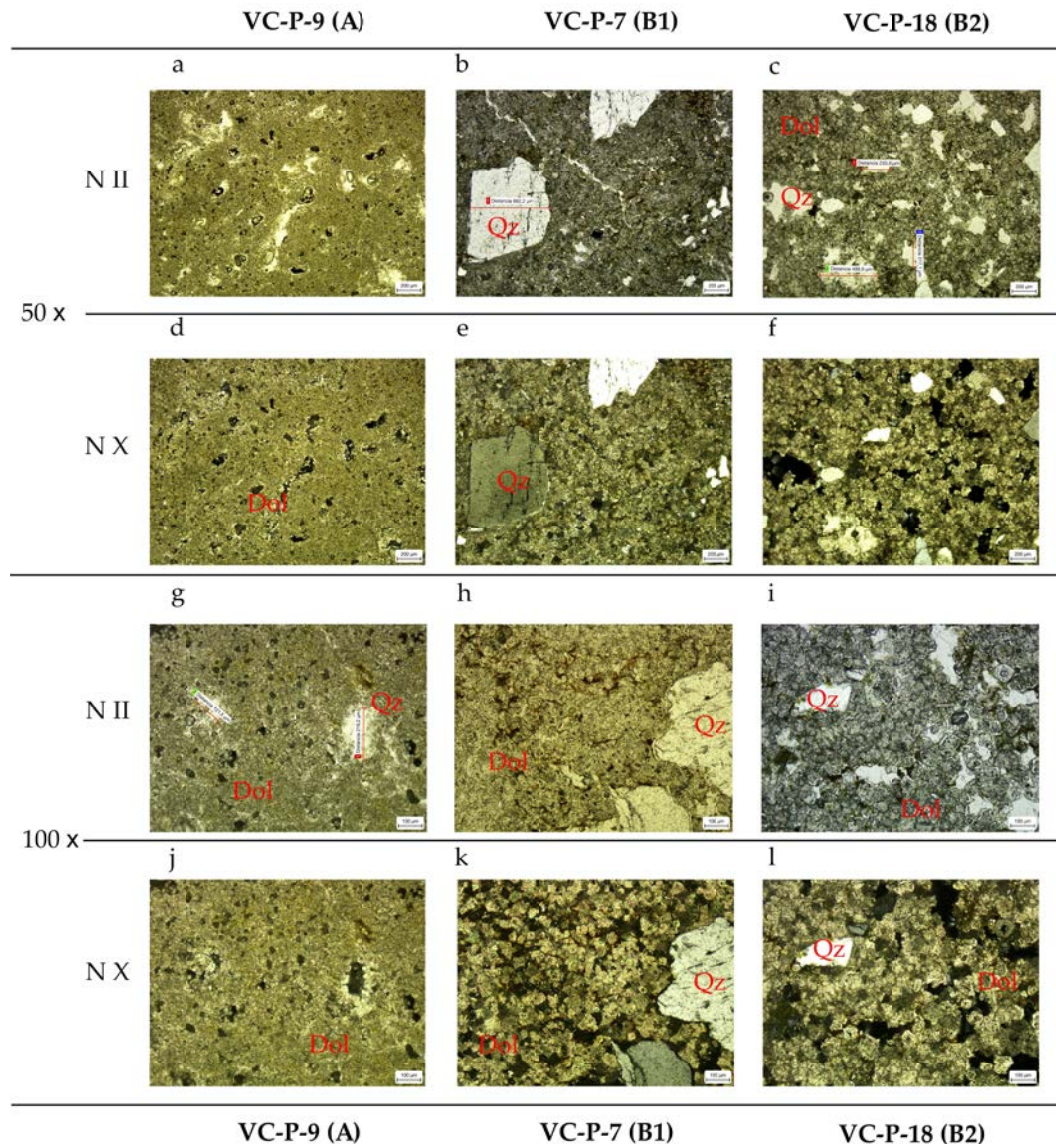
As the representative sample of Group A (Figure 10a,d,g,j), VC-P-9 is characterized by POM. Homogeneity and lack of interconnected porosity, with pore sizes of approximately 50 μm , were observed. The absence of quartz is obvious. The dolomite grains have an irregular, fine-grained morphology. SEM-EDX (Figure 11a,d) shows a closed porosity. Well-formed dolomite crystals are observed, as well as recrystallized dolomite. Surface alteration is minimal. EDX analysis indicates the presence of calcium, magnesium, carbon, oxygen, and iron, interpreted as dolomite and iron products of weathering.

Figure 10. Thin section of the church's samples: (a) VC-P-09 (Group A), 50 \times magnification parallel nicols; (b) VC-P-07 (Group B), 50 \times magnification parallel nicols; (c) VC-P-18 (Group C), 50 \times magnification parallel nicols; (d) VC-P-09 (Group A), 50 \times magnification crossed nicols; (e) VC-P-07 (Group B), 50 \times magnification crossed nicols; (f) VC-P-18 (Group C), 50 \times magnification crossed nicols; (g) VC-P-09 (Group A), 100 \times magnification parallel nicols; (h) VC-P-07 (Group B), 100 \times magnification parallel nicols; (i) VC-P-18 (Group C), 100 \times magnification parallel nicols; (j) VC-P-09 (Group A), 100 \times magnification crossed nicols; (k) VC-P-07 (Group B), 100 \times magnification crossed nicols; and (l) VC-P-18 (Group C), 100 \times magnification crossed nicols.

In VC-P-7, from Group B1 (Figure 10b,e,h,k), two different sizes of quartz crystals are observed by optical microscopy. The larger ones measure approximately 600 μm , while the smaller ones measure 100 μm , both exhibiting subhedral morphology. In addition, recrystallization of dolomite about 70 μm in size is observed (Figure 10k). Brownish oxides are presented in the matrix, indicating the weathering of the sample. Two distinct grain textures, one finer and the other larger, are identified by SEM images (Figure 11b,e). The surface texture of altered dolomite crystals shows high porosity and disintegration of the grain matrix, indicative of biological alteration. EDX analyses confirm the presence of clays and dolomite, as well as all the minerals detected by XRD.

VC-P-18, representative of Group B2 (Figure 10c,f,i,l), shows both anhedral and subhedral quartz crystals, measuring around 300 μm , displaying undulating extinction. The dolomite matrix shows a variety of textures and sizes, with recrystallized dolomite. Pronounced intercrystalline and interconnected porosity is evident, accompanied by intracrystalline fungal attack. This sample stands out as the most substantially altered sample examined by POM. In Figure 11c,f, by SEM, the texture appears altered with loose and detached grains in the matrix, resulting in high porosity. Observations include biological alterations on the crystals, disaggregation, and poor adhesion to the matrix. EDX analysis confirms the presence of minerals identified by XRD (quartz, dolomite, and clay), together with biological alteration and iron-related smooth weathering processes.

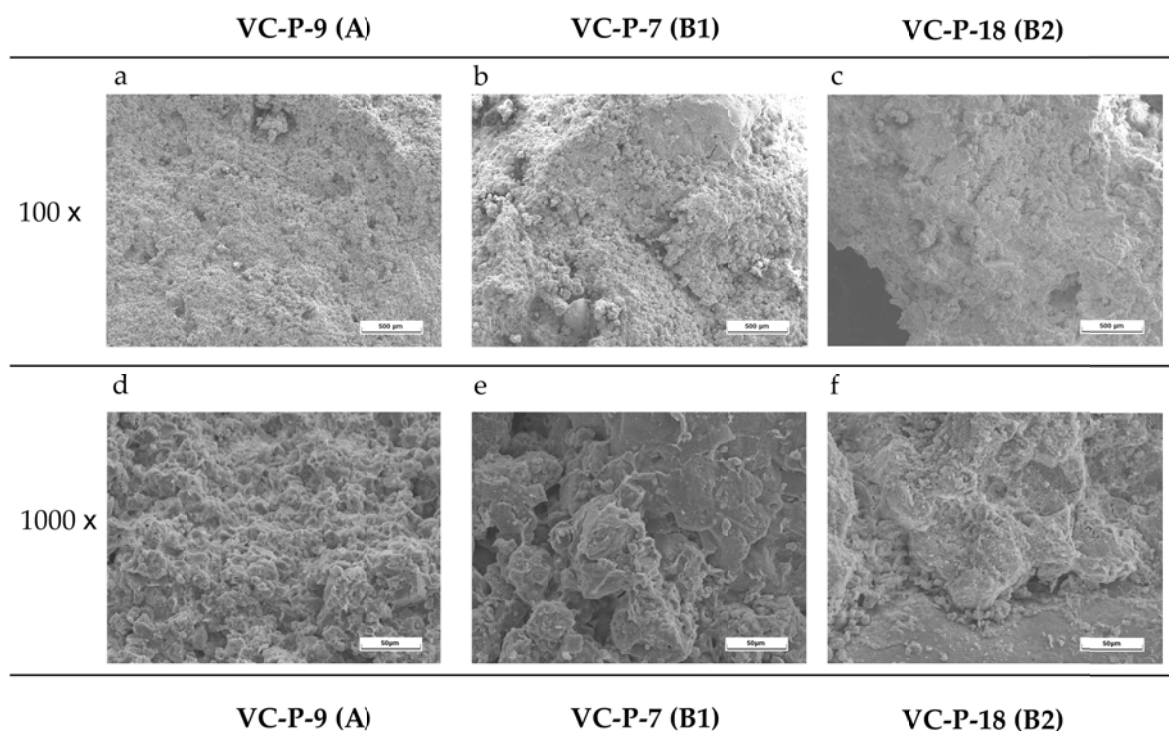
Figure 11. Electron microscopy images, secondary electrons at 20 kV. (a) VC-P-09, 100 \times magnification; (b) VC-P-07, 100 \times magnification; (c) VC-P-18, 100 \times magnification; (d) VC-P-09, 1000 \times magnification; (e) VC-P-07, 1000 \times magnification; (f) VC-P-18, 1000 \times magnification.

Samples of groups B1 and B2, with quartz contents between 15% and 30%, show two grain sizes (600 µm and 100 µm), lower dolomite purity (average 66%), and higher porosity. They showed similarities to sample Z-01, obtained from the historical quarry of Zamarramala. In particular, Group B2 samples, unlike those of Group B1, are located in areas more exposed to environmental conditions, that cause physical, mechanical, and biological alteration.
