Correction of one unstable embankment in Spain

C. Jurado

Professor at the Polytechnic University of Madrid, (Spain).

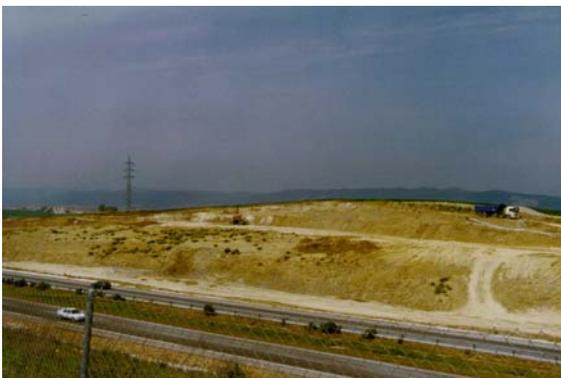
Figure 1. Sliding embankment of the CN-IV in P.K. 385.750

As a result of the analysis made it was proposed the adoption of a rock wall on the foot of the embankment and the restoration of the slope surface using gravels.

The works were realized during the summer of 1998 with satisfactory result up to now.
