A real case of thin film PV alternatives to cSi based on a-Si and CdTe. Results after eleven years operating at same conditions

Miguel-Ángel Muñoz-García, Guillermo P. Moreda, M.B. Nieto-Morone, M.C. Alonso-García

To appear in: *Renewable Energy*

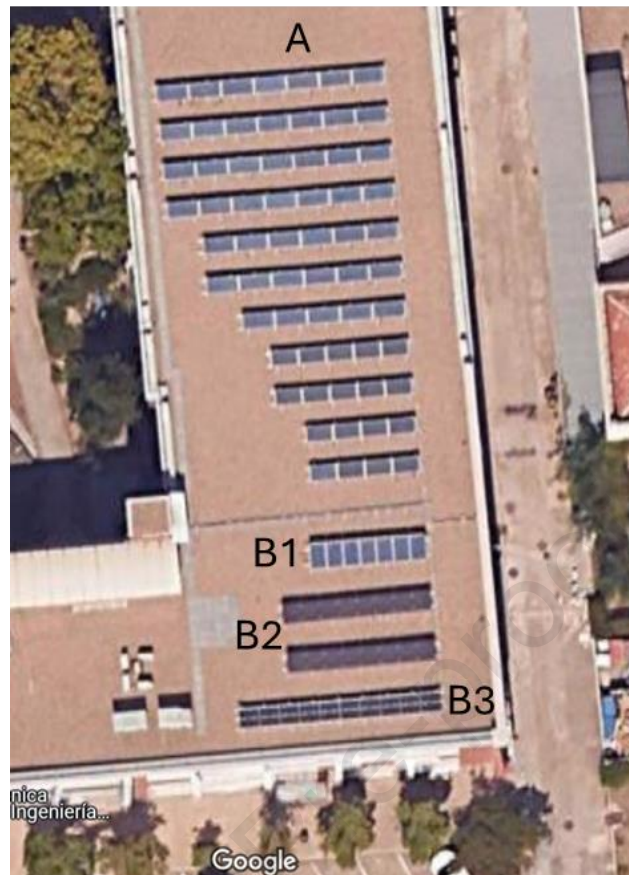
119
120 The system is divided in two main sections, A and B (Figure 1). Section A is the largest
121 and it is devoted to electricity production, although it is monitored as well, and the data are
122 registered by a computer program. Section A is formed by two sub-sections, A1 and A2,
123 with the following features:

Figure 1 Google Maps view of the PV plant.

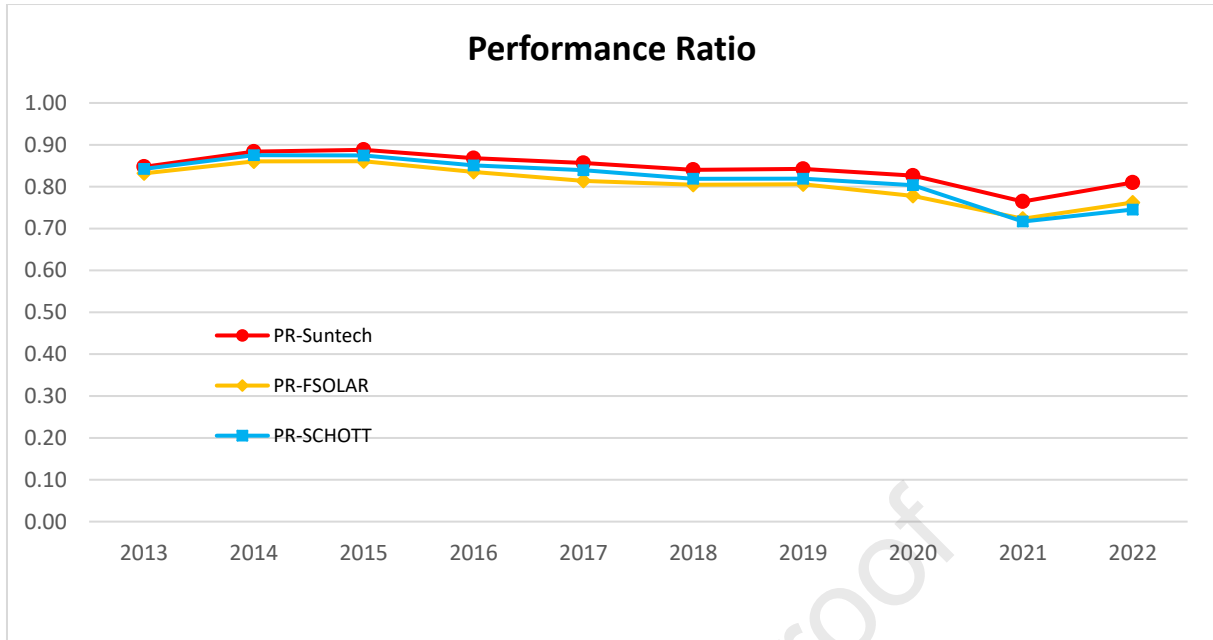
The PR calculated and shown in Figure 4 carried out considering the yield of generated energy, the peak power of each section and the peak solar hours. No correction is made for temperature, so that the variability of the different technologies can be appreciated in their real form.

Figure 4.- Performance Ratio (PR) calculated for each technology section.

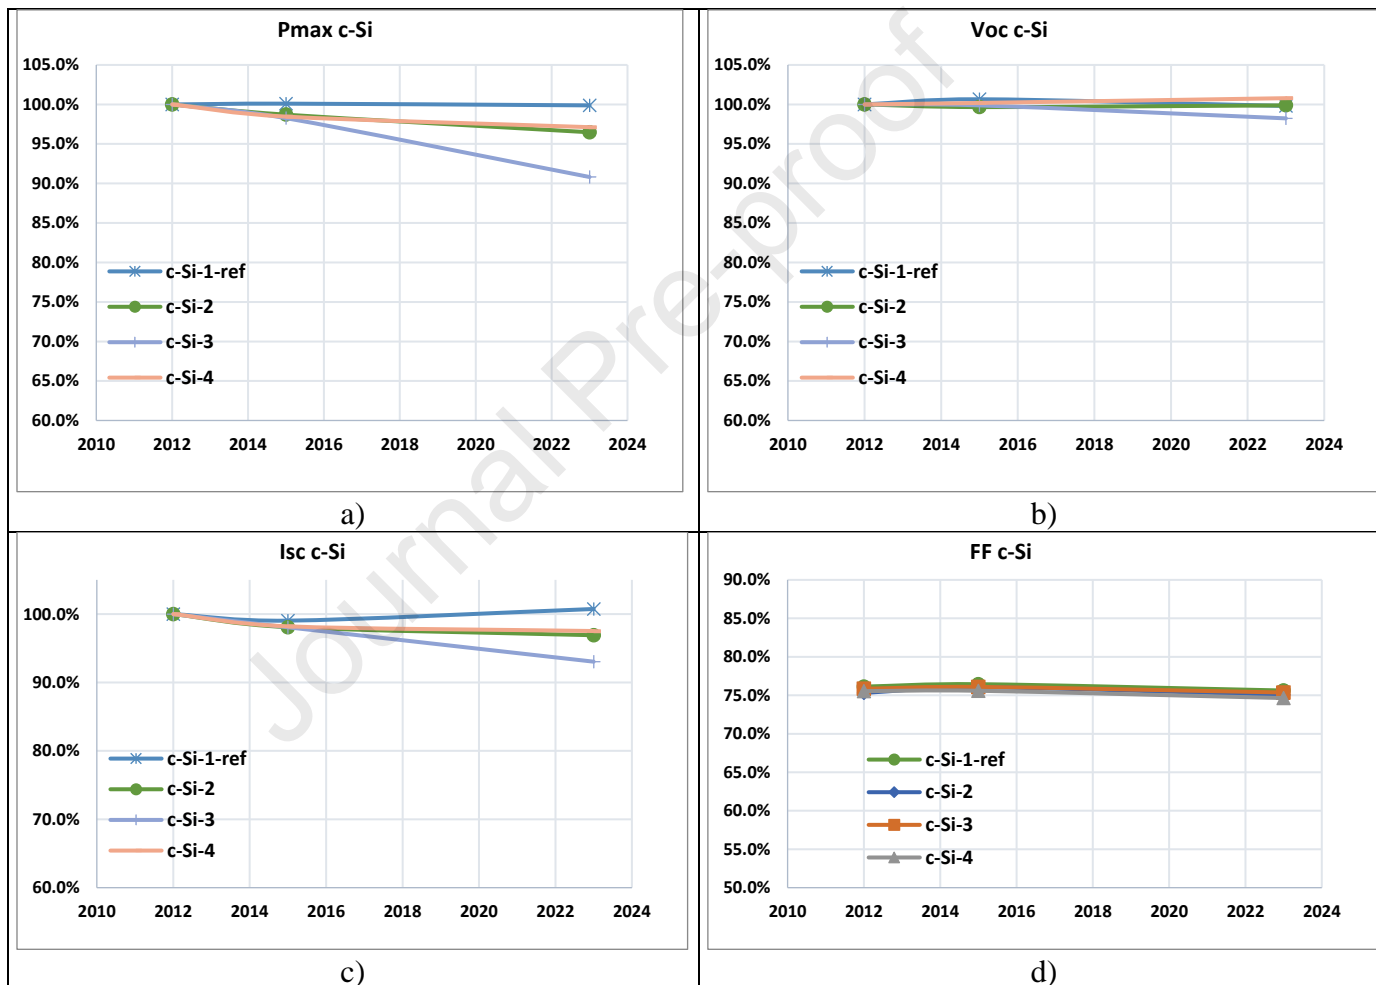
315 Figure 6.- Parameters evolution along ten years for cSi, including reference module and three in-operation modules. a)
 316 maximum power, b) voltage in open circuit, c) short-circuit current and d) fill factor.

317 These group of modules demonstrated a stable performance over the period of study with a
 318 slight decline in Pmax and FF. The values for Pmax declined from 3% (modules 2 and 4) to
 319 10% (module 3), while the reference module remained stable without losses.

320 The open circuit voltage presented a lower descent (1-2%) compared to the short-circuit current
 321 (3-7%), thus indicating the robustness of this technology under sustained operational
 322 conditions.

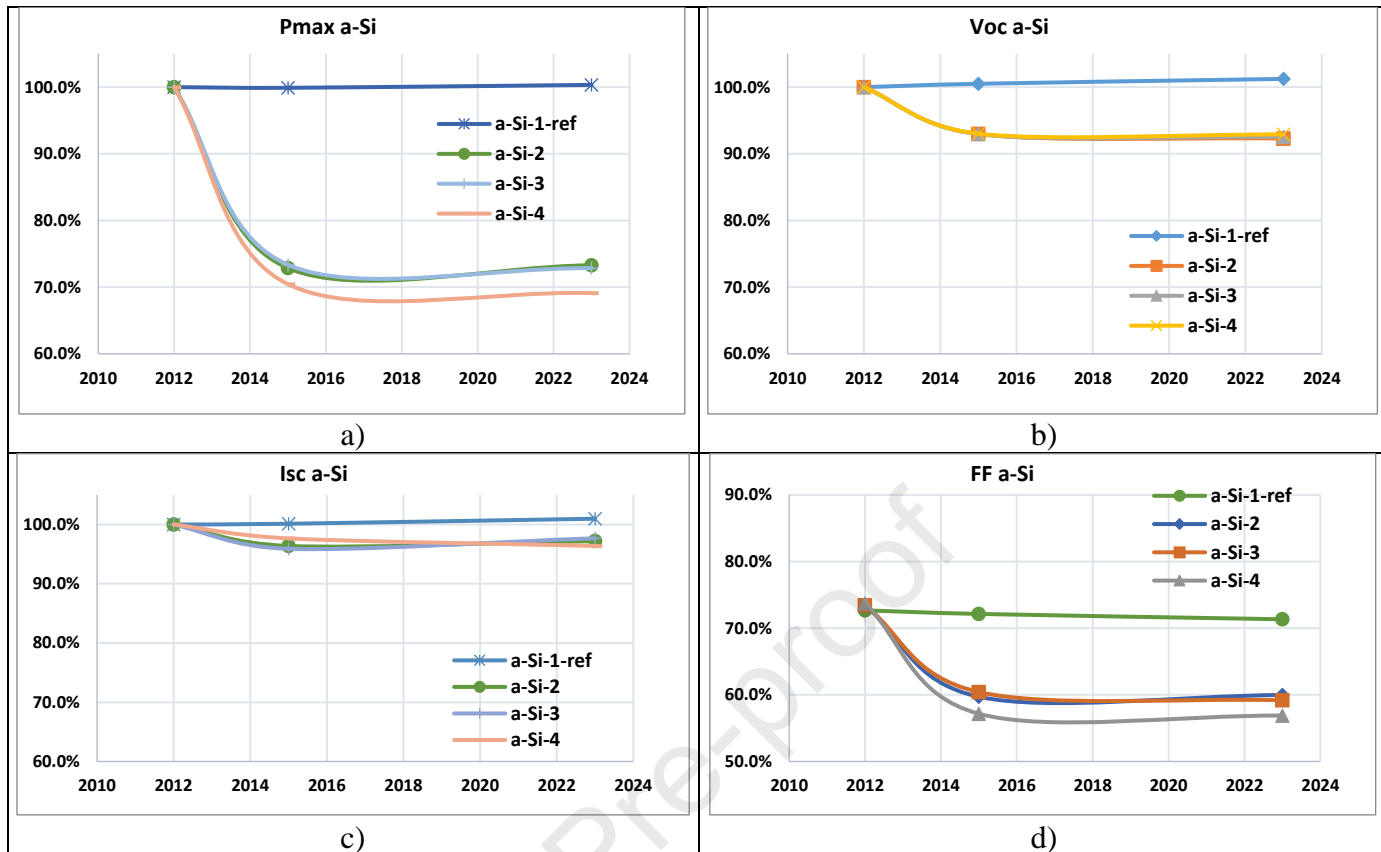
325 Figure 7.- Parameters evolution along ten years for aSi, including reference module and three in-operation modules. a)
 326 maximum power, b) voltage in open circuit, c) short-circuit current, and d) fill factor.

327 The analysis of the a-Si modules is of great interest. Unlike crystalline silicon, in which initial
 328 power stabilization ends after the first few days of panel outdoor exposure (Munoz et al., 2011),
 329 a-Si takes longer to stabilize, typically they do after 1000 hours of light exposure (Berov et al.,
 330 2014). Amorphous silicon technologies suffer from an initial light induced degradation known
 331 as Staebler–Wronski effect (Staebler and Wronski CR, 1977). The stabilization period depends
 332 on the type of module and the environmental conditions, with documented periods of
 333 stabilization from 6 weeks to one or more years (Piliouguine et al, 2022 b). In our case, this
 334 stabilization seems to be achieved after one year and half, and it is observed in all module
 335 parameters, Isc, Voc, Pmax and FF.

336 Thereby, an aspect of utmost importance regarding improvement of a-Si application is
 337 stabilized conversion efficiency (Ichikawa et al., 1990). In our case, it can be seen how after
 338 the initial stabilization, where the panels lose more than 27% (an effect that is known and does
 339 not imply irreversible degradation but, as mentioned, stabilization), the electrical parameters
 340 remain stable over time with a non-significant degradation of Pmax, Isc and Voc. Even the fill
 341 factor remains stable from the second measurement (2015) to the last one (2023). Piliouguine et
 342 al. (2022b) found that while in the first two years of operation the degradation of a-Si panels is
 343 mainly due to a decrease of the current, the long-term degradation is dominated by the reduction
 344 in voltage. Nakamura et al. (2023) reported an annual degradation rate of 3.776% for the first
 345 two years of operation of their a-Si panels followed by 0.31% per year in the eight next years.

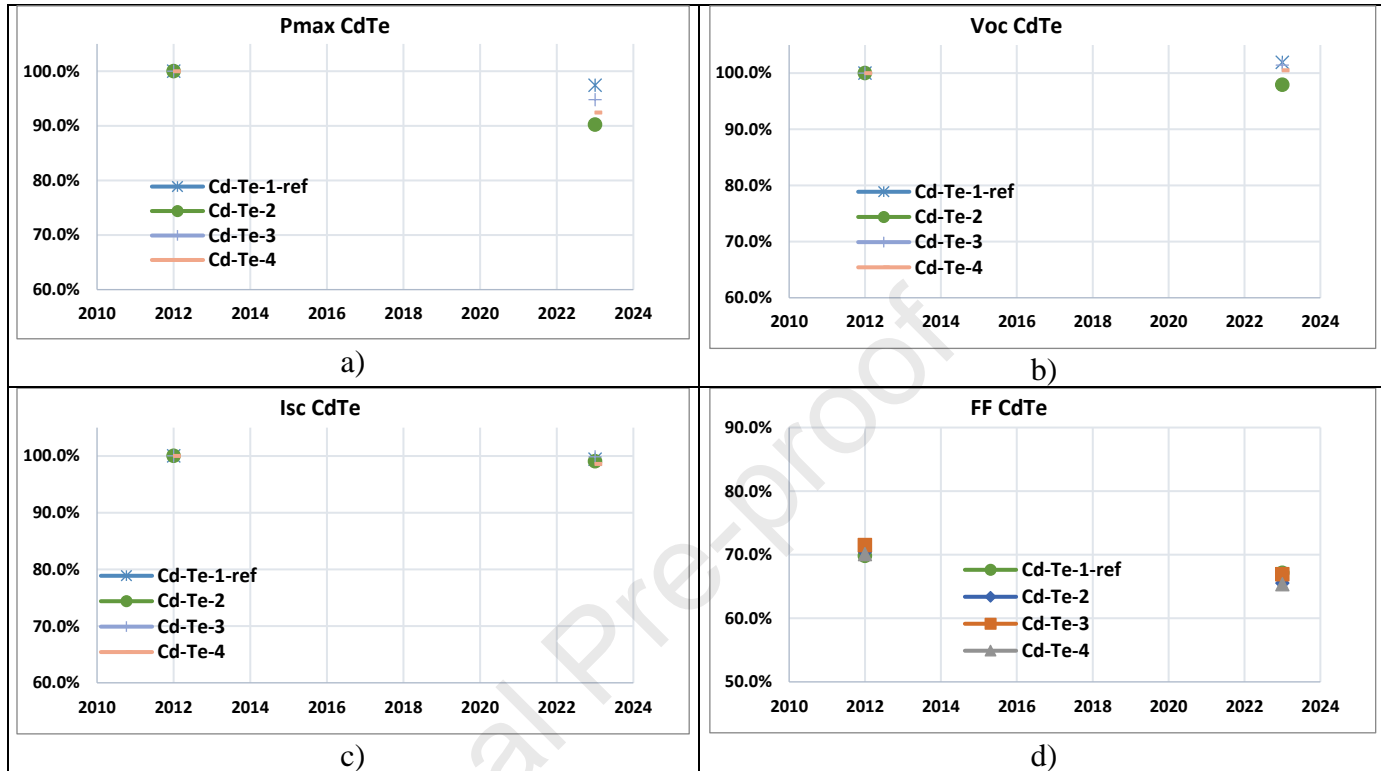
356 *Figure 8.- Parameters evolution along ten years for CdTe, including reference module and three in-operation modules. a)*
 357 *maximum power, b) voltage in open circuit, c) short circuit current and d) fill factor.*

358 Regarding CdTe modules, they showed a different degradation pattern compared to the two
 359 groups of panels analysed above. Although P_{max} output values decreased a 9,8 %, open circuit
 360 voltage and short-circuit current remain reasonably stable. Thus, the degradation came from the
 361 descent in the fill factor, which points at the degradation of internal parallel and series
 362 resistances. Nevertheless, the degradation rate remained within the expected values.

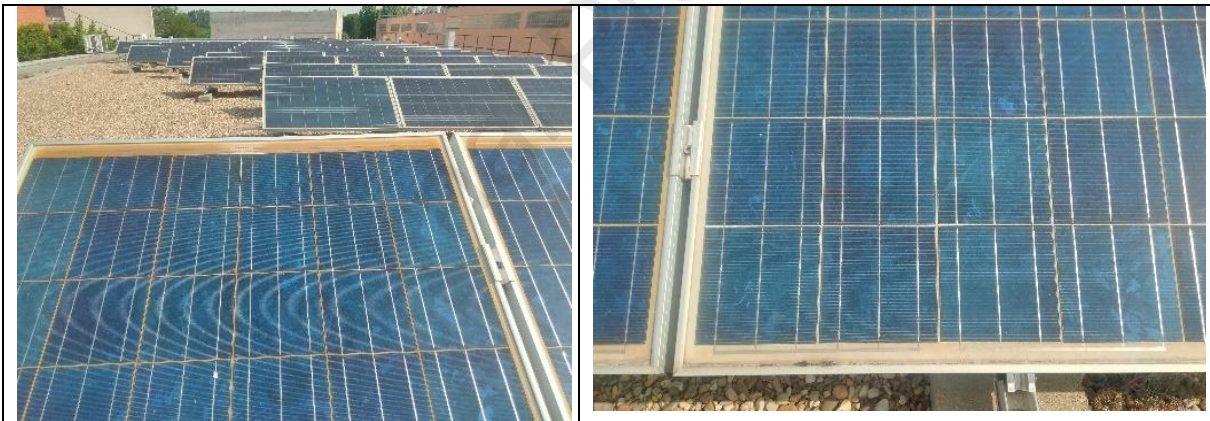
400 The Figure 10 shows a general view of the cSi experimental area. A yellowing effect is clearly
401 observed in the image. This effect is not present in the panels that are part of the non-
402 experimental area. The difference between one area and another is the aspect orientation of the
403 panels, since they are the same brand and model. This could lead to thinking about an effect of
404 greater heat accumulation in panels that are placed vertically (portrait aspect) as a possible cause
405 of the difference, since the ambient temperature and radiation is the same in both cases.

431 *Figure 10.- Perspective image of the experimental and commercial areas with c-Si panels of the same model.*

396 On the other hand, cSi panels present generalized yellowing. Once again, this is a visual defect
397 that, in view of the results of the energy generated as well as the data obtained in the solar
398 simulator, does not seriously affect operation.

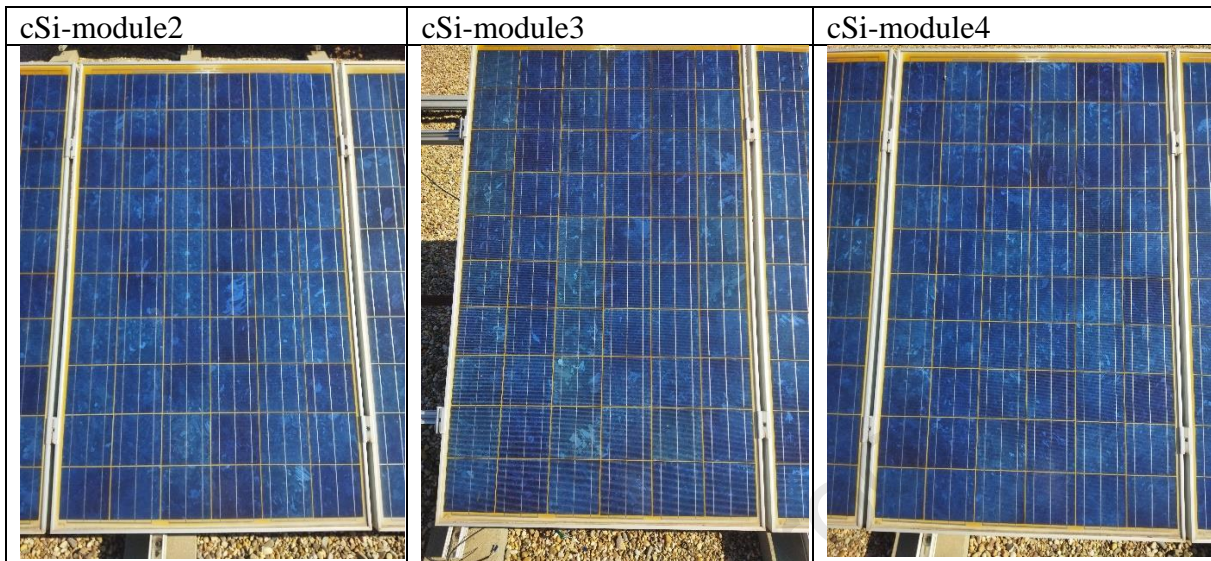
438 *Figure 12.- View of the three installed and working cSi modules used in for the analysis.*
