**Robustness of building floors under column
removal. Experimental and theoretical study.**

DOCTORAL THESIS

**Doctoral Degree in Engineering of Structures, Foundations and
Materials**

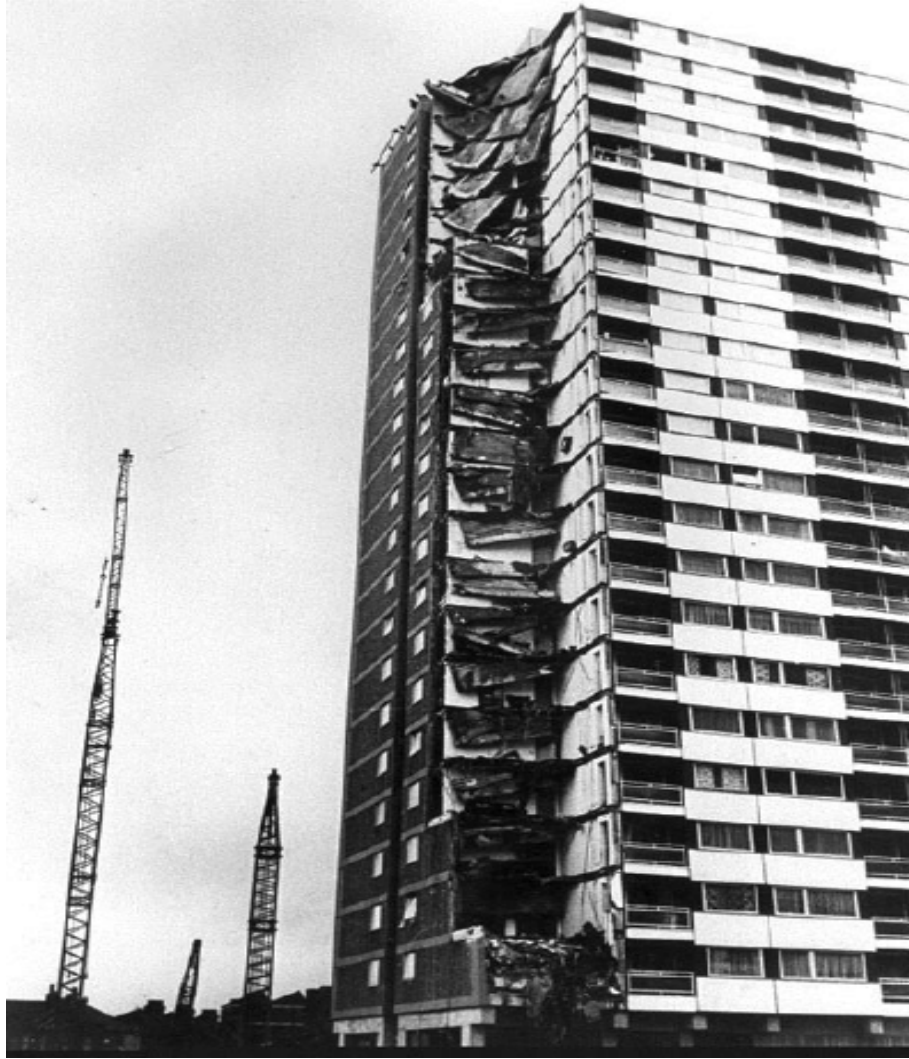
Figure 2.1: The Ronan Point disaster, 1968. Source:©London Borough of Newham - Heritage & Archives

Later at the end of the 70's, a gas explosion on the 18th floor of the 22-story Ronal Point apartment tower in Newham (London), caused the loss of support near the corner of the building. This caused the floors above to collapse and set off a chain reaction that ended up with the failure of all the corner bay of the building, as can be seen in figure 2.1.

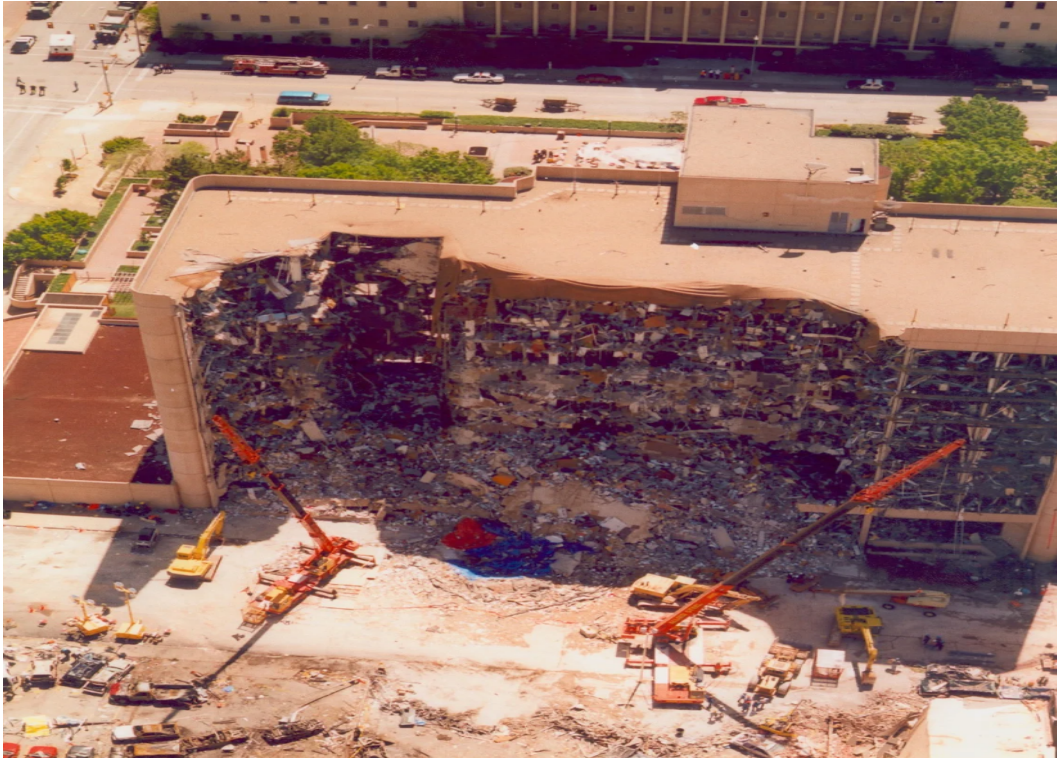
Figure 2.5: Alfred P. Murrah Federal Building in Oklahoma City on April 19, 1995

On 19 April 1995, the Murrah Federal Building in downtown Oklahoma City was destroyed by a bomb located inside a truck parked at the base of the building. The bomb destroyed or badly damaged three columns. This loss of support led to failure a transfer girder. And this caused the collapse of columns supported by the girder and the floor areas that were sustained by the columns. As a result, a big area of the building collapsed as can be seen in figure 2.5. The collapse of this structure was a clear example of a progressive collapse in the entire terms:

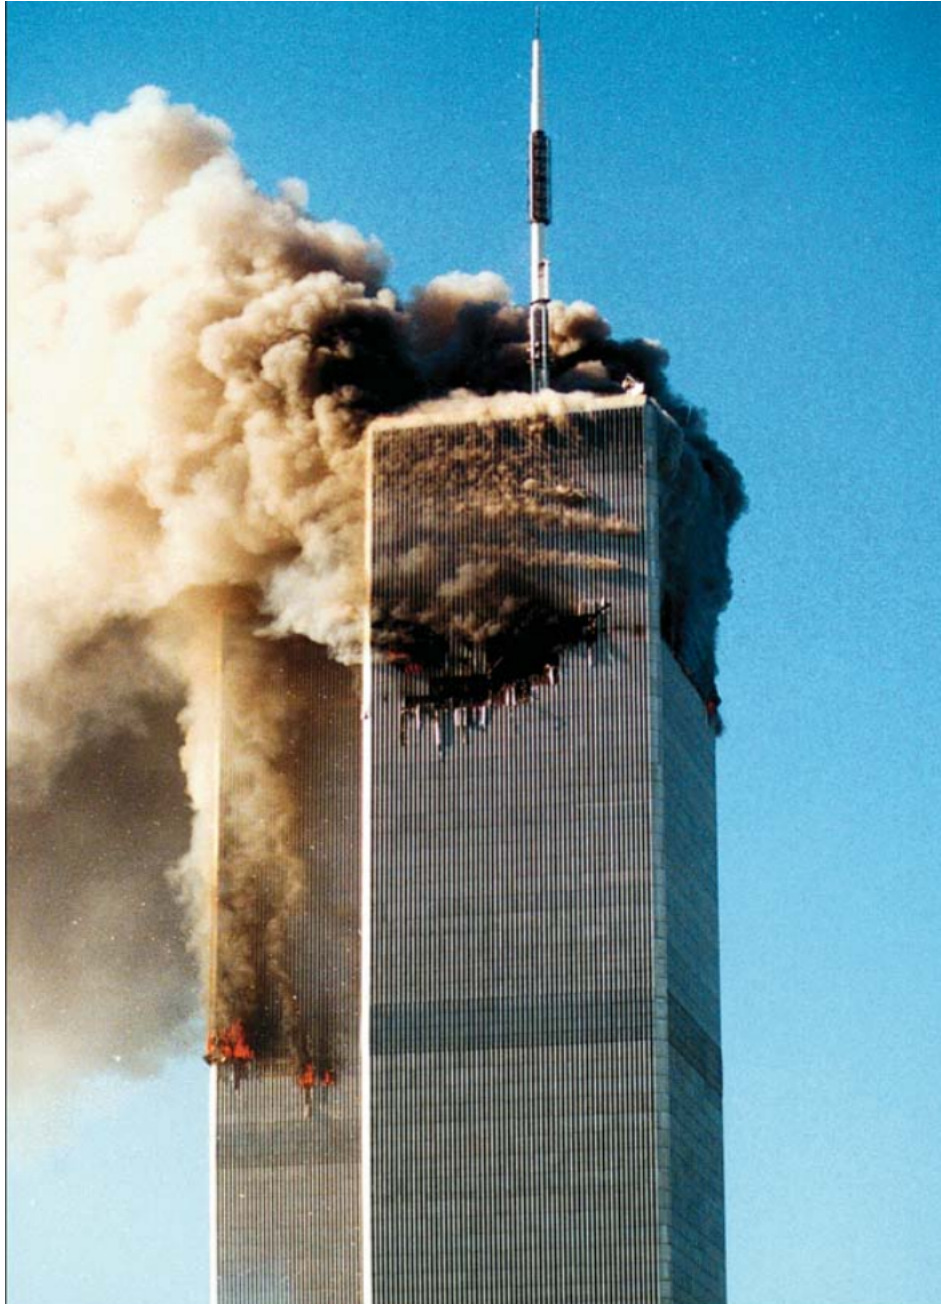
Figure 2.6: World Trade Center Towers, 2011. Source: ©Roberto Rabanne

On September 11, 2001, two Boeing 767-200ER commercial aircraft hit the World Trade Centre buildings killing over 2800 people in the biggest terrorist attack on the United States. The two towers experienced a similar, but not identical, series of loading events. The sequence of the events was the same for the two buildings, although the timing was not. In the first event, the aircraft impacts resulted in severe structural damage in each case, including some localized partial collapse. The second was the ignition of the fuel and the growth of fires over several floors and different zones of the buildings. The fires heated the structure, causing stresses on a structure previously damaged by aircraft impacts and causing a loss of strength that started the third event, a progressive sequence of failures that ended up in the collapse of both towers.

This event was an example of progressive collapse, where a pancake type collapse mechanism led to progressive failure of the structure and ended with the complete destruction of the towers. After these two big attacks, an alarmed public opinion led to the introduction of new standards and recommendations.

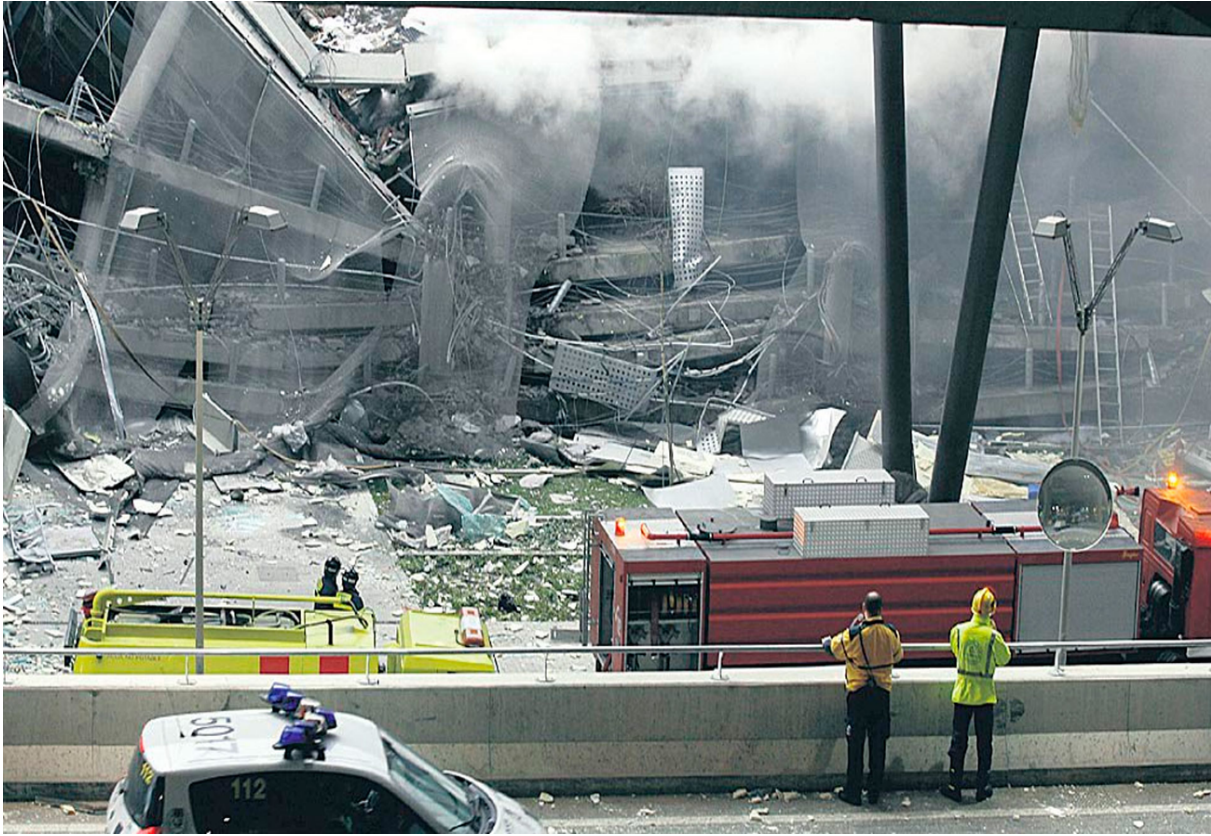
Figure 2.7: T4 Terminal, Madrid Airport, 2006

In 2006, Terminal 4 of Madrid's Airport was hit by a terrorist attack. A van bomb parked in the second floor of the car park, on module D exploded. The explosion demolished almost all the five floors of the car park and produced tones of debris. After the explosion, the failure of

the connection between supports and slabs was caused by load inversion Bermejo et al., 2015.

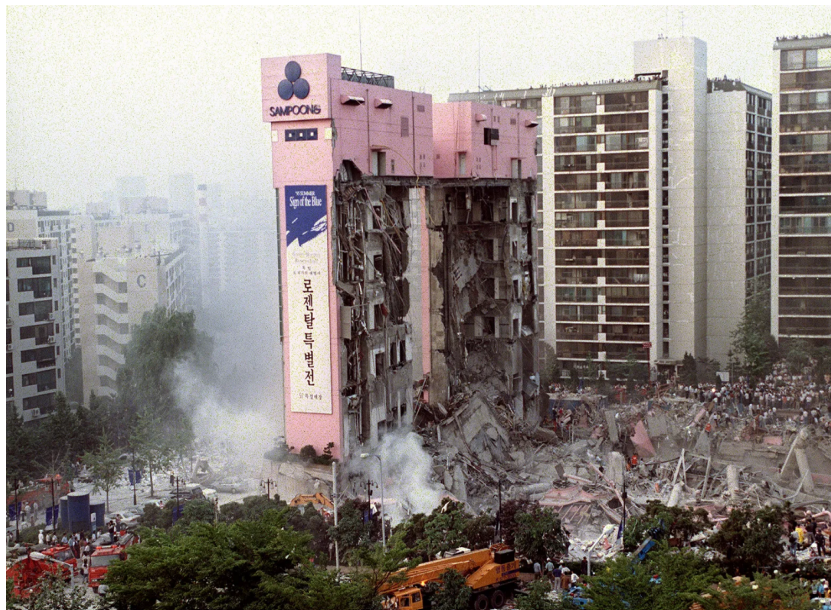
Figure 2.10: Sampoong Superstore collapse. Source:©AFP—Choo Youn-Kong/Getty Images

In real world structural failures, it is rare for only one type of collapse to occur; instead, mixed type collapses are more common Kiakojouri et al., 2020. Despite limited research on categorizing and analyzing combined collapse types, several well known incidents illustrate these complex failure mechanisms. According to Starossek, 2009, collapse of the Sampoong Superstore in Seoul in 1995, exemplifies a mixed type failure : it began with columns punching through the slabs. as the load was redistributed, the failure propagated horizontally, inducing a zipper type collapse, ultimately leading to a loss of vertical load bearing capacity in the slabs and causing a pancake collapse.

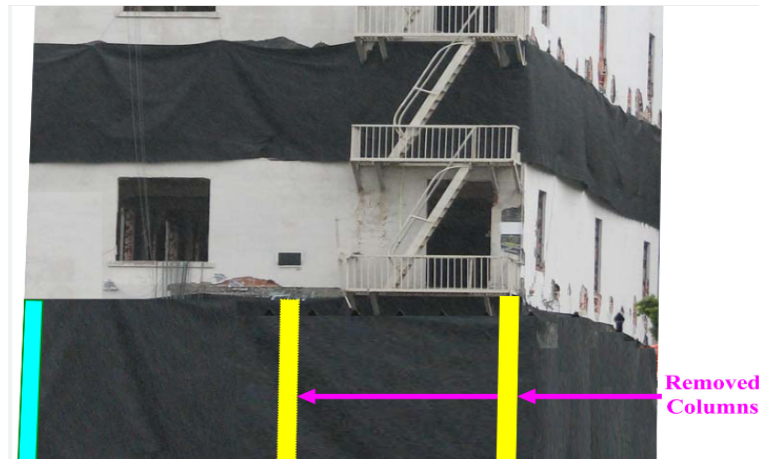
Figure 2.15: Hotel San Diego. Photo extracted from Journal of Structural Engineering Vol. 134, N°3 (Mehrdad Sasani)

Sasani and Sagiroglu, 2008 and Sasani, 2008 focused on the 6-story Hotel San Diego in San Diego, built in 1914. After removing non-structural elements like partitions and plumbing, and then causing the failure of two columns with explosives, the vertical displacement of the slabs was minimal. This was due to the development of alternative load paths based on Vierendeel action and the role of the remaining infill walls.

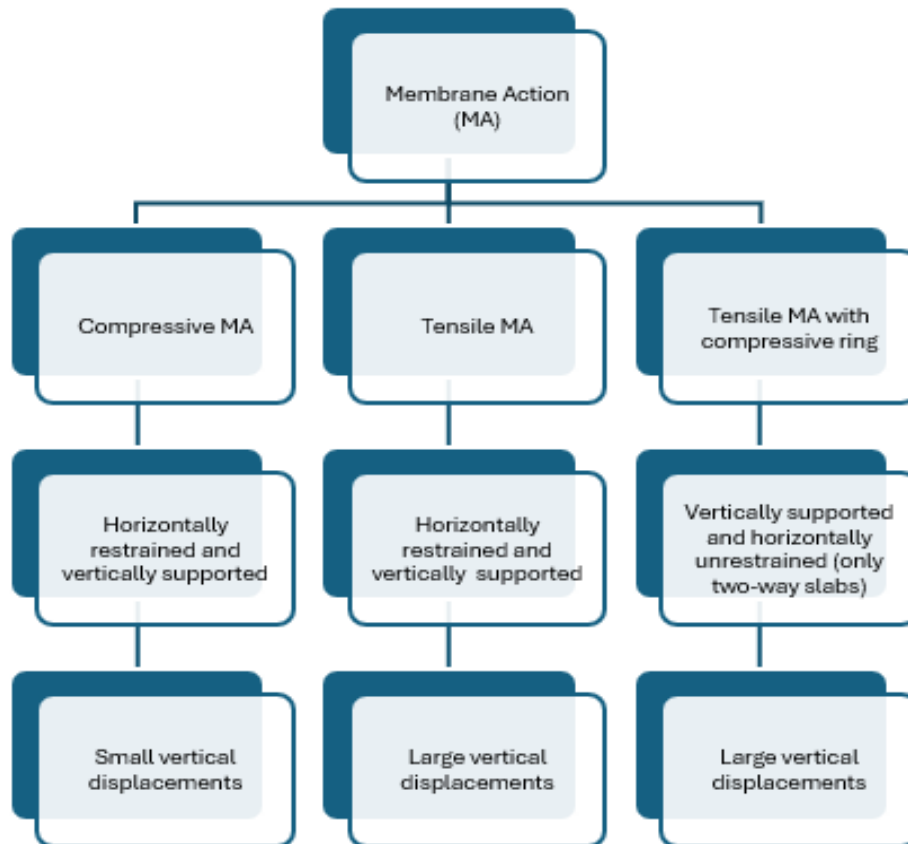
Figure 2.16: Different types of membrane action

When examining membrane action in reinforced concrete elements, it is crucial to differentiate between one-way and two-way load-bearing elements. Additionally, the horizontal boundary conditions of these elements should be considered. Figure 2.16 provides an overview of the various types of membrane action.

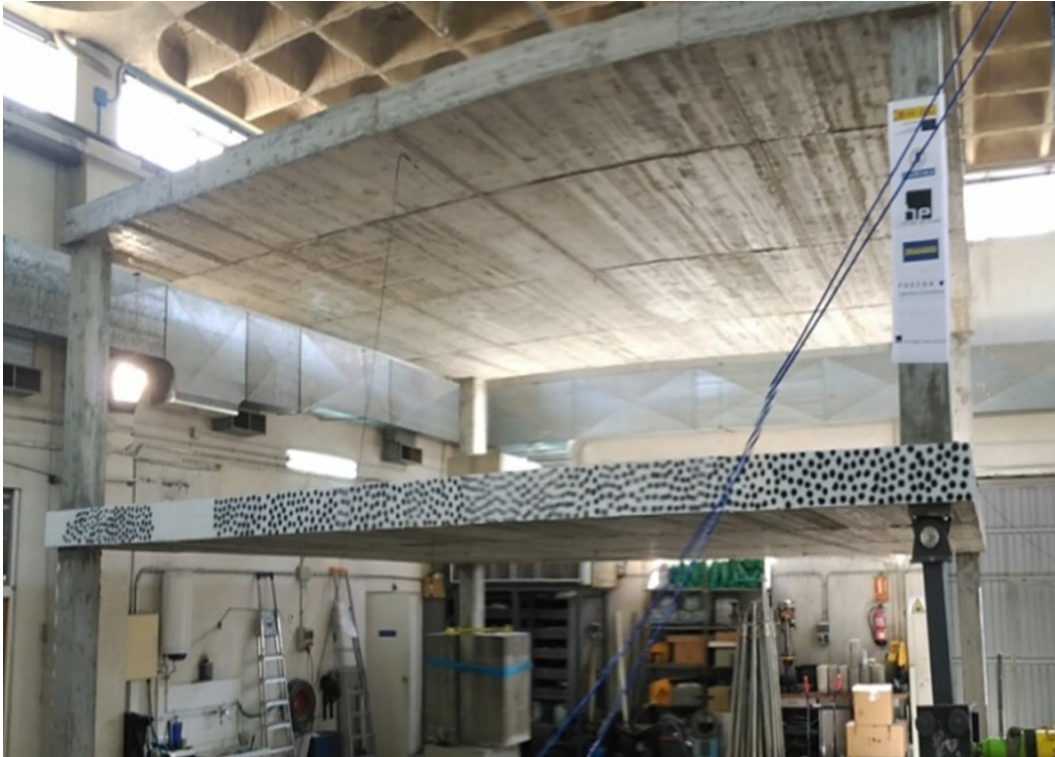
Figure 2.22: View of the structure built inside the laboratory

Figure 2.22 shows the structure built inside the lab. The dotted pattern on the side of the lower slab was used to measure the time-history of deflections along the edge of the slab during the test using Digital Image Correlation (DIC).

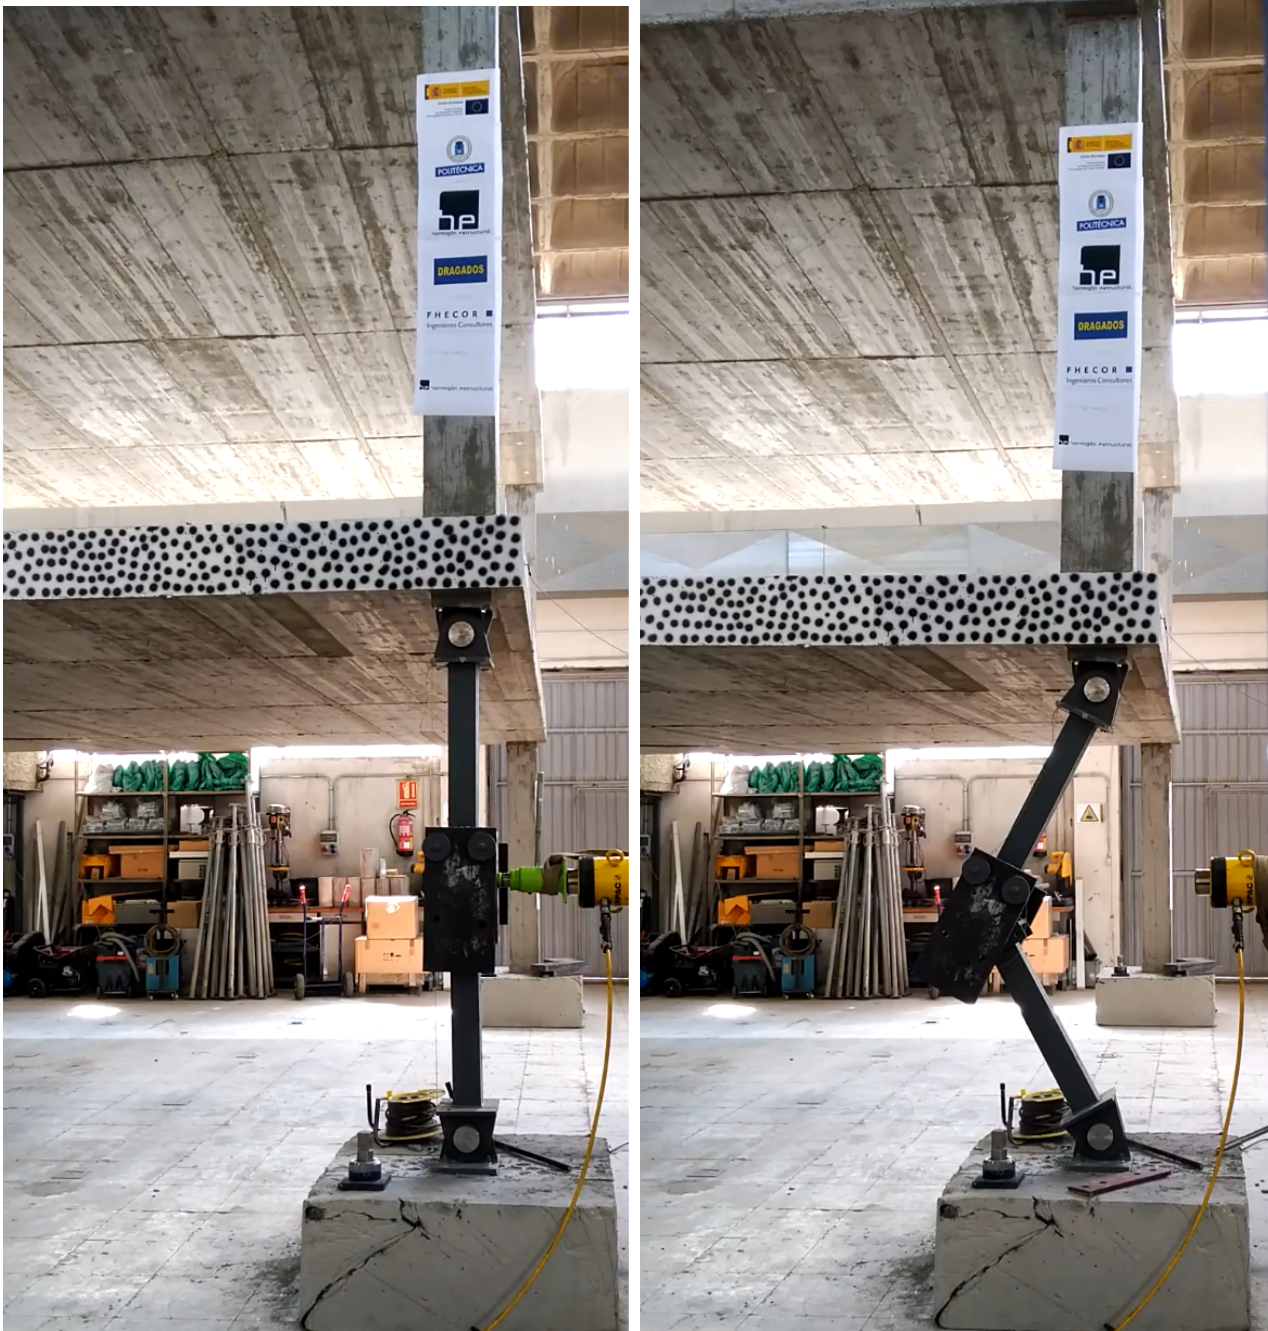
Figure 2.23: Hinge before and after the test

Figure 2.24 shows the detail and materialization of the central hinge of the steel column. The hinge is blocked by inserting 4 horizontal 20 mm steel rods through the 21 mm holes in the top and bottom vertical plates.

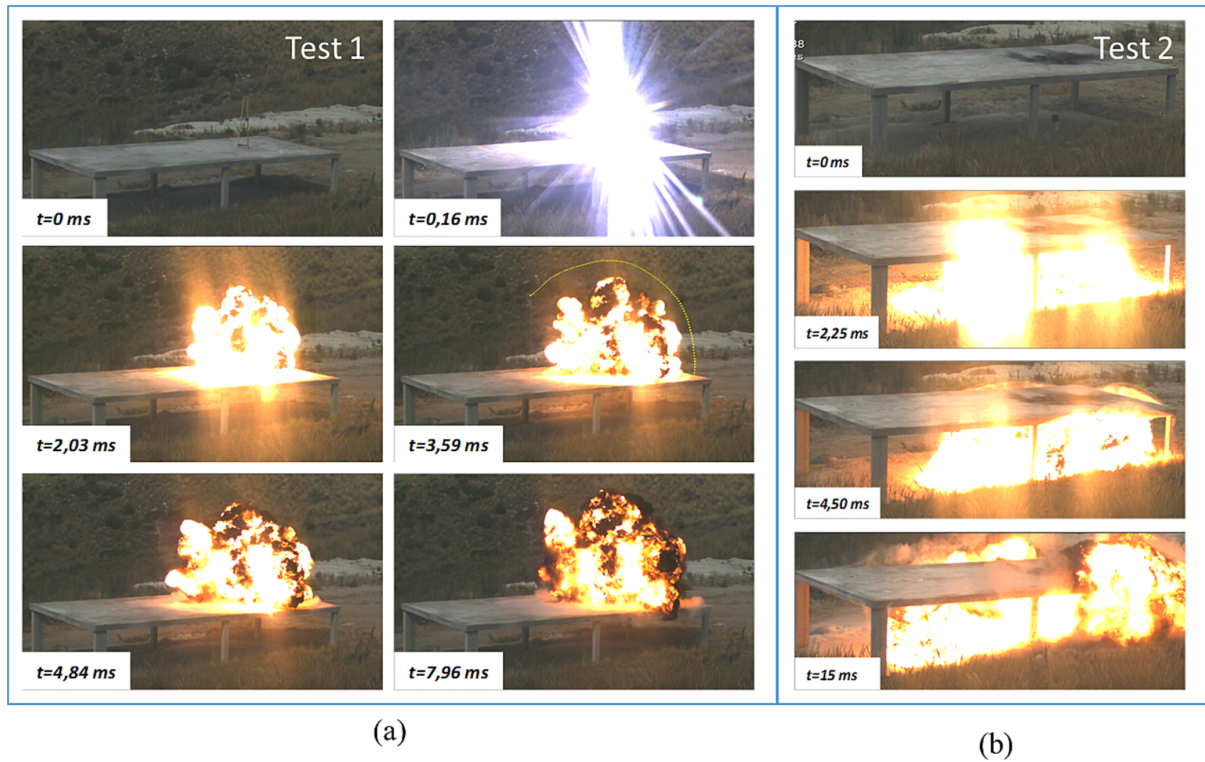
Figure 2.37: Sequence obtained with high-speed camera. a) Test 1 (yellow lines over image point out the shock wave) b) Test 2. (For interpretation of the references to colour in this figure legend, the reader is referred to the web version of this article.)

Figure 2.37-b shows 4 sequences from 0 to 15 ms in which the extent of the fireball can be observed. With this type of explosive charge, it is already necessary to consider the possible damage to the structure and its covering caused by the fire. Figure 2.36 shows the image sequence obtained in test T3 with high-speed camera and details the time that elapses between images taking as reference ($t = 0$) the first photo before the detonation. As mentioned above, for T3 test, five targets were positioned on the structure surface (see Figure 2.33) in order to evaluate the shock arrival times. Table 2.9 shows the arrival time results extracted from the images. Due to the fireball, only the arrival times on targets numbered T3, T4 and T5 were visible.
