Article

UAS IR-Thermograms Processing and Photogrammetry of Thermal Images for the Inspection of Building Envelopes

Keywords: UAS; IRT; thermal inspection; aerial inspection; 3D thermal photogrammetry; heat leaks; cellar; winery; thermal bridges

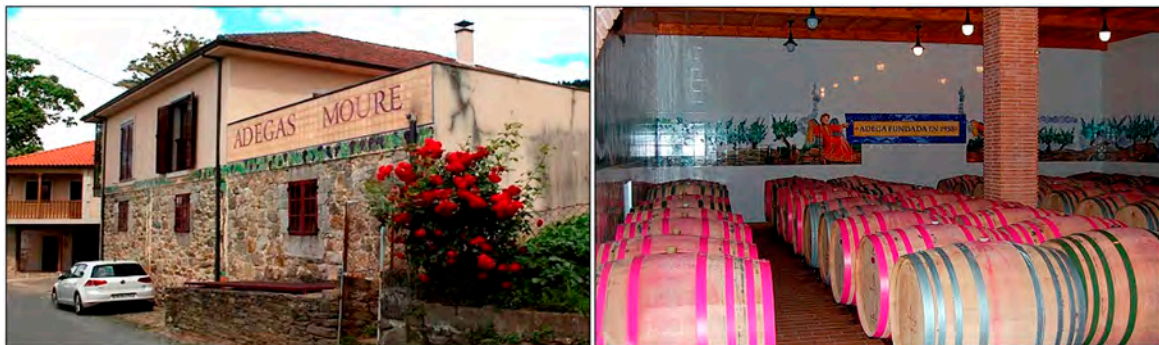
The exterior walls are mainly made of granite, and the doors, windows, and the structure supporting the roof are made of wood. Ceramic tiles were used for the wall cladding and the pillars and floor are built with bricks. Figure 1 shows the location of the winery and the exterior appearance of the building. Figure 2 shows a closer photograph of the exterior walls of the building and the interior.

Figure 2. On the left, the outer walls; on the right, the wine-aging room (ground floor).

The validity of the thermal model for obtaining an overall picture of the building envelope condition can be checked by simply reviewing Figures 1, 2 and 7. In the first two figures, it is clear how the wall shows stains caused by humidity. In Figure 7, one of the views of the 3D model constructed with the RGB images also shows the same pathology. Finally, Figure 18 is a side view of the model. Although it is impossible to make any kind of analysis here, it is presented to show how, even on the wall that is least likely to be photographed due to its position, which has a minimal projection towards the camera during the flight, it is almost possible to perform the reconstruction as well.

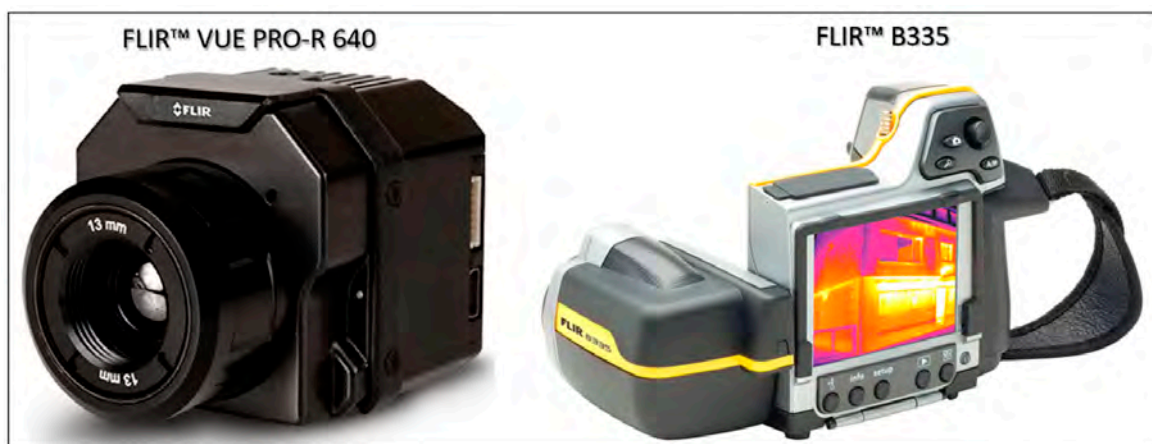
Figure 3. Thermal cameras used during the study.

The locations of the data loggers and the temperature probes will be presented below. Two radiometric thermal imaging cameras from FLIR™ Systems, USA were used for the non-contact measurement of the Surface Temperature (SF) of the walls in the wine cellar. The first, called FLIR Vue Pro-R 640, is lightweight and compact, designed to be installed on board a UAS. The second, the FLIR B335, is a conventional handheld camera. The former presents a resolution of $640 \times 512 \text{ px}$, the maximum resolution that most UAS cameras allow without interpolation. The latter has a resolution of $320 \times 240 \text{ px}$. The focal length of both cameras is 19 mm; pictures of both devices are shown in Figure 3.

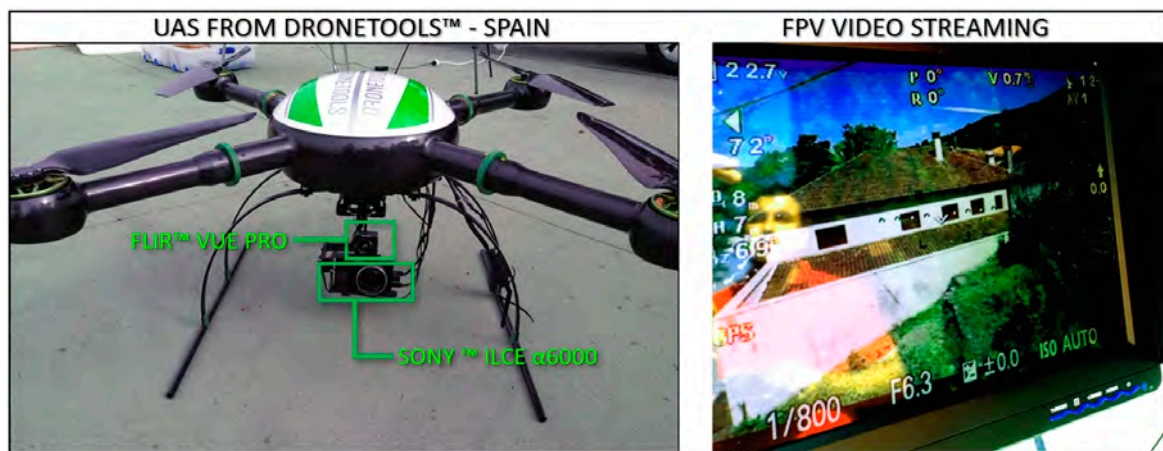
Figure 4. UAS, on board cameras, and FPV system.

Two methods were used to record the images of the cellar walls. Firstly, the FLIR VUE Pro R camera was installed on a UAS called Quasar™, manufactured by the company Dronetools™-Sevilla. This 4-rotor aircraft has an autonomy of approximately 1 h carrying a payload of 1.2 kg. The thermal camera was installed together with a Sony™ mirrorless RGB camera, ILCE $\alpha 6000^{\text{TM}}$, of 24 MPx. Both were mounted on a gimbal that kept them stabilised. The shots from the two cameras were synchronised, and the video transmitter installed on board allowed real-time video streaming to a monitor on the ground. Although the UAS

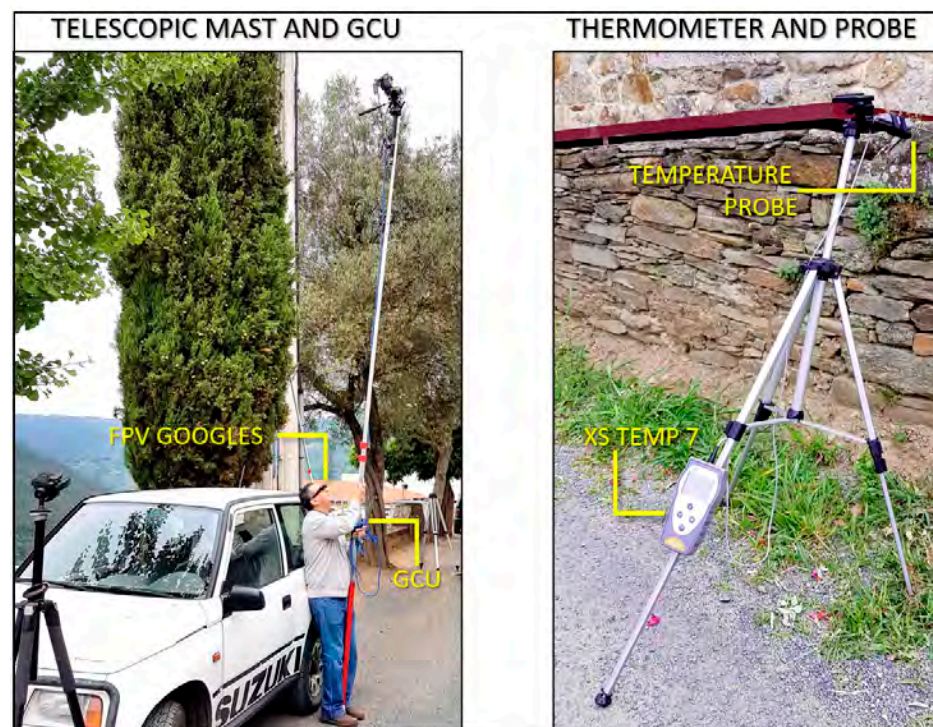
Figure 5. Telescopic tool, GCU, thermometer, and probes.

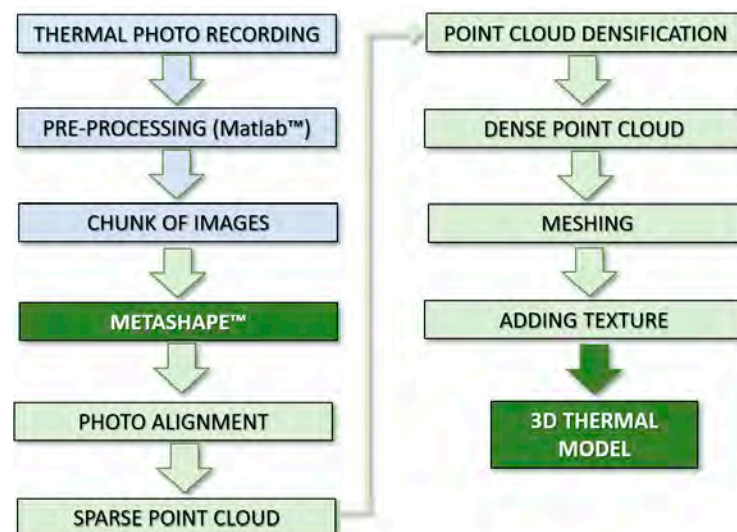
Figure 6. Workflow for obtaining the three-dimensional model from thermal images.

In the flowchart presented in Figure 6, the parts of the process that are carried out outside the photogrammetry software are coloured in blue and those that are carried out inside Metashape in green. It can be observed that after capturing the images, processing is required that does not apply to the RGB images. Although its mathematical foundations will be explained in detail in later sections, it can be anticipated that it mainly consists of the application of filters to eliminate noise or improve the focus of the images.

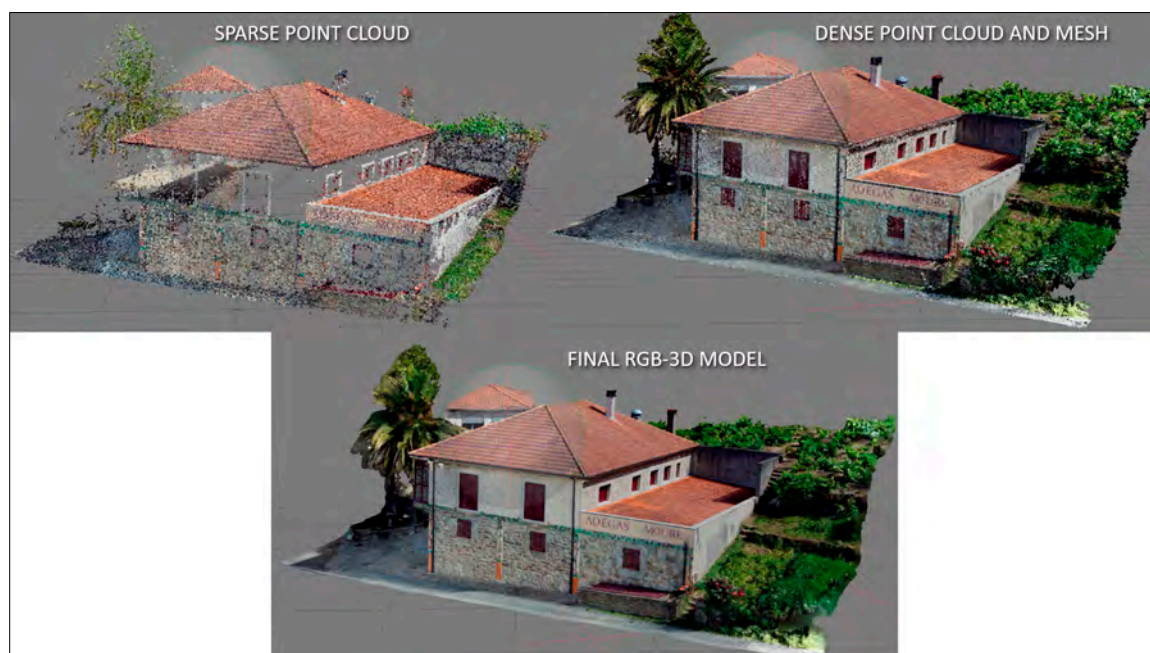
The meshing process consists of the creation of a mesh of triangular elements that join the points of the dense cloud. Once the mesh has been constructed, the three-dimensional model is visible. However, its surface does not have the texture of the real object or structure. In order for the final results to have the right texture, the pattern defined by the photographs is used. To facilitate the understanding of the process, Figure 7 shows 3 screenshots of the RGB model from the sparse point cloud to the final model.

Figure 7. Phases in the construction of the 3D-RGB model of the cellar.

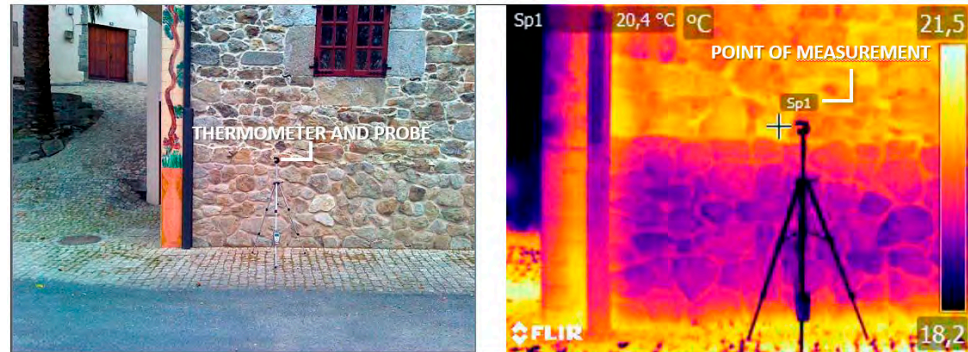
The results obtained are shown below: Figure 7 shows different views of the 3D model built with RGB images, Figure 8 shows the procedure for measuring the temperature of the walls using thermal probes and Figure 9 shows the thermal images with the sensitive points selected for the study.

Figure 8. Measurement procedure.

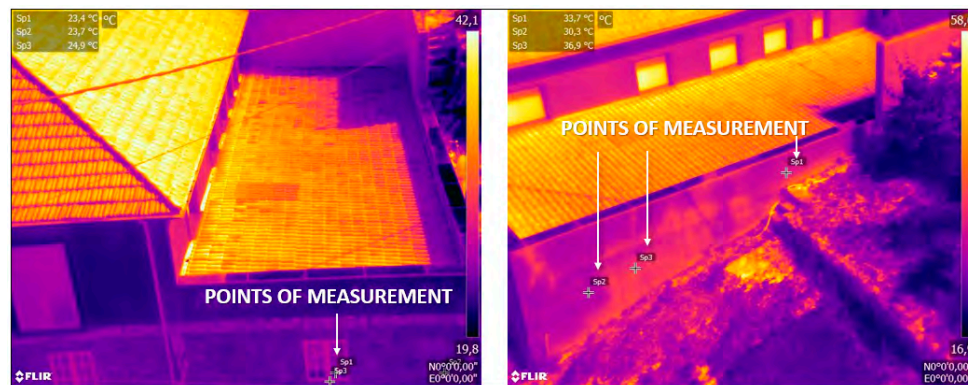
Figure 9. Thermal images, points of measurement and anomalies (different colour patterns).

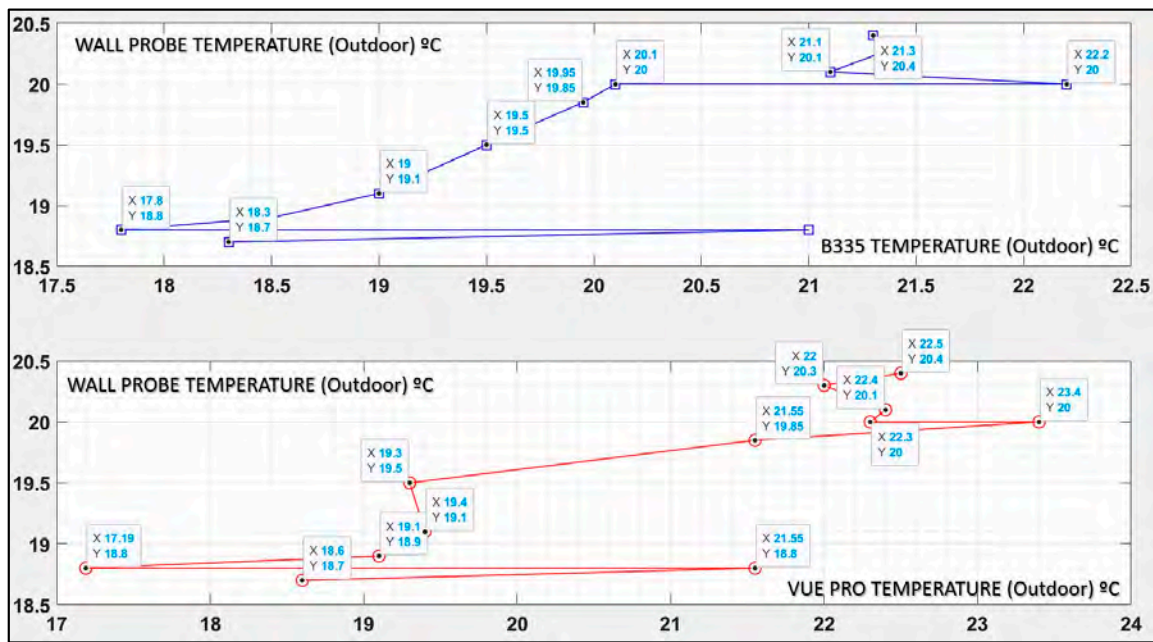
To check the validity of the study and to determine the accuracy that could be obtained by radiometric thermal imaging, the temperature values provided by the cameras at the reference points were compared with those obtained from the thermal probes in direct contact with the walls. The study was carried out for both cameras, inside and outside the envelope. Figures 10 and 11 show, on the ordinate axis, the temperature measured by the probes, and on the abscissa axis, those obtained from the thermal images. Figure 10 shows the outside temperature results and Figure 11 shows the inside temperature results.

Figure 10. Comparison between outdoor temperatures measured with the probes and those extracted from the two thermal cameras.

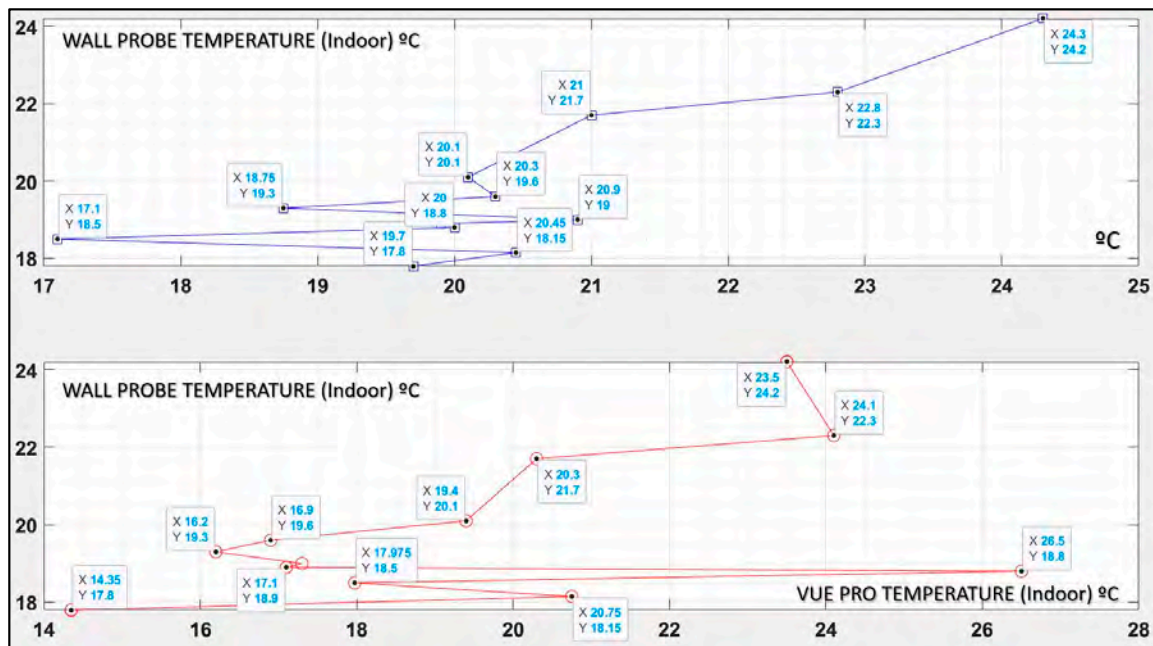
Figure 11. Comparison between the indoor temperatures measured with the probes and those extracted from the two thermal cameras.

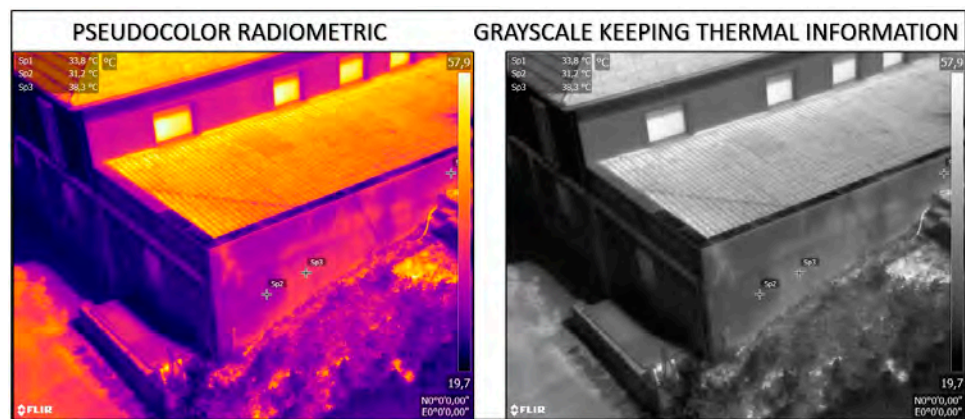
Figure 12 presents the conversion of a radiometric thermal image recorded with a colour palette to a greyscale image while retaining the thermal information. This transformation was performed to add to the set of photographs from which the model was generated, some taken by hand, thus making it possible to increase the size of the chunk loaded in Metashape.

Figure 12. Conversion to greyscale keeping thermal information.

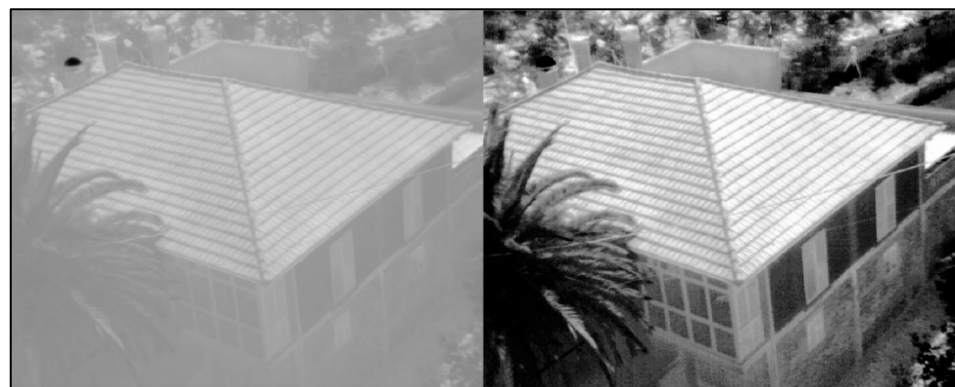
As can be seen from Figure 13, some thermal images have a very uneven histogram that prevents the detection of tie points during photogrammetric processing. This figure shows the original photo on the left and on the right the same image after redistributing the histogram. Although the improvement in the result is clear and the resulting 3D model is valid and shows the sharpest geometric details, it was not used, because the redistribution of the histogram showed some thermal anomalies more intensely, but diluted the edges of the affected regions on the roof of the building.

Figure 13. Histogram equalisation. Left, original image; right, equalised.

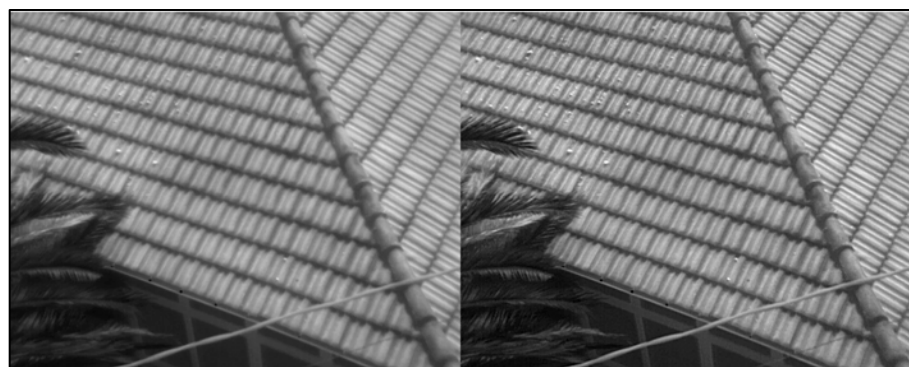
Figures 14 and 15 are of the greatest interest. They depict the application of two Gaussian filters with different depths. The first one, used in Figure 14, is of lower intensity than the one in Figure 15. In both cases, the better focus of the original image after applying the filter is evident. Since the final model was constructed after focusing the images and this type of filter is particularly suited to the characteristics of a thermal image, its mathematical foundations and properties are presented below. Its advantages for global and direct

Figure 14. Gaussian filter with minimum depth. Left, original image; right, focused.

By selecting the correct value, as in the photographs in Figure 14, there is no variation in the thermal information collected by the image and the improved focus allowed 199 images to be oriented, compared to the 153 that Metashape aligned before processing. Although the resulting model is not comparable to that extracted from the RGB images (6000×4000 px vs. 640×512) the areas of the walls and roof where thermal anomalies were measured are easily identifiable and the pre-processing valid for any three-dimensional reconstruction using thermal imagery.

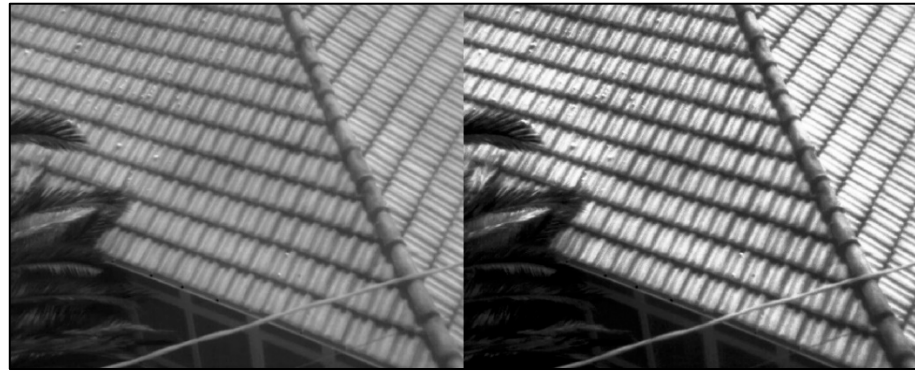
Figure 15. Gaussian filter with maximum depth. Left, original image; right, focused.

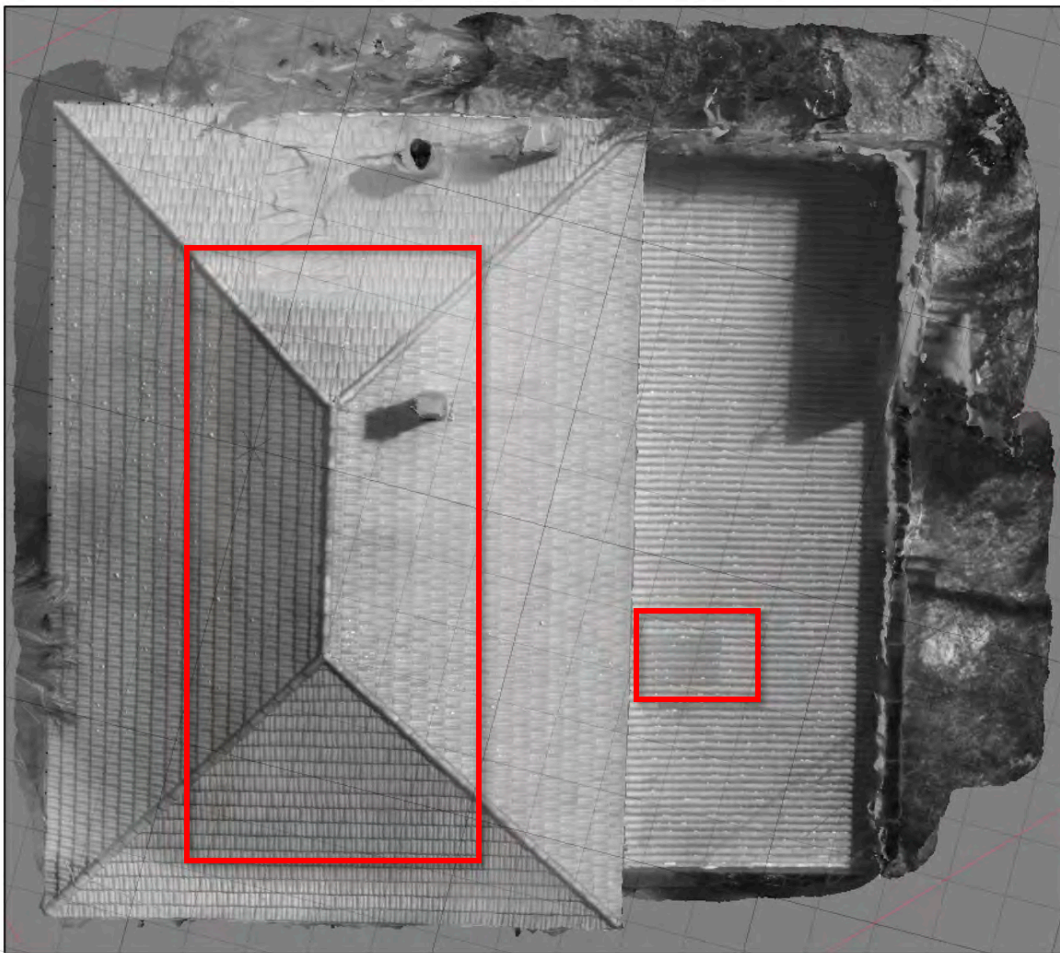
Figures 16–18 show three views of the thermal model. Figure 16 presents a zenithal view. It can be seen that in the main roof, in the central area where both sides converge, there is a central area and an outer area with different shades of grey, indicating the non-uniform distribution of temperatures. To maintain the thermal equilibrium of the envelope, the structure in these regions must be insulated.

Figure 16. Top view of the model, thermal anomalies in the roof.

1. Installation of systems for thermal bridge rupture in the joineries.
2. Double-glazing windows.
3. Reinforcement of the insulation layer in the subfloor.
4. Cladding the concrete columns.

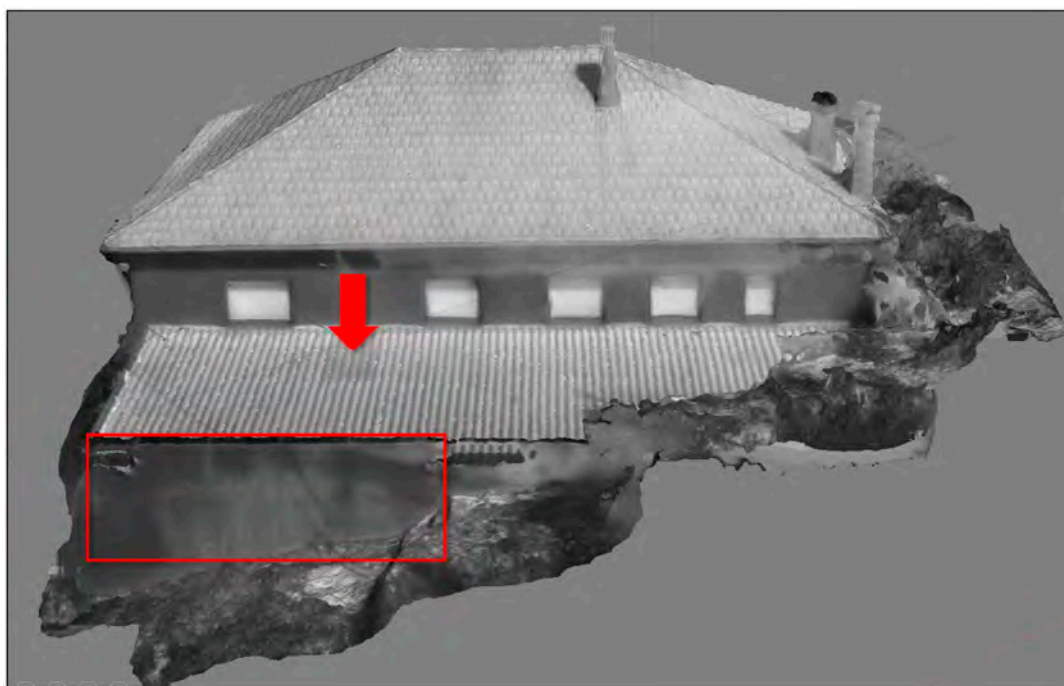
Figure 17 is a front view of the model. In this image, it is possible to inspect the front wall on the left side. As in Figure 16, the temperature is not uniform, and the anomaly is also presented as a set of grey shades with different tones. In the region shown in the model within the red rectangle, the presence of moisture was detected.

Figure 17. Front view: thermal anomalies in the wall. The red arrow points to a small area with a thermal anomaly on the roof.

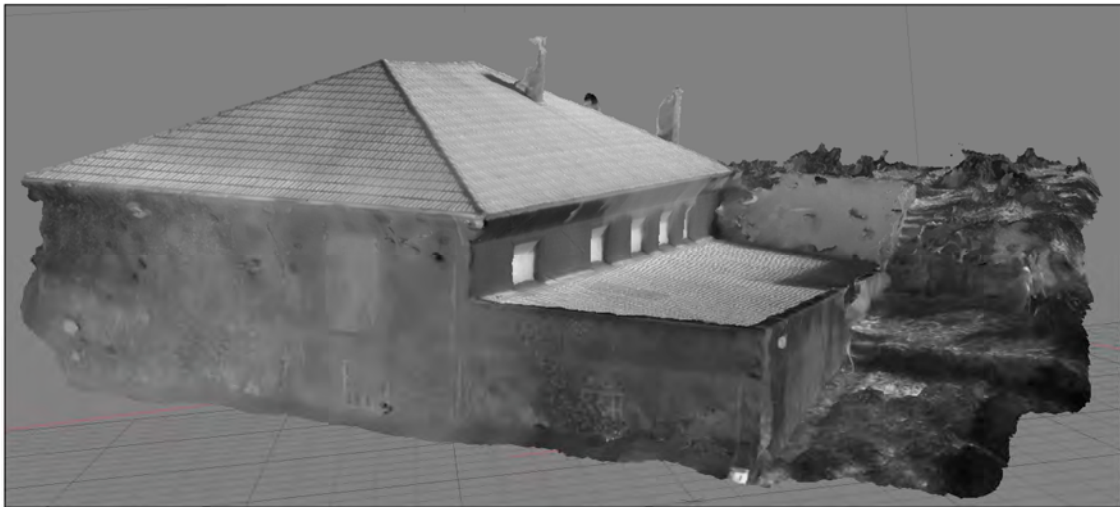
Figure 18. Side view, even the most hidden wall is almost reconstructed.
