GEOMETRICAL VARIATION OF CORROSION PARAMETERS IN A BEAM AND A PILLAR OF REINFORCED CONCRETE CONTAINING CL-

B. Sanz. UPM-CISDEM
C. Andrade. IETCC-CISDEM

JOINT *fib*- RILEM WORKSHOP
MODELLING OF CORRODING CONCRETE STRUCTURES
22-23 November 2010
Madrid, Spain

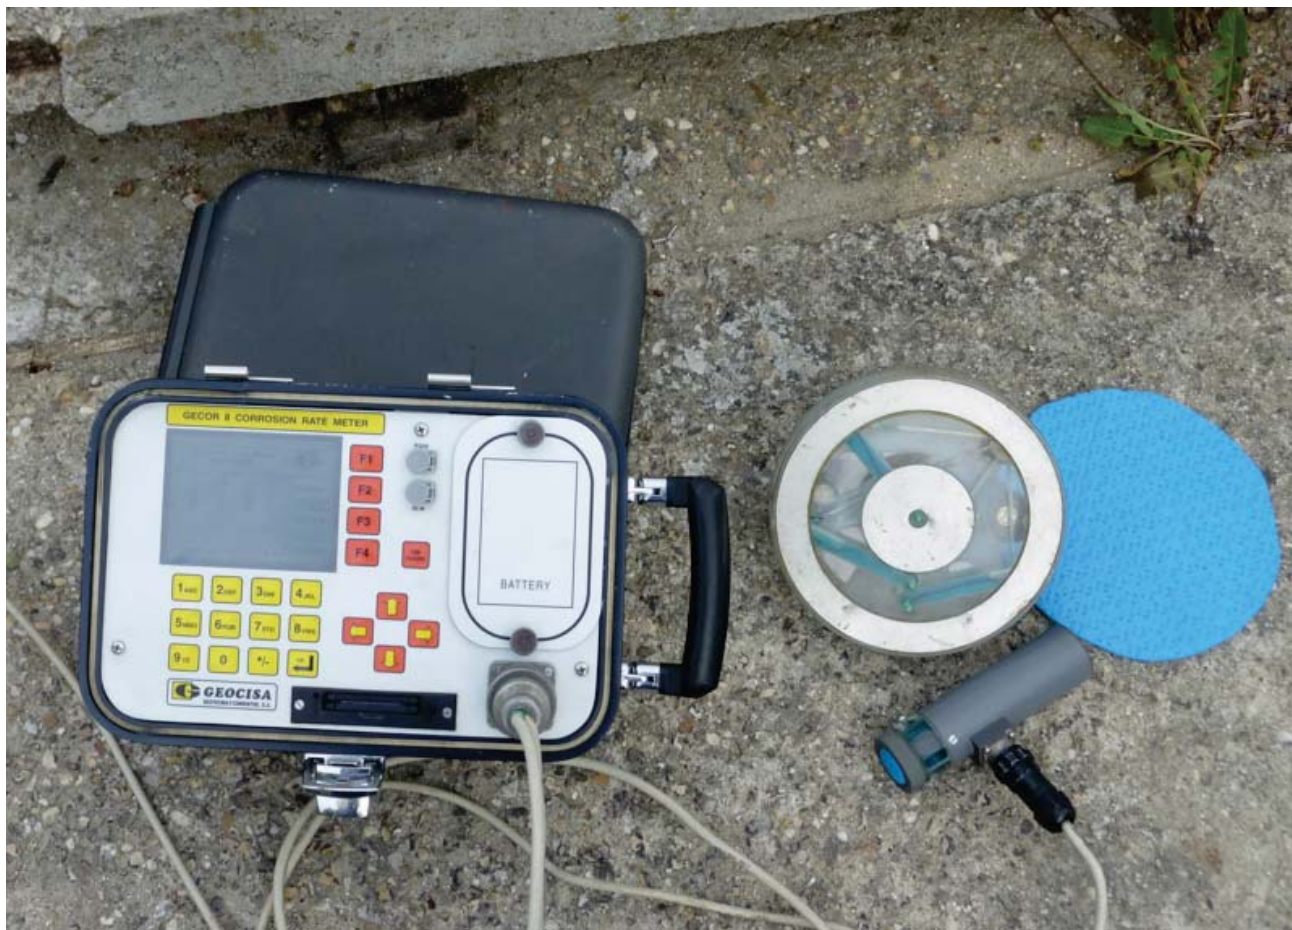
Measurement instrument: GECOR 8

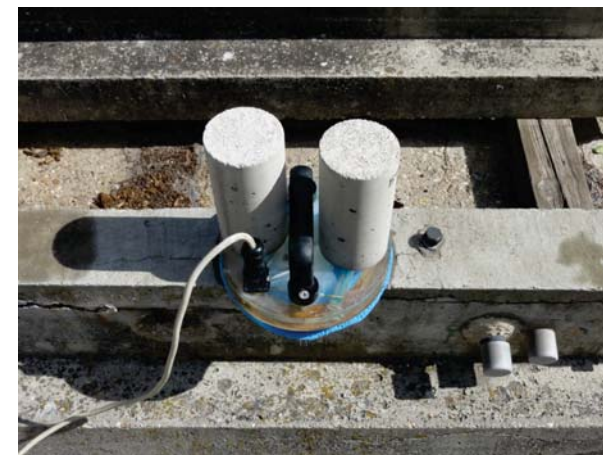
Confinement

E_{corr} i_{corr} R_e

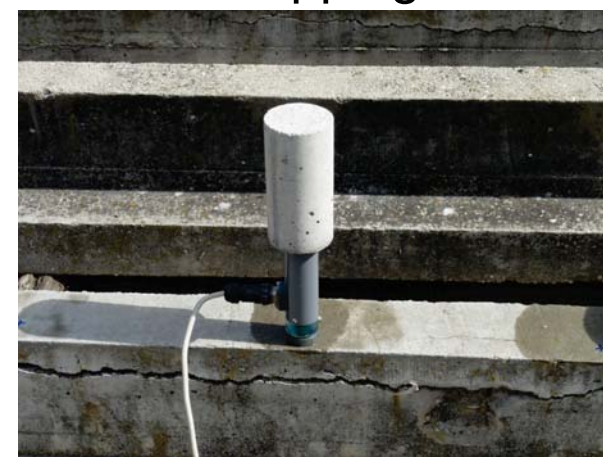
Mapping

E_{corr} ρ risk level

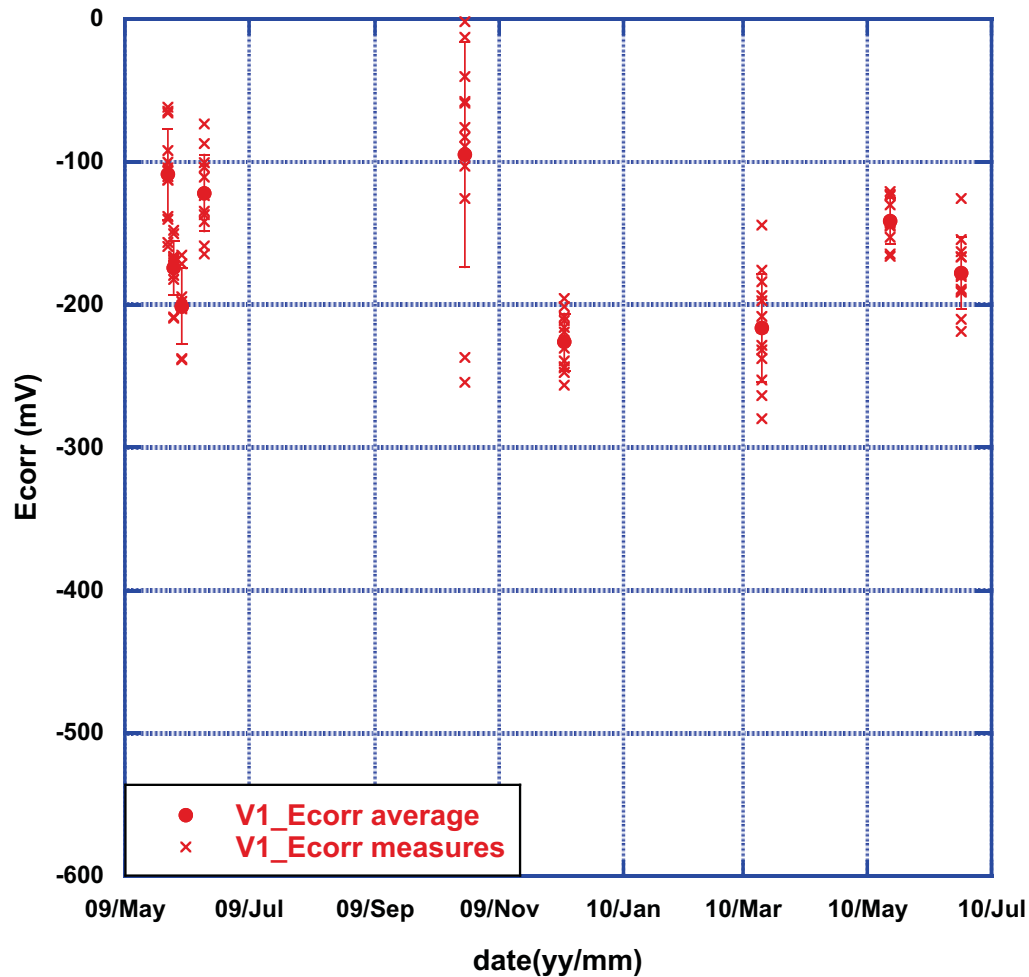
V1 Ecorr vs date

Average and measurements vs date: Ecorr

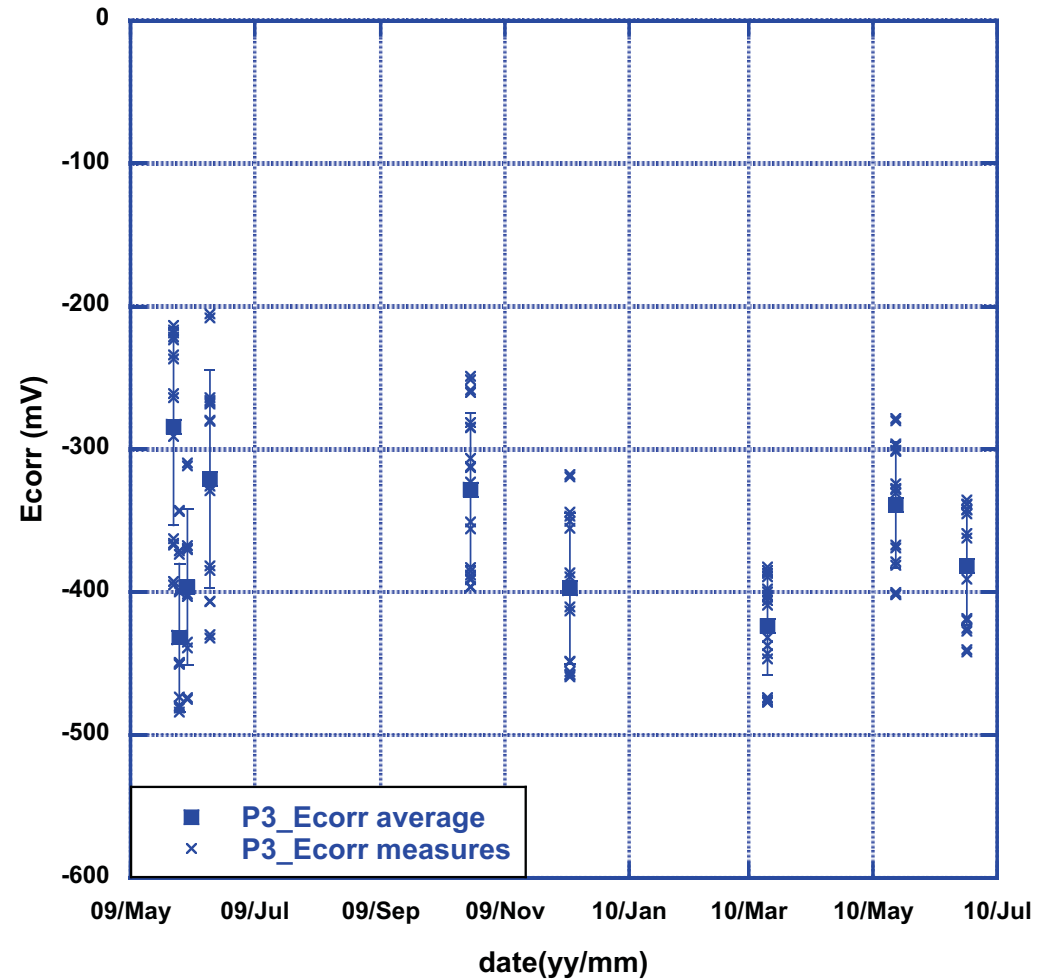
P3 Ecorr vs date
