# Quasi-Prototype Size Testing of Wedge-Shaped Block for Armoring Embankment Dams and Levees

**Abstract:** A series of tests of wedge-shaped blocks intended for armoring embankment dams and levees was carried out in a new experimental facility (*‘Hydraulic Experimentation Facility—Luis Ruano’*) under quasi-prototype conditions. This unique facility is located in the canal leading to the Laverné reservoir (Zaragoza, Spain) with a maximum vertical drop of 7 m and discharge up to 9 m<sup>3</sup> s<sup>−1</sup>. The aim was to conduct experimental research on technologies to protect embankment dams and dikes against overflowing erosion under quasi-prototype conditions. The results of the tests demonstrate the ability of the WSBs to withstand high unit discharges under extremely negative conditions at the upstream and downstream ends of the armoring. The tests also helped to identify potential failure modes for the armoring blocks.

**Citation:** Caballero, F.J.; Toledo, M.Á.; Moran, R.; Peraita, J. Quasi-Prototype Size Testing of Wedge-Shaped Block for Armoring Embankment Dams and Levees. *Water* **2023**, *15*, 662. <https://doi.org/10.3390/w15040662>

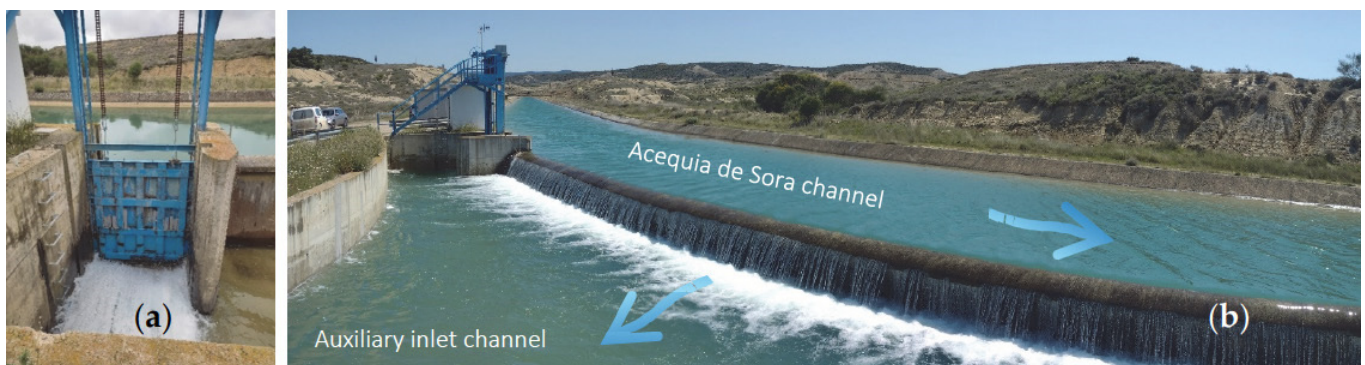
**Figure 2.** Intake work in the Acequia de Sora channel: (a) View from downstream of the flow control gate in operation. (b) Flow control structure on the left and side spillway from the Acequia de Sora to the auxiliary channel.

The auxiliary channel is 600 m long from the intake structure drawing water from the Acequia de Sora channel to the reservoir, at the downstream end. The inlet consists of a motorized rectangular flow control gate of  $2.50 \times 3.00 \text{ m}$  (Figure 2a) and a 30 m long side-channel spillway weir, curved in plan, located immediately downstream of the gate (Figure 2b and Videos S1 and S2 in Supplementary Materials).

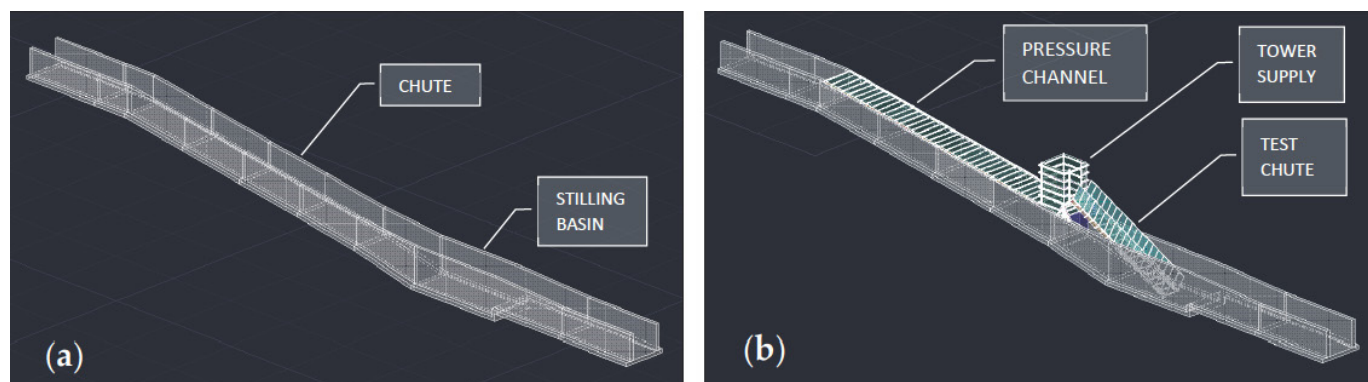
**Figure 3.** 3D view of the auxiliary channel (a) Initial situation (b) Situation after the installation of HEFLR.

The experimental facility was built inside the existing auxiliary channel, approximately 90 m downstream from the headworks. The existing chute section (Figure 3a) has the following characteristics: 52.25 m long reinforced concrete channel with a rectangular cross section of 4.00 m wide, with variable height from 3.66 to 3.75 m in the first 41.80 m, and 3.75 to 5.27 m in the last 10.45 m. The longitudinal slope of the chute is 14.57% in the first 41.80 m and 22.88% in the last 10.45 m. The vertical drop between the crest of the inlet weir and the invert of the upstream section of the chute is 3.16 m. At the end of the chute there

The HEFLR located inside the chute consists of an upstream pressure channel formed from the bulk of the existing chute, an intermediate steel supply tower, and the test chute (Figure 3a,b).

The pressure channel was designed to have the highest water elevation in the tower supply (Figure 3b), with negligible head loss for test flows and sectional capacity. The pressure channel is 38 m long and consists of a simple lining of the existing channel using lightweight precast concrete slabs (except at the end of the pressure channel close to the tower supply, in which the last two slabs are replaced by metallic plates) (Figure 4a–c). The concrete slabs are attached to the top of the side walls of the concrete chute and are supported by a rigid skeleton made up of metal beams anchored in the reinforced concrete of the existing walls (Figure 4d). A sealing treatment has been provided in the slab-slab and slab-pocket joints (Figure 4e).

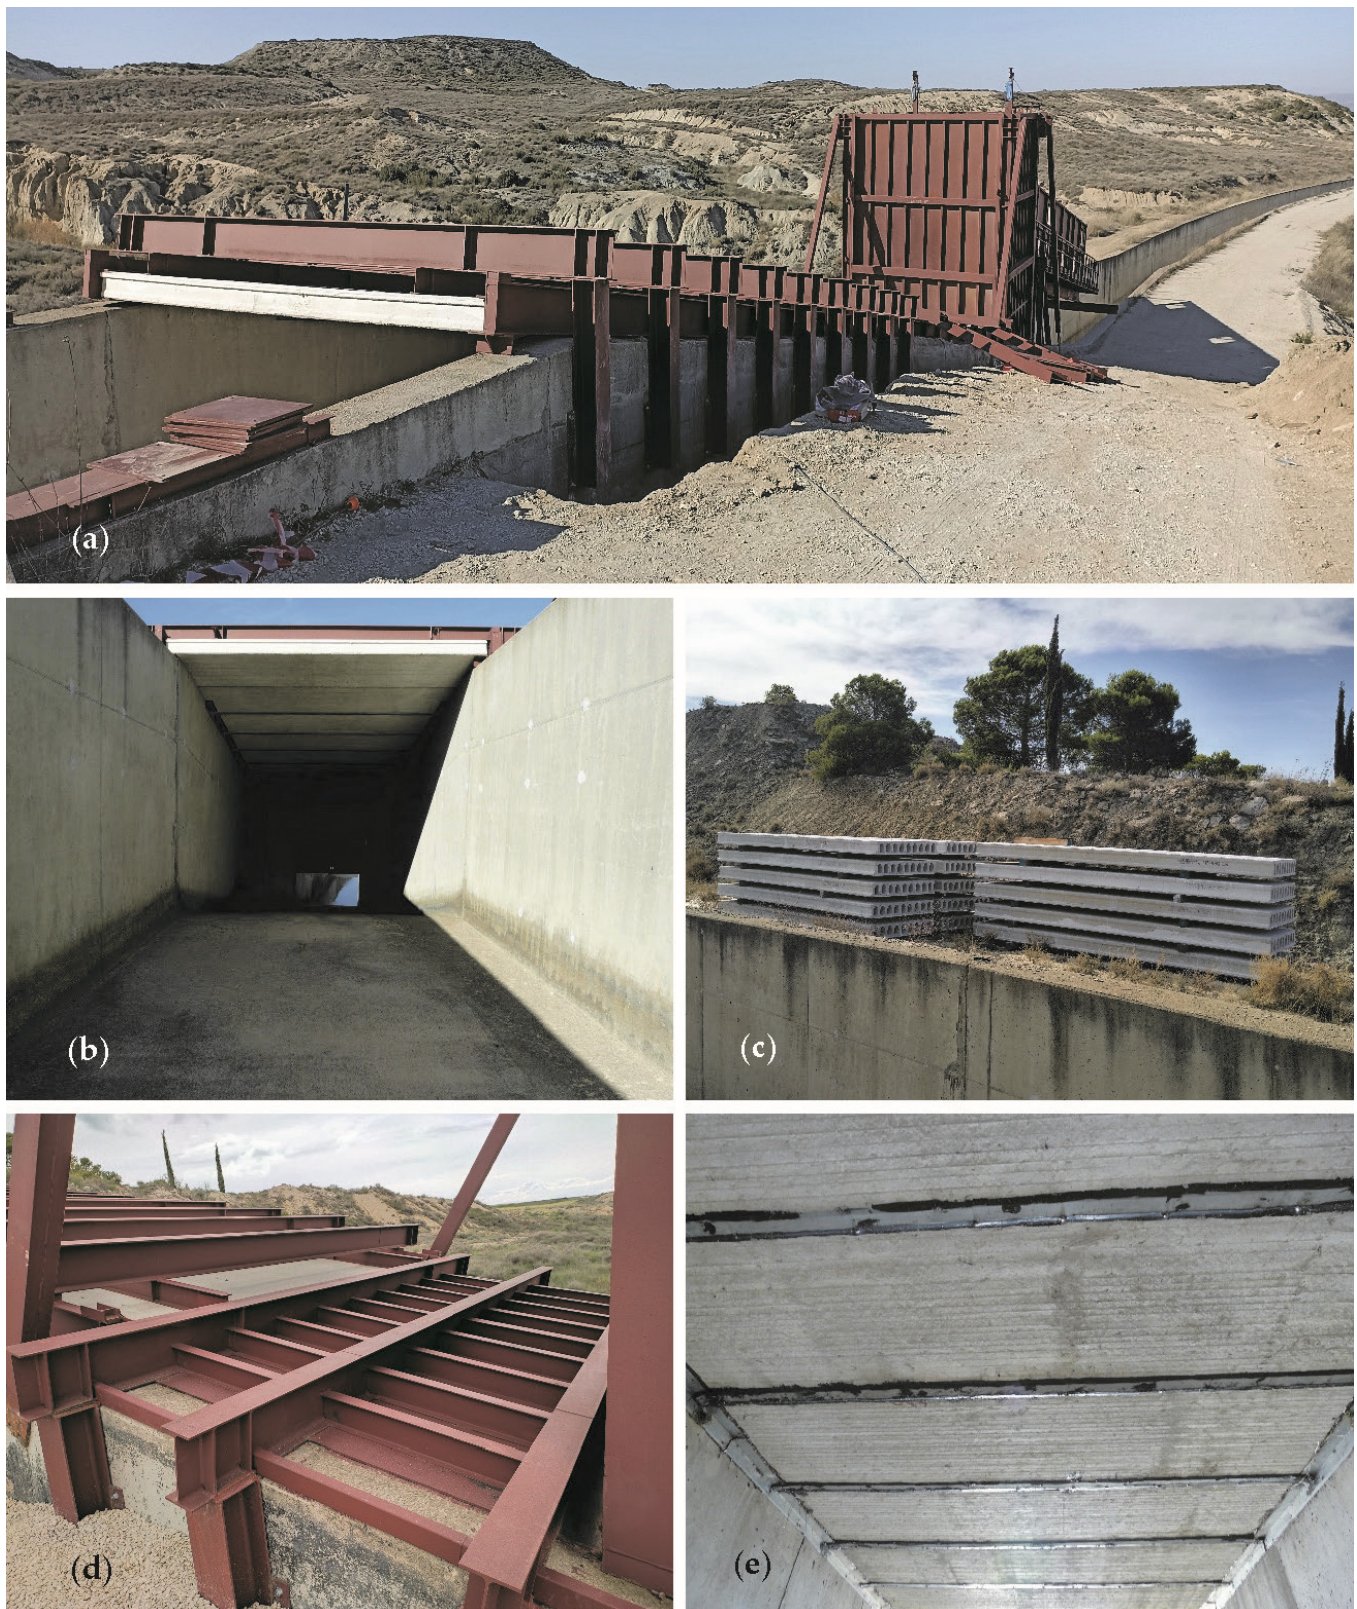
**Figure 4.** (a) View of HEFLR from the right bank of the auxiliary channel. (b) View of the interior of the auxiliary channel from upstream of the pressure channel. (c) Storage of the honeycomb slabs used to cover the pressure channel. (d) Metallic frames used to support the honeycomb slabs of the pressure channel and the metallic plates on the connection to the tower supply. (e) Detail of the sealing between the slabs and the channel walls (view from inside the pressure channel).

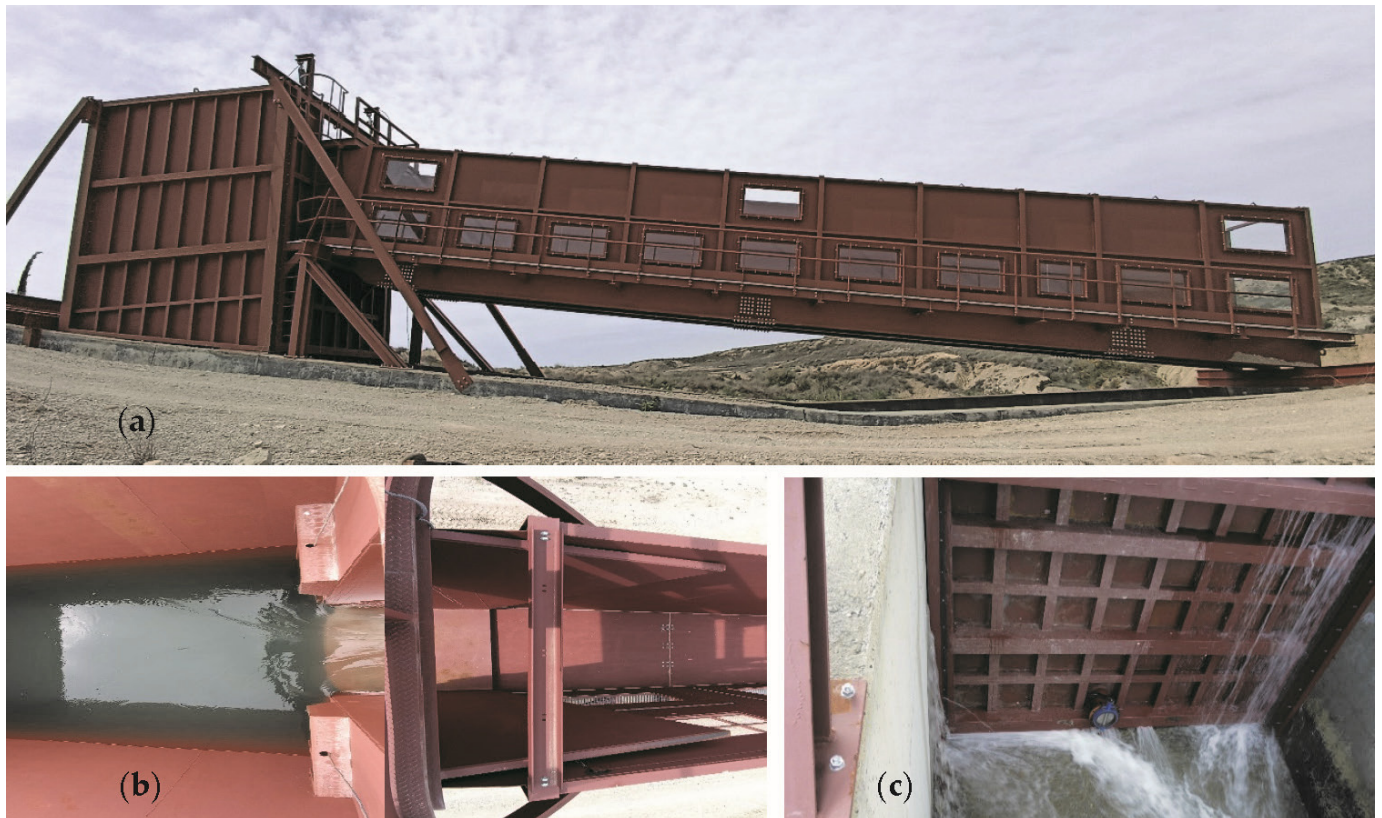
**Figure 5.** (a) General view of the supply tower and the test chute before being lowered to the bottom of the auxiliary channel (b) Photographic montage of the water inside the supply tower (left) exiting towards the test chute (right). (c) Wall gate of the supply tower and 250 mm diameter butterfly valve to facilitate its operation by emptying the water retained upstream.

The test chute is a modular steel structure supported on a metallic platform (Figure 5a) with a total width of 3.00 m and a maximum vertical drop of 7.05 m. The chute is equipped with a 0.50-m-wide platform beside the right wall. The width of the chute can be adjusted from 0.5 m to 2.0 m in 0.5-m intervals. The tests described in this article used a 2.0 m total width, subdivided by a 0.40 m high steel wall to form a pair of 1-m wide test sections. The longitudinal slope can be changed from 1 H:1 V to 3.5 H:1 V with increments of 0.5 H:1 V. The change is accomplished by pivoting the chute at the upstream end and adding or removing downstream of chute modules to adapt the corresponding length. The configuration selected for the tests was 2 H:1 V. The side walls of the chute are 2.50 m high, measured perpendicular to the bottom. The wall on the right side has clear methacrylate windows to allow observation during tests (Figure 5a).

When the testing chute is not used, it remains elevated above the auxiliary channel, supported by a metal beam at its downstream end (Figure 5a). The chute can be lowered (or lifted) at the lower end using a crane (Video S3 in the Supplementary Materials)

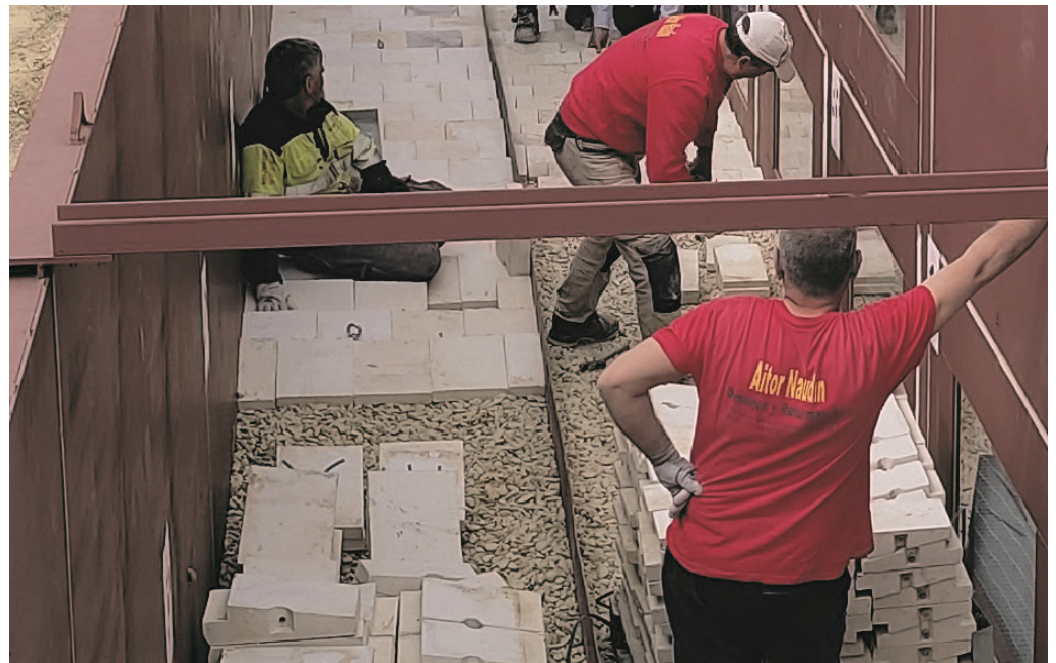
**Figure 6.** Picture of the placement of the WSB on the gravel bedding layer.

The different WSB models tested in each trial were placed on a 0.20 m thick bedding layer of homogeneous gravel in the particle size range of 12 to 20 mm. This granular layer was placed over wire mesh with 40-mm openings fixed to the bottom of the testing chute (Figure 6).

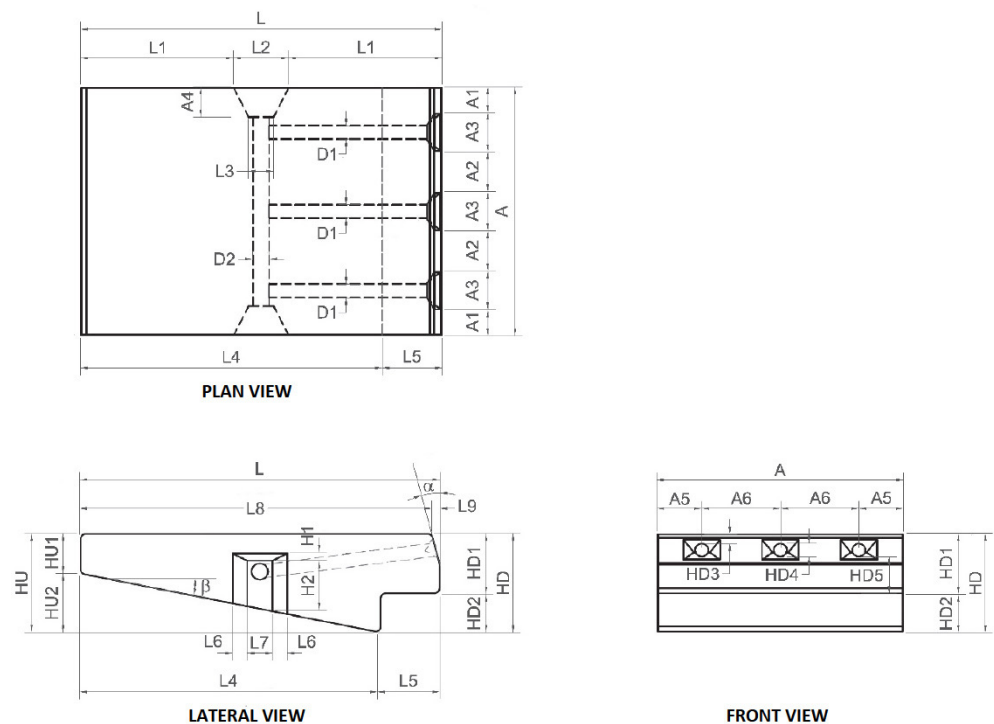
**Figure 7.** Geometrical parameters of the ACUÑA® blocks.

The WSB model used in the tests was ACUÑA® (Figure 7) with three 3 different sizes (Table 1):

- Small block, weighing 5.0 kg, 167.0 mm wide (A) and 243.3 mm long (L).
- Medium block, weighing 15.0 kg, 250.0 mm wide and 364.3 mm long.
- Large block, weighing 35.0 kg, 330.0 mm wide and 401.8 mm long.
- Note that the dimensions are proportional for every size of the block. Thus, the scale ratio between the small and large WSB is 0.51, and 0.76 between the medium and large.

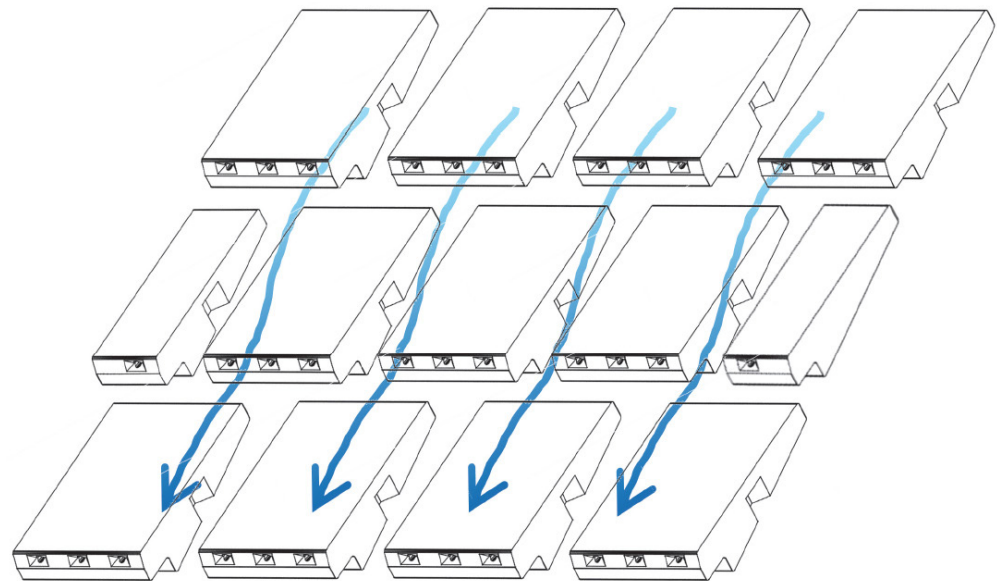
**Figure 8.** Scheme of the placement of WSB in rows and the creation of staggered longitudinal joints by using half-WSB. The arrows represent the flow of water.

The WSBs were placed in horizontal rows, starting from the bottom row (row #1) and working upward. WSB placement used a staggered configuration of longitudinal joints among the blocks. To achieve the staggered pattern, half-pieces of WSB were placed at the end of alternate horizontal rows, as shown in Figure 8.

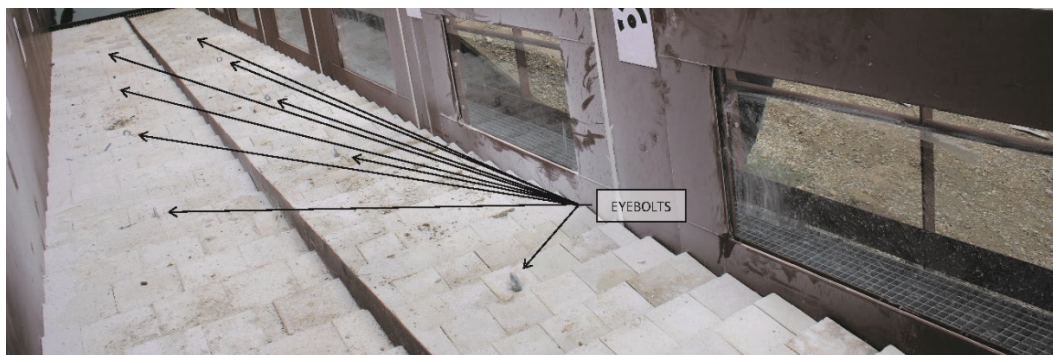
**Figure 9.** Picture of the intermediate wall dividing the two areas with different WSB sizes and eyebolts installed on some of the WSBs for block-extraction tests.

Two types of WSB were tested in each of the two sessions of tests. To do this, the flume was divided into two halves, 1 m wide each, symmetrical along the longitudinal axis of the chute. The division was made by a longitudinal intermediate wall formed by a 400 mm high metallic sheet welded to the bottom of the chute (Figure 9).

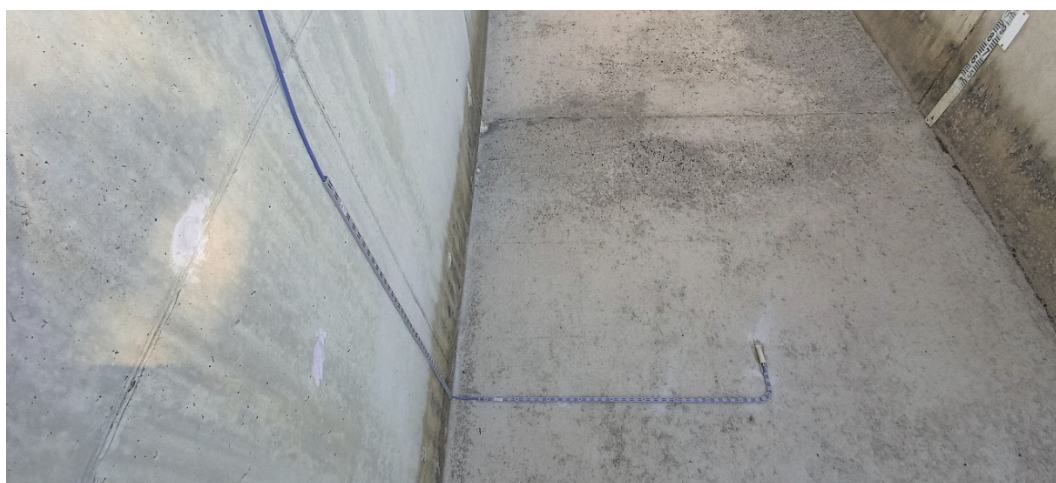
**Figure 10.** Picture of the sensor of the *Nivus Portable Flowmeter* installed in the centre of the auxiliary channel, upstream of the testing chute.

Flow rates were continuously recorded with a Nivus Portable Flowmeter, model NFM 750, connected to a combined sensor (CSM Flow Transducer model CSM-V1D0KN007P) for flow velocity and water depths (Figure 10).

The flowmeter uses the operating principle of ultrasonic correlation to determine the speed of water at different water depths, whereby the reflective particles contained in the medium (minerals, bubbles of air, dirt, etc.) are scanned using ultrasonic pulses transmitted at a certain angle.

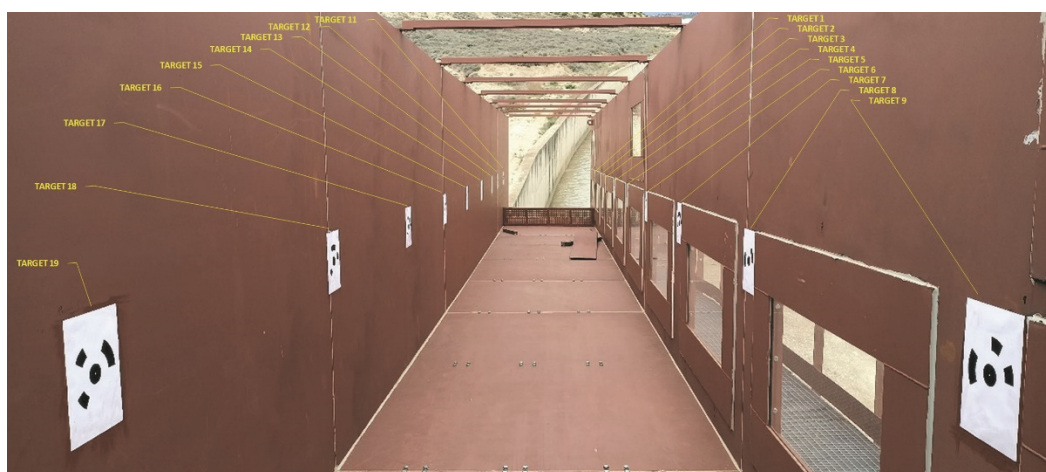
**Figure 11.** Picture of the targets on the sides of the testing chute.

The movements of the blocks after each test session were measured by means of a comparison between 3D digital models of the external surface of the initial and final state. Digital terrain models (DTM) were obtained from photographs with digital cameras processed by *Agisoft PhotoScan Professional v.1.4.3*. The assignment of scale and a reference system to the DTM required a series of known support points (targets) that must appear in the different frames. Therefore, 18 targets were generated and adhered to the side walls of the chute (Figure 11). Nine were installed on the right wall of the chute, numbered from 1 (downstream) to 9 (upstream), and the other nine were installed on the left wall of the chute, numbered from 11 (downstream) to 19 (upstream).

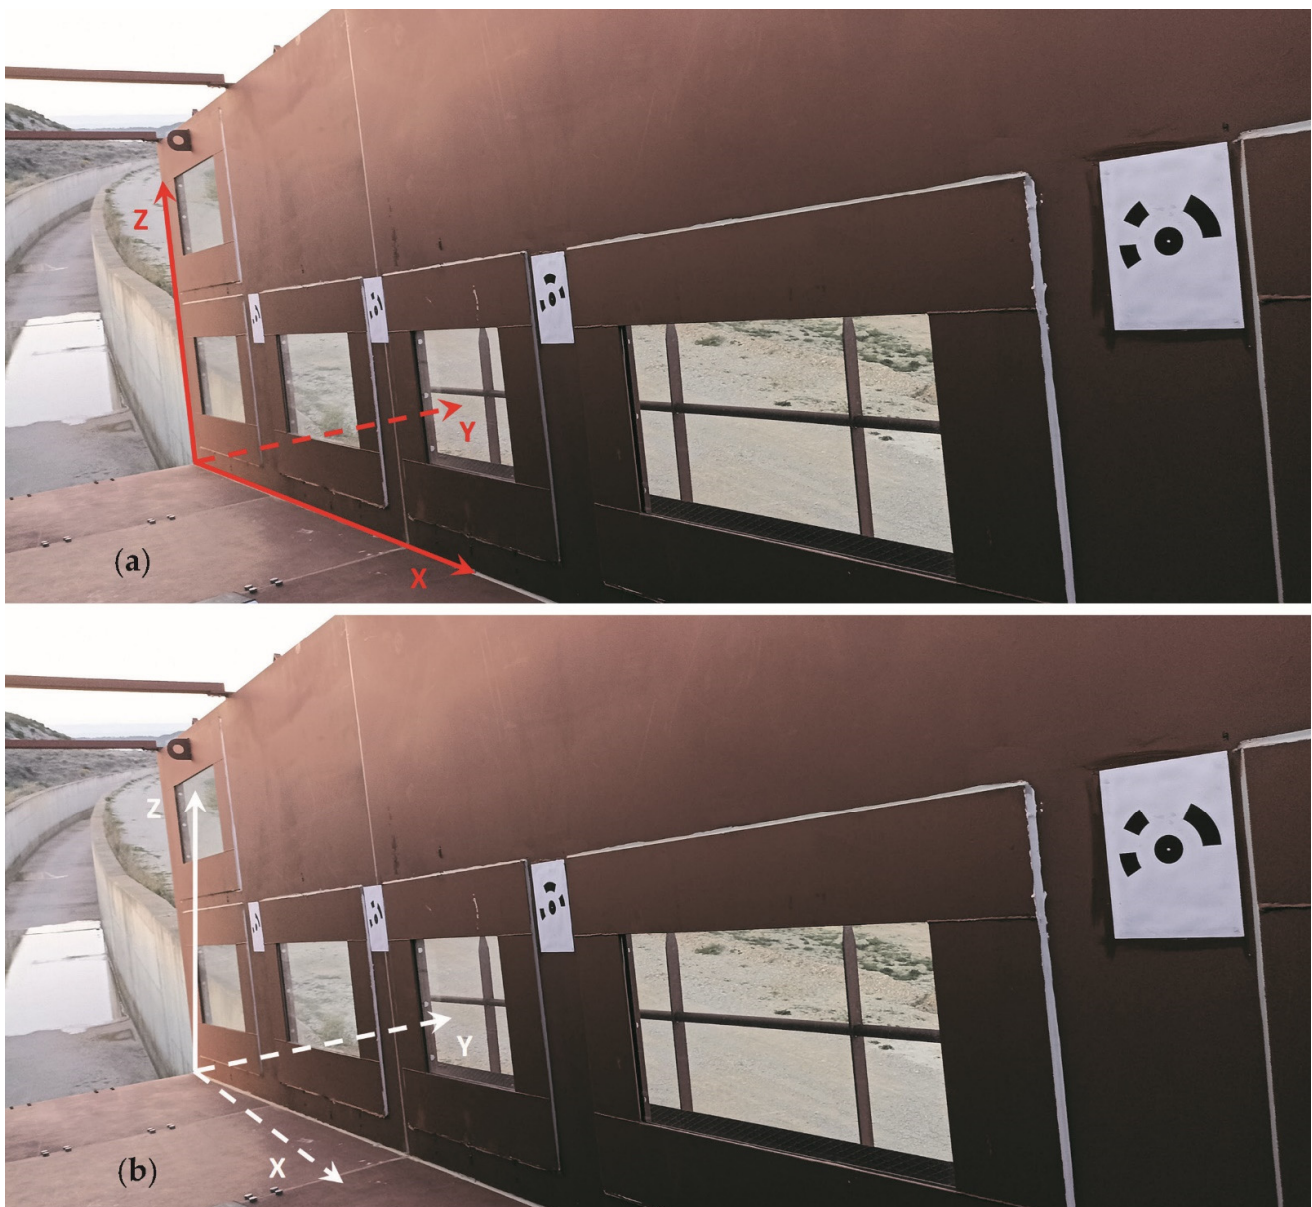
**Figure 12.** Location of the coordinate systems in the testing chute. Relative ((a), red line) and absolute ((b), white line).

Two coordinate systems (one relative to the chute and other absolute, relative to true vertical) were used during the research work (Figure 12). The movements of the blocks were registered in the system relative to the chute. The coordinates of the markers are reflected in Table 2.

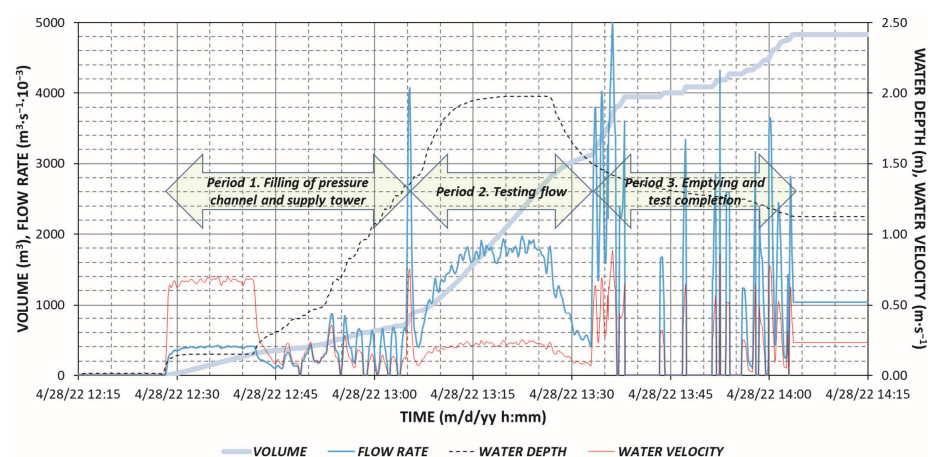
**Figure 13.** Test Session 1: Inflow hydrograph, water volume, water depth, and flow velocity recorded by the flowmeter in the auxiliary channel.

The inflow hydrograph and the time series of water velocities, water depths, and water supply volume during this session are presented in Figure 13 with data registered every 5 s.

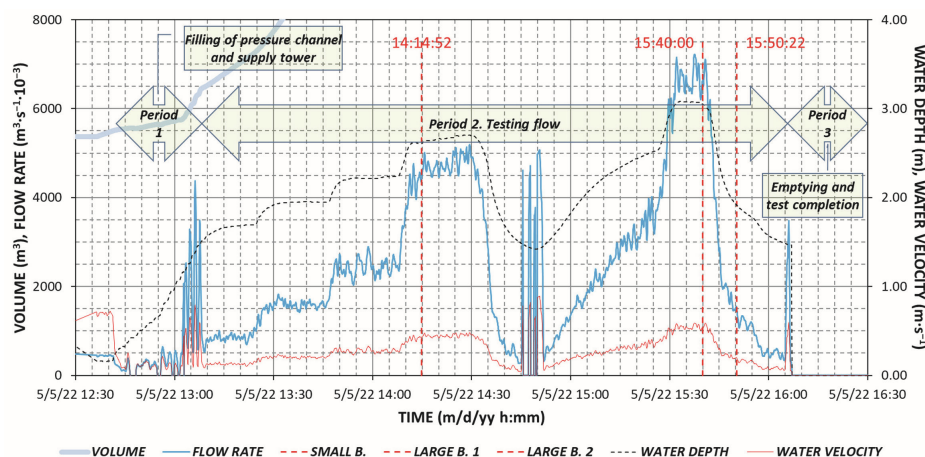
**Figure 14.** Test Session 2: Inflow hydrograph, water volume, water depth, and flow velocity recorded by the flowmeter in the auxiliary channel.

The last discharge was the maximum possible inflow that could be supplied through the inlet control gate. Higher discharges required the closure of the gate to be able to operate the overflow weir at the inlet. This operation lasted almost 1 h, at which time the discharges were significant and the level in the Acequia de Sora increased. At that time, the Acequia intake gate was completely reopened and a discharge of  $6.8 \text{ m}^3 \text{ s}^{-1}$  was achieved with peaks of  $7.2 \text{ m}^3 \text{ s}^{-1}$ . This hydraulic loading was the maximum discharge that could be achieved with the conditions of the Acequia de Sora at that time. The team decided to end the test session by closing the control gate as quickly as possible to save the maximum volume of water. The total volume of water supplied from Acequia de Sora, during approximately 3 h of the test session 2, was almost  $30,000 \text{ m}^3$  of the  $52,000 \text{ m}^3$  that was planned. The inflow hydrograph and the evolution of the water velocities, water depths, and volume of water supply during this session are presented in Figure 14 with data registered every 5 s.

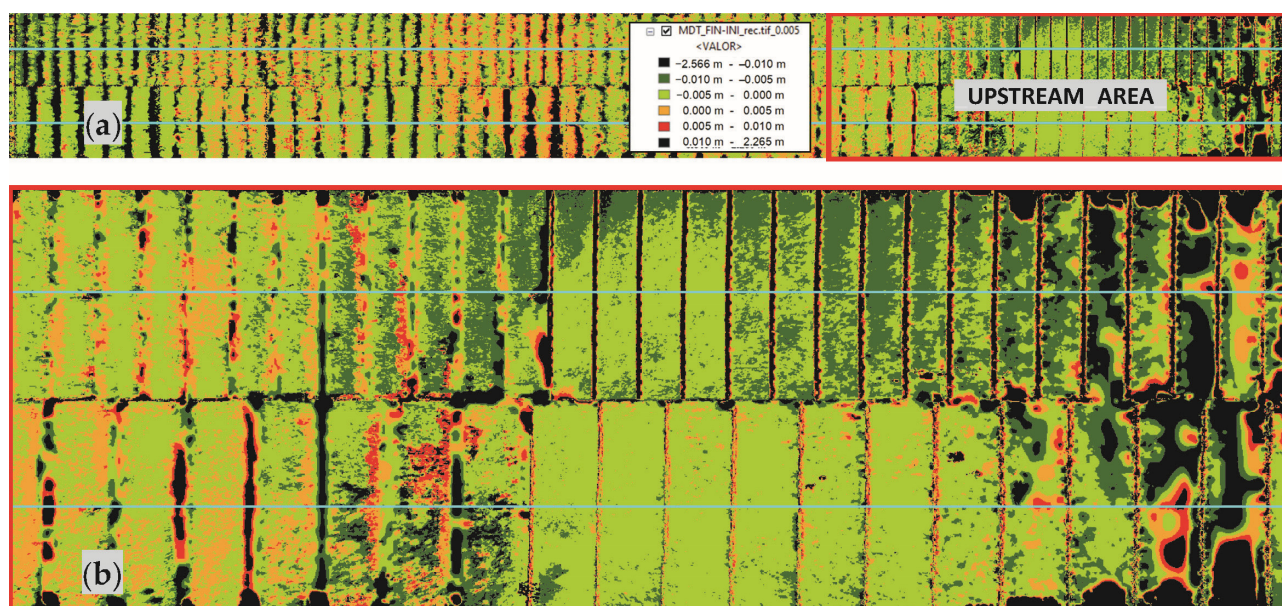
**Figure 16.** (a) Sketch of the situation of the upper rows in the test chute. (b) Detail of the upstream area of the channel (rows #53 to #81 of the small WSB, in the upper part of the photograph, and rows #35 to #54 of the medium WSB, at the bottom of the figure).

- A more detailed representation of the upper rows of the WSB armoring (rows #53 to #81 of the small WSB and #35 to #54 of the medium WSB) is shown in Figure 16. In the initial and final zones of the channel, the decrease occurs in complete blocks (mainly green zones) and is especially pronounced in the small blocks of the upper part of the channel (dark green).

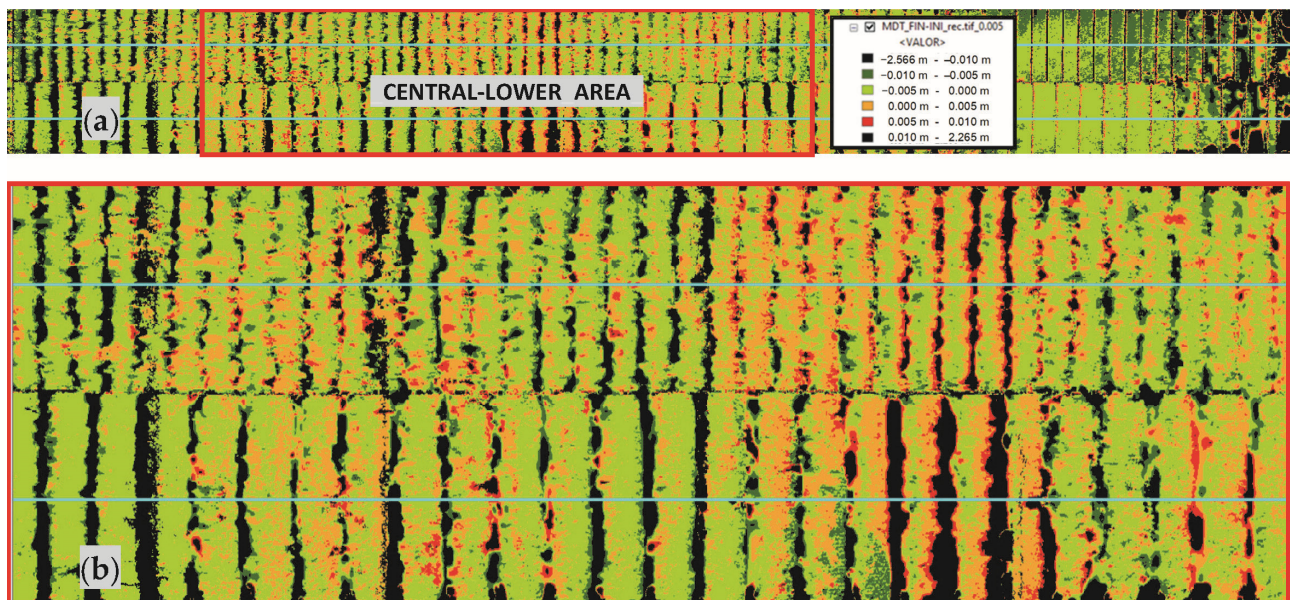
**Figure 17.** (a) Sketch of the situation of the central-lower rows in the testing chute (b) Detail of the upstream area of the channel (rows #6 to #43 of the small WSB, in the upper part of the photograph, and rows #4 to #29 of the medium WSB, at the bottom of the figure).

- In contrast to the upper rows, upward movements appeared frequently in the lower and central rows, but with values lower than 5 mm (orange colors), and were usually accompanied by areas with downward movements (green colors) within the same row of blocks (Figure 17).

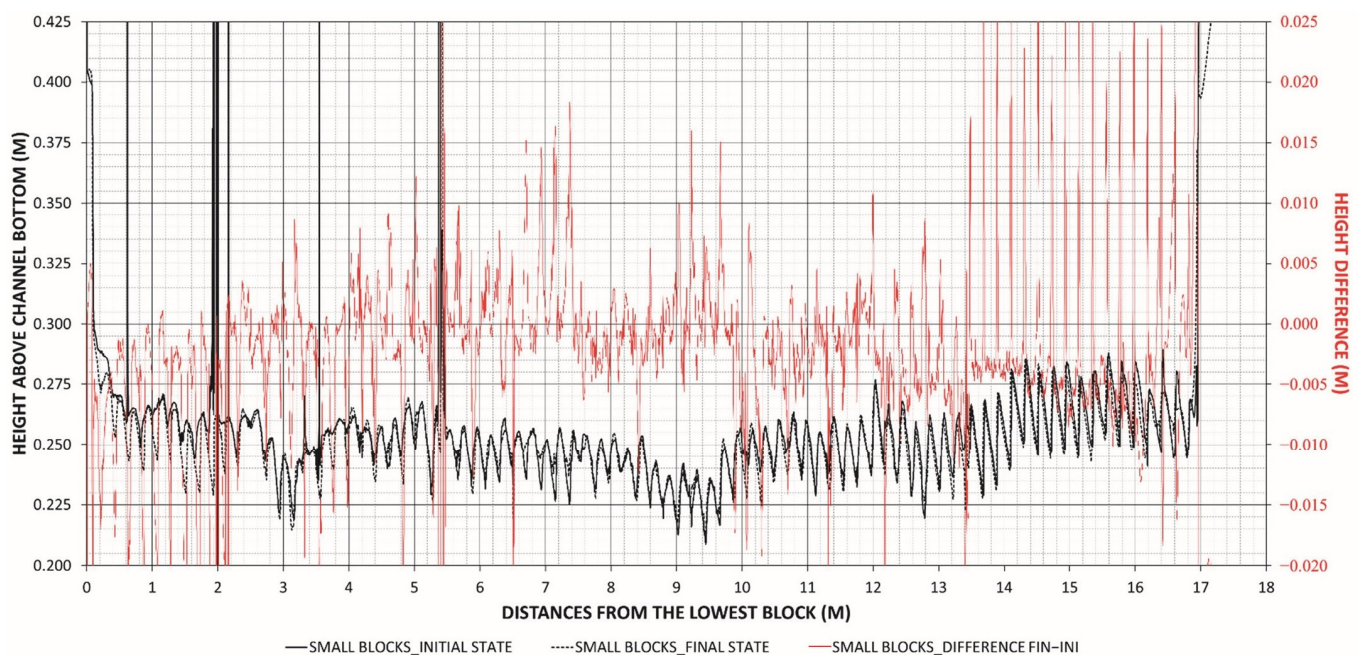
**Figure 18.** Longitudinal profiles in small blocks: initial state (continuous black line), final state (continuous dotted line), and difference final vs. initial (red line).

The longitudinal profiles of the WSB armoring in the initial and final states, and the differences between both are presented in Figure 18 (for the small WSB) and Figure 19 (for the medium WSB). The blue lines in Figure 15 show the position of the axes where the longitudinal cross sections were obtained.

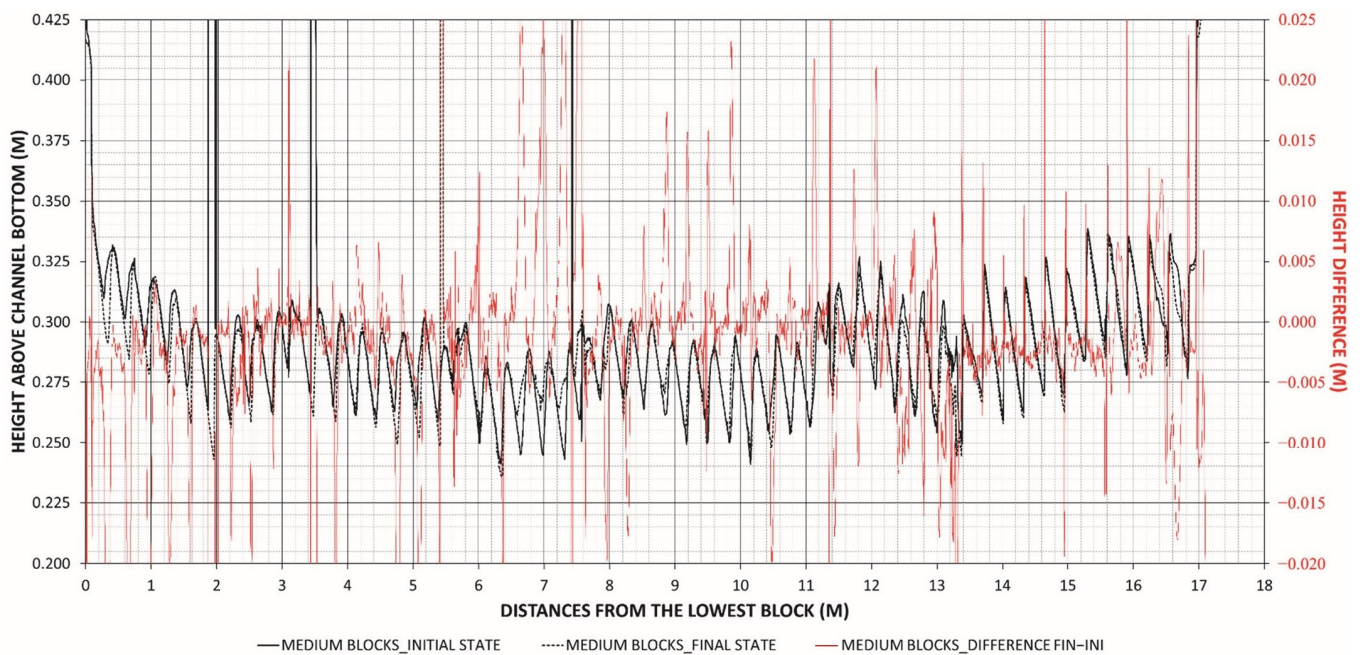
**Figure 19.** Longitudinal profiles in the medium blocks: initial state (continuous black line), final state (continuous dotted line), and difference final vs. initial (red line).

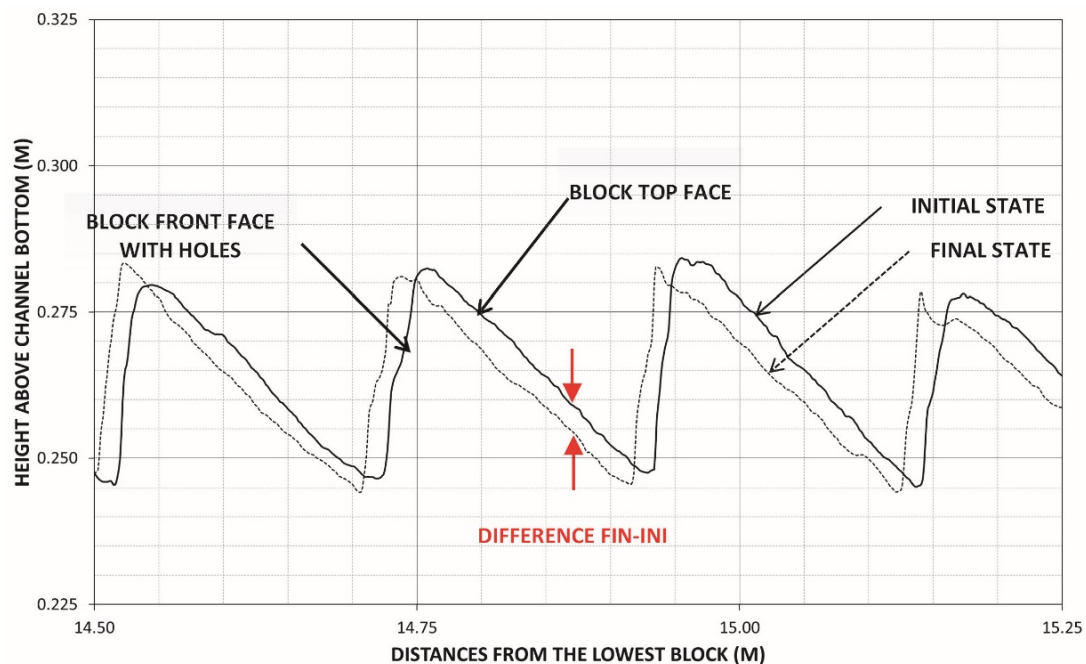
**Figure 20.** Detail of the longitudinal profile of the WSB armoring. The black dotted lines represent the final state, while the continuous black line represents the original state.

Figure 20 presents a scheme to help interpret the vertical differences between the original and the final DTMs presented above. Therefore, Figure 20 shows a detail of the longitudinal profile of four blocks that have experienced displacements (indicated with grey arrows in Figure 21) at the end of the test session 1, which illustrates the predominance of green (small negative differences in the upper faces of the WSB) and orange-red black (large positive differences at the downstream edges of the WSB). As can be observed, the armoring direction of the displacement of WSBs is mainly in the downstream-downward direction, as could be expected.

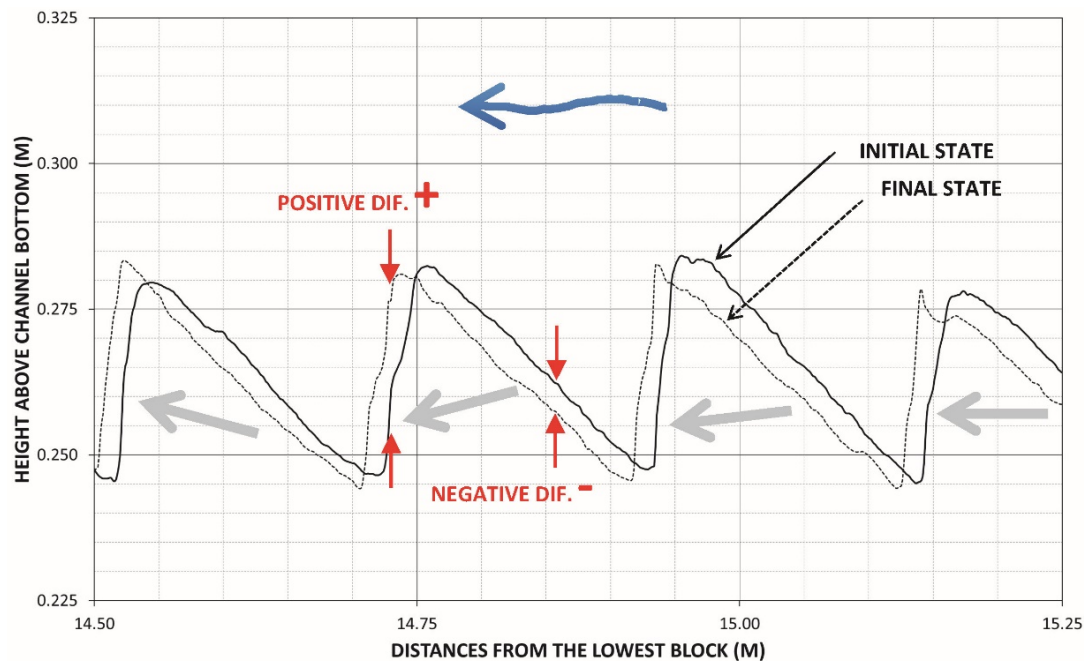
**Figure 21.** Support scheme for the interpretation of the values obtained (the blue arrow indicates the direction of the flow).

Thus, the green colors on the upper face of the blocks in Figure 15 indicate displacement downstream, or a combination of downstream displacement and settlement, but not solely settlement since the decrease in elevation is, in general, due to its displacement downstream. The areas dominated by orange-red colors indicate an increase in the external surface of the WSB armoring. A conceptual scheme of the displacements of the WSBs in the longitudinal cross section, considering the vertical and horizontal movements, is presented in Figure 22.

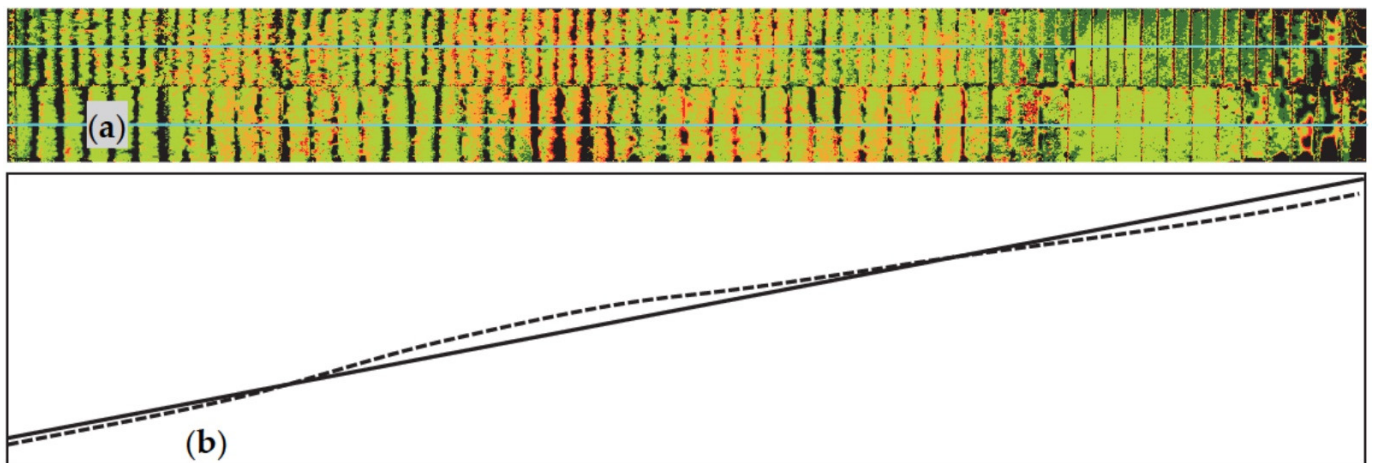
**Figure 22.** (a) Position of the longitudinal axes in the plan view of the WSB armoring at the testing chute; (b) Conceptual scheme of the longitudinal profiles of the initial (continuous) and final (discontinuous) states of the WSB armoring in Test Session 1.

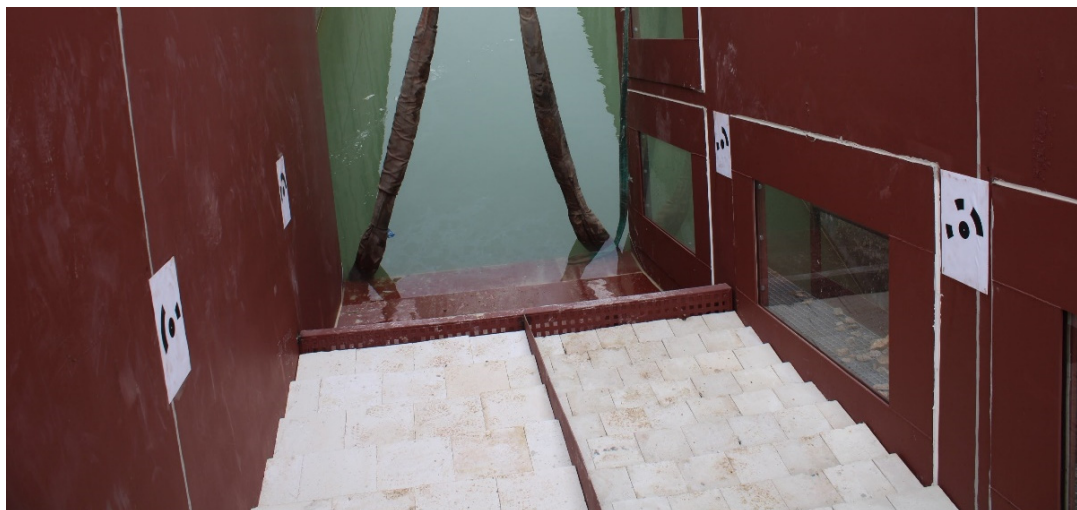
**Figure 23.** Detail of the perforated metal plate, where the downstream row of the WSB was supported.

Another cause could be the insufficient drainage capacity of the supporting drainage layer for rapid reduction in skimming flow. Furthermore, the perforated metal supporting the downstream row of WSBs (Figure 23), could limit drainage and cause an increase in uplift pressure under the lower rows of WSBs. This metal plate at the downstream end of the chute also formed was an obstacle for the skimming flow due to the offset between the pseudo bottom of the stepped WSB armoring and the top of the plate. This could cause

hydraulic jacking due to the development of the stagnation pressure by transformation of the kinetic energy of the flow into pressure energy, causing large static or dynamic pressures that are transmitted to the base, destabilizing the downstream rows of the WSBs.
