# Failures of harbour walls at Malaga and Barcelona

José María del Campo · Vicente Negro

**Abstract** The paper describes the failure of harbour walls which occurred at Malaga on 4th July 2004 and at Barcelona on 1st January 2007, associated with an inadequate consideration of the ground conditions in the light of the marine environment. At Malaga, there was an existing breakwater hence the new harbour was protected from the effect of the waves while at Barcelona, the construction of the quay wall proceeded at a faster rate than the breakwater. In both cases the wharf backfill was placed rapidly on the soft muds, progressing from the inland side. The paper discusses the importance of an overview including the ground investigation, engineering design, construction method and speed of construction.

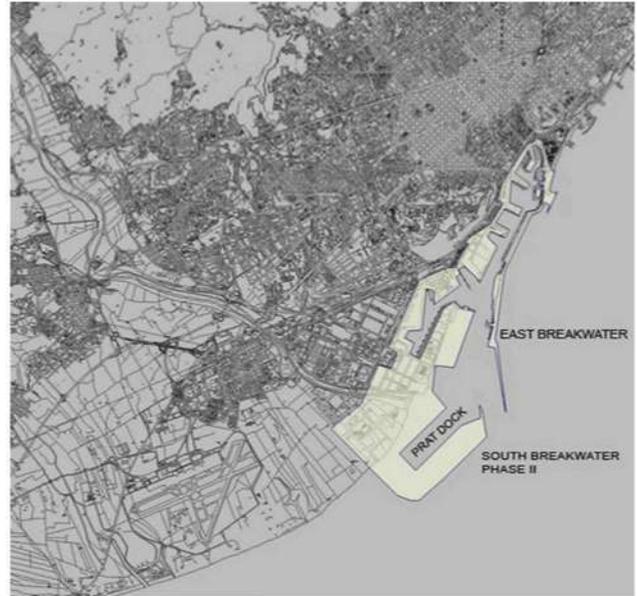
Fig. 6 Barcelona Harbour extension projects, 2005–2015

The Prat Quay is a 1,500 m long construction with two sections (I and II) protected by the south extension to the Barcelona breakwater (Figs. 5, 6, 7). Prat I was built after mud dredging from 16 to 25 m bsl and the placement of a 9 m thick rock fill blanket. The wall itself consisted of four caissons on granular foundations. During the construction of the second phase, the work was protected by the extension to the sloping breakwater. Following dredging to 24 m bsl, the 11.5 m wide caisson was placed on a 8 m thick rock blanket at a level of 16.5 m bsl (Negro et al. 2008) (Fig. 8).
