# Preliminary Geospatial and In Situ Reconnaissance of the 8 September 2023 Moroccan Atlas Earthquake Damage

**Abstract:** This research investigates the post-earthquake performances of structures in four rural villages in the Moroccan Atlas, emphasizing common construction system characteristics and design flaws that render buildings susceptible to seismic events. Village selection was based on a prior multispectral satellite-image study, proving effective for planning high-impact, post-earthquake field campaigns. The significance of this research resides in on-site data collection, facilitating the physical assessment of earthquake-induced damage and identification of inherent vulnerabilities in construction systems. The constructions in the study area exhibited structural design deficiencies, inadequate construction techniques, and urban modifiers, leading to damage extensively documented in the literature, as well as less-documented unique damage. Predominant seismic-design shortcomings in the study area included subpar material quality, insufficient earthquake-resistant design, and unskilled labor. In situ data were complemented by a global geospatial approach using different

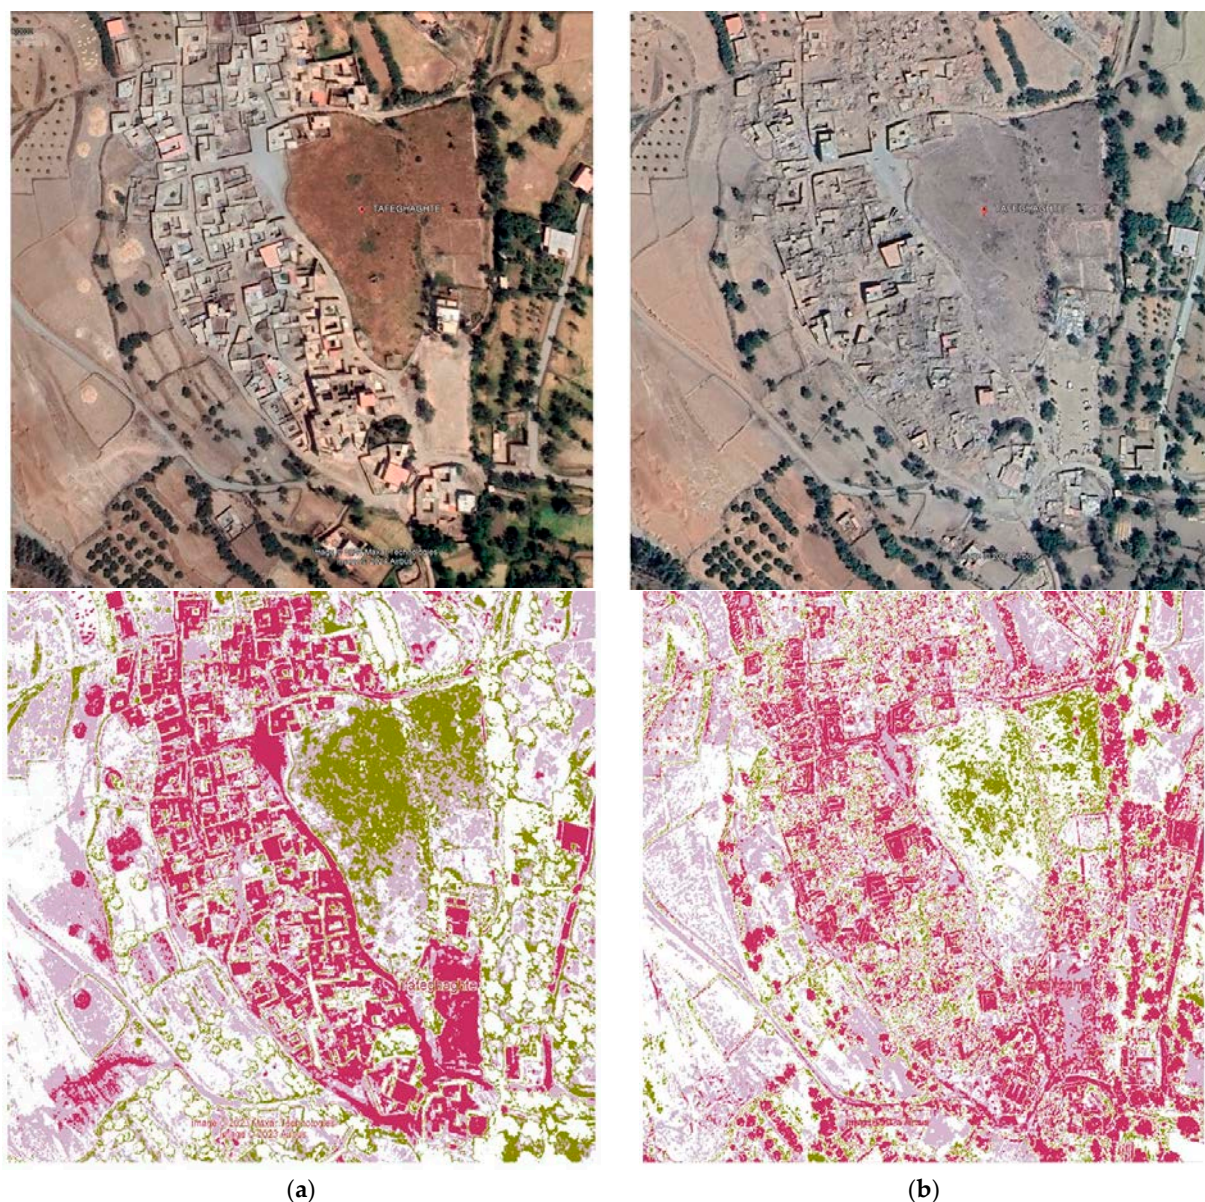
**Figure 6.** Detail of Tafeghaghte before (06/2022) and after (10/2023) the occurrence of the earthquake of 8 September 2023, (a,b), respectively. Digital classifications of typologies using the k-means algorithm in which two classes of interest (cluster 6 and 7) for research are highlighted, covered by buildings and artificial structures such as roads and streets.

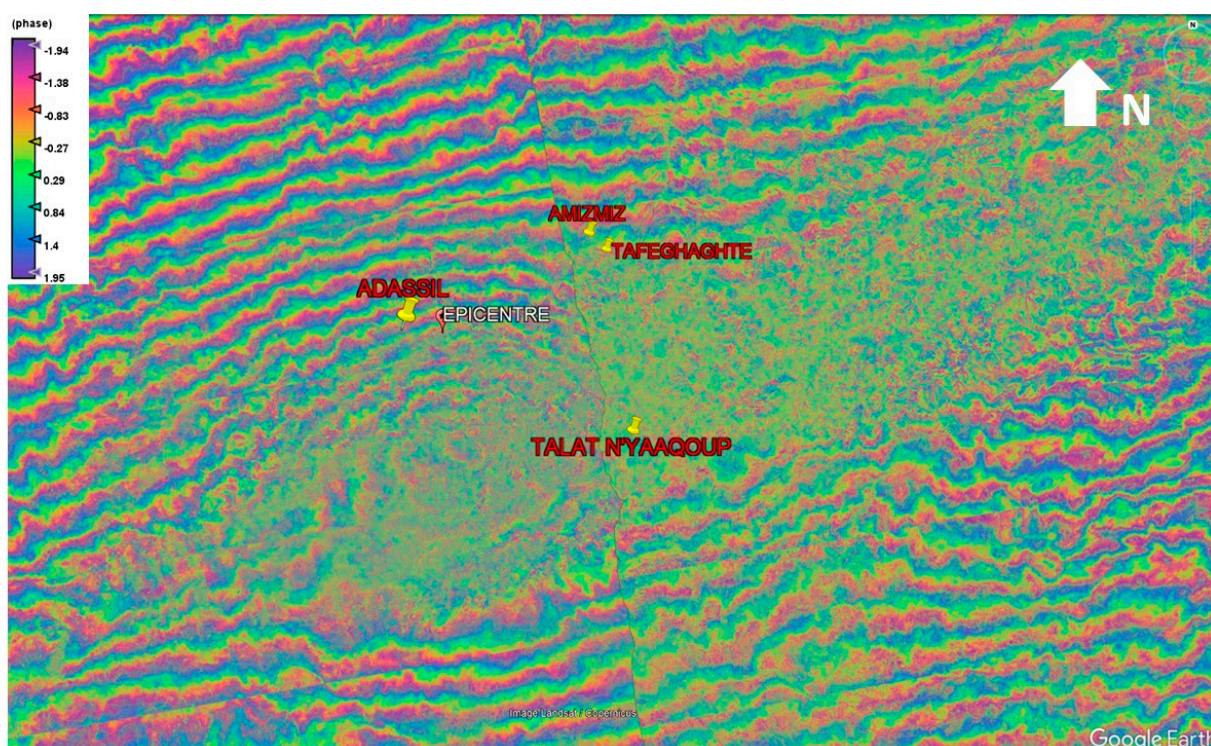
**Figure 9.** Detail of the differential interferogram DInSAR computed from Sentinel 1 radar images (3–15 September 2023) for Amizmiz, Adassil, Tafeghaghte and Talat N’Yaaqoud. Surface displacements upwards (towards the satellite) or downwards (away from satellite) in the line-of-sight direction of the satellite.

According to the estimations over the computed DInSAR interferogram, in the visited areas the surface moved upwards in Adassil by an amount ranging from 8 to 12 cm, in Tafeghaghte by 19 to 23 cm, in Amizmiz by 19 to 23 cm and in Talat N’Yaaqoud by 23 to 27 cm. Furthermore, an apparent topographic effect, that is, surface uplifts and surface subsidence, was observed in the cases of Tafeghaghte and especially Talat N’Yaaqoud.
