# EXPERIMENTAL ASSESMENT OF THE STRENGTH OF COACHES STRUCTURES AFTER COLLISION REPAIR

## ABSTRACT

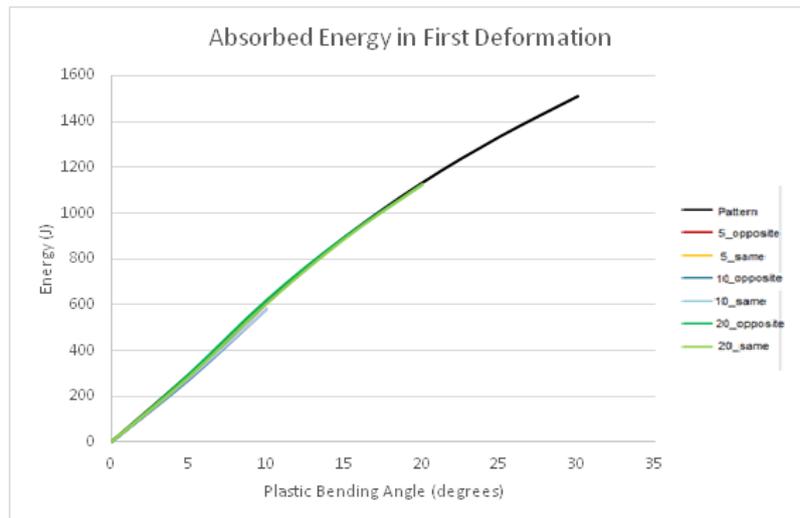
All test samples were manufactured using the same steel casting in order to eliminate the effects from variations in material properties. In figure 1, the absorbed energy by the profiles during the first deformation is shown, following the same curve. The behaviors of the profiles are, indeed, the same during the STEP 1 deformation process.

**Fig. 1 – Absorbed plastic energy in STEP 1 deformation.**

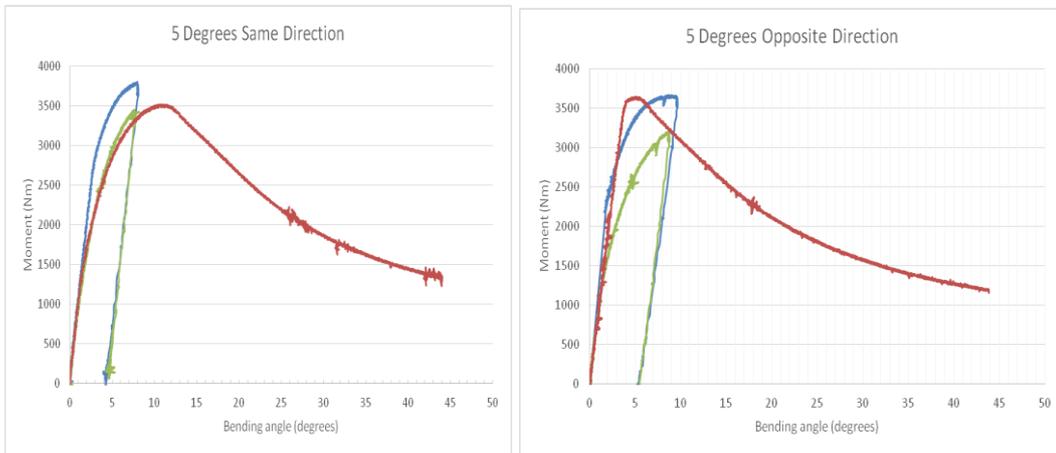
The next figures represent the Moment vs Bending angle curves of every profile tested, being:

- Blue curve: First deformation.
- Green curve: Repair.
- Red curve: Second deformation.

In every case, the curves are compared between both with the same first deformation bending angle but contrary direction in second deformation.

**Fig. 2 – Moment – Bending angle. 5 degrees first deformation.**

In order to understand the figures above, the next tables quantified the loss in energy absorption capability and maximum moment, which are the two values that give a better understanding of the behavior.

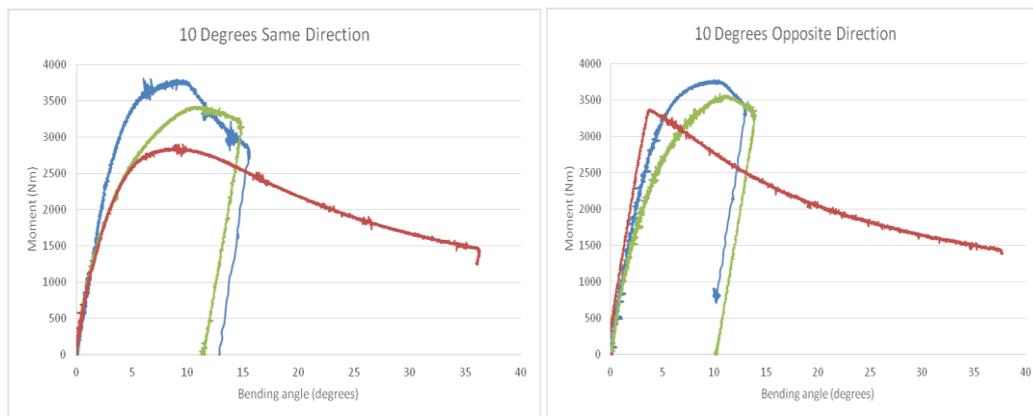
**Fig. 3 – Moment – Bending angle. 10 degrees first deformation.**

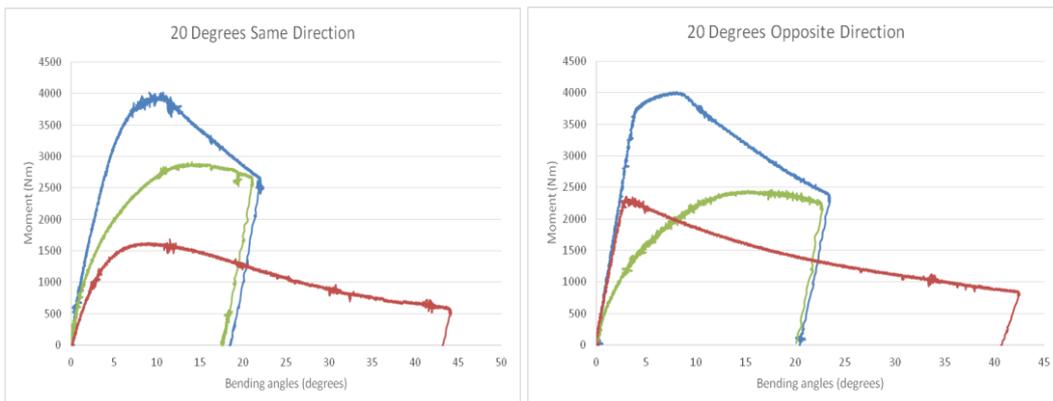
**Fig. 4 – Moment – Bending angle. 20 degrees first deformation.**

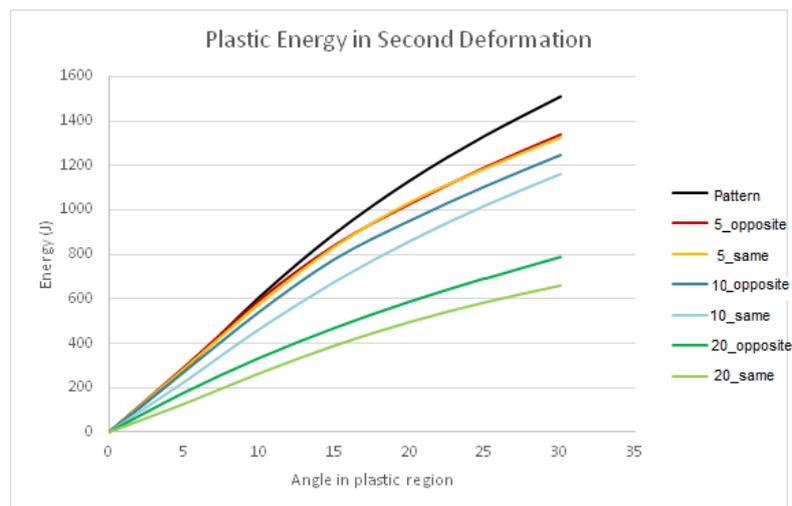
Table 3 compares the absorbed energy in the second deformation at the point of 30 degrees in plastic region. The absorbed plastic energy during all the process is in figure 5.

**Fig. 5 – Absorbed plastic energy in second deformation.**

The results show a loss of strength in the profiles tested during and after the repair compared to their initial characteristics. This loss is greater as the bending deformation angles are increasing, reaching in the 20 degrees deformation samples a loss of 50 per cent.
