Masonry or Wooden Vaults?: The Technical Discussion to Rebuilt the Vaults of the Cathedral of Lima in the Seventeenth Century

Pedro Hurtado Valdez

Ricardo Palma University, Lima, Peru – ICOMOS Peru

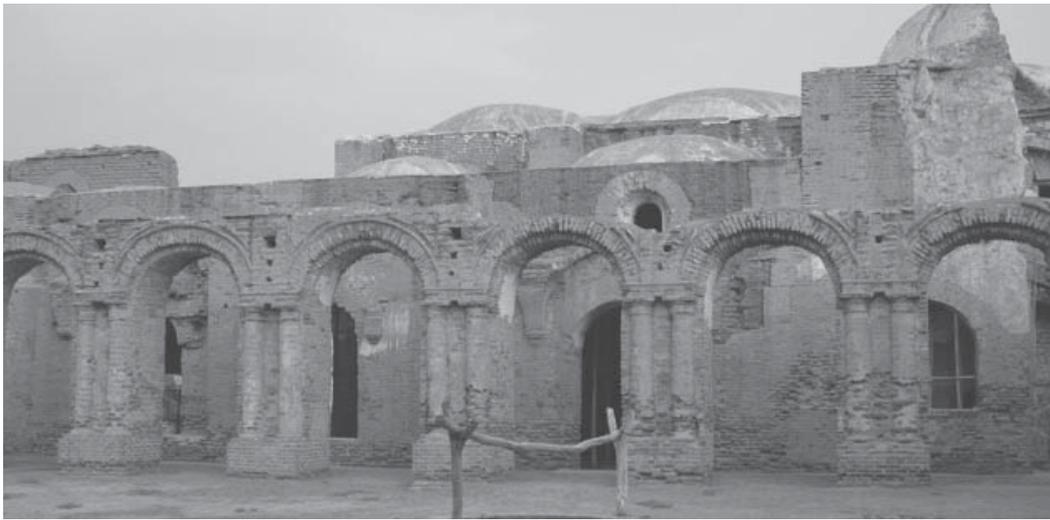
Figure 1: Church of San Agustín (Zaña, Peru), with vaults and arches built of brick.

Certainly throughout the sixteenth and seventeenth century Lima's churches continued to be erected with stone or brick domes and vaults, and then reconstructed with the same materials after having collapsed under the effects of seismic activity. This phenomenon also occurred in churches of other cities, whose masonry vaults we can still see in the ruins of San Agustín church in Zaña (Fig.1).

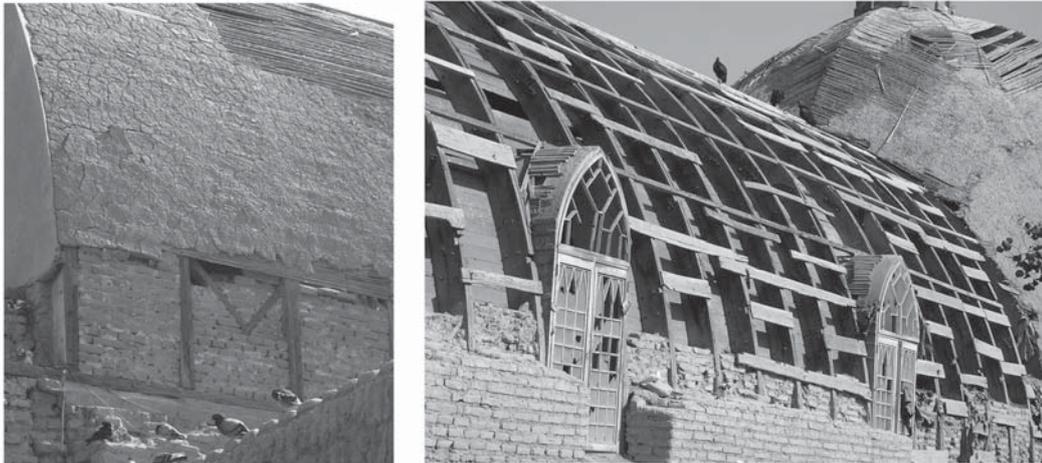
Figure 3: Wooden vault, with adobe fill reinforcement (Lima, Peru)

In this way, giving to the timber plank a curved profile, for both intrados and extrados, reinforcement elements like purlins and a wall plate on the top of walls, where will set the wooden arches. All these elements, already raised by De L'Orme in 1561, incorporate new solutions, such as the adobe fill at the bottom of the vaults to counter thrusts and flexible joints with ribbons of leather (Fig.3). The earthquake of 1687, which caused the collapse of many masonry vaults in Lima, raised again the issue of earthquake resistance of the masonry structures in the debate, especially after masons saw the good performance of the timber plank vaults in some churches years before (Hurtado 2007, pp.538-539).

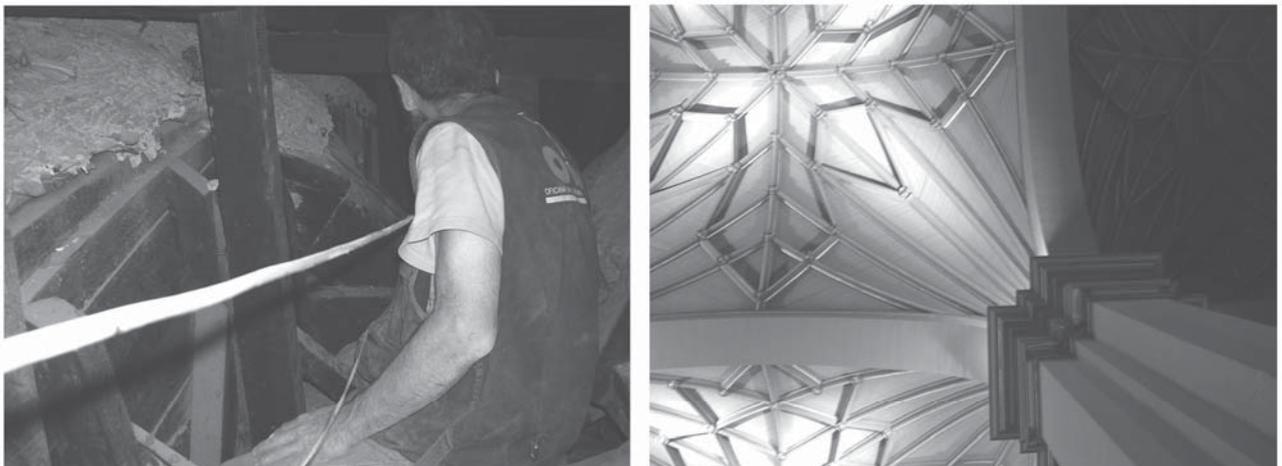
Figure 4: Intrados and extrados of the wooden vaults at the cathedral of Lima (Peru)

Then the Metropolitan Council awarded Maroto, in his capacity as principal master builder of the cathedral, the design of the new vaults. Fray Diego Maroto explained on the Book Factory of the cathedral the constructive characteristics that would have these wooden vaults, in imitation of the Gothic-ribbed vault, describing in detail the number of wooden arches, the joints and the fixing metal system used. He mentions that these vaults are composed with arches made with timber curved plank of cedar with a cross section of 28 x 14 cm. He also gave indications of use the rubble fill in the base of the vaults (Fig.4):

...the first vault must make with eleven keys and be covered with the curved timber plank of cedar wood and which has few clear for the gypsum plaster that served to imitate the brick vaults... (MA b/f/38r-39v).
