# Non contact inspection of the fatigue damage state of carbon fiber reinforced polymer by optical surface roughness measurements

This work presents the evaluation of a new non-contact technique to assess the fatigue damage state of CFRP structures by measuring surface roughness parameters. Surface roughness and stiffness degradation have been measured in CFRP coupons cycled with constant amplitude loads, and a Pearson's correlation of 0.79 was obtained between both variables. Results suggest that changes on the surface roughness measured in strategic zones of components made of the evaluated CFRP, could be indicative of the level of damage due to fatigue loads. This methodology could be useful for other FRP due to similarities in the fatigue damage process.

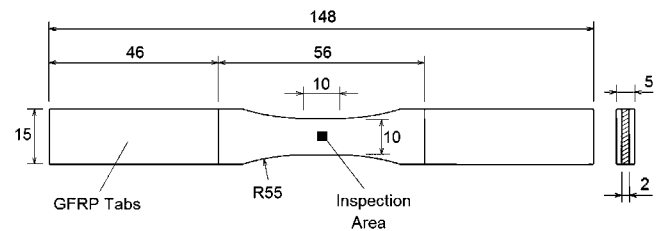
Fig. 1. Coupon geometry, surface inspection area.

For the present study, 13 coupons with dog bone geometry shown in Fig. 1 were extracted from the panels. GFRP tabs were bounded at both ends with film adhesive MTA240 from ACG, in order to obtain a better load introduction and to protect the coupon against the gripping forces of the test machine. The notched geometry of the coupon tests with a gage zone of  $10 \times 10 \times 2 \text{ mm}^3$  was designed and verified by finite element analysis, in order to guarantee the highest

Surface topography inspection has been done on both faces of the specimen in an area of  $1.55 \times 1.49 \text{ mm}^2$  near to the center of the face as shown in the Fig. 1. Due to the stacking sequence, the layer inspected is at  $45^\circ$  respect to the load direction. The size has been chosen to assess an area with a dimension similar to the area evaluated by laser speckle techniques, in order to have similar statistic and scale. An arbitrary position near to the center of the face has been selected because there is a uniform damage distribution expected along the gage zone of the specimen. The confocal microscope with an objective of  $50 \times$  zoom has been used to obtain the topography of the evaluated area, measuring

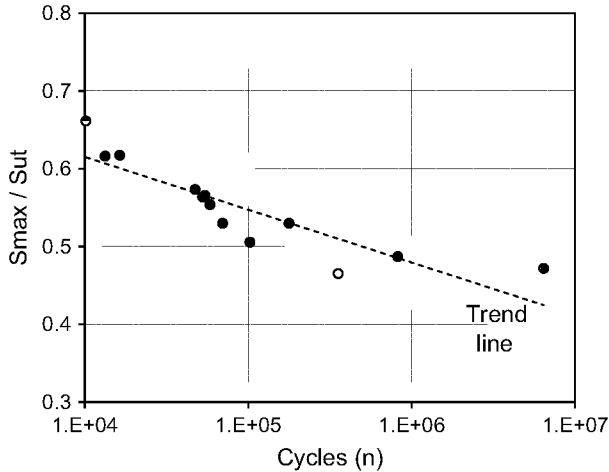
Fig. 3. Stress–life curve (S–N) for  $R=0.1$  and average  $S_{ut}=938$  MPa.

Cycling loads were applied to 13 specimens under constant amplitude load with a stress ratio of  $R=0.1$  (tension–tension load). Different levels of maximum stress ( $S_{max}$ ) between 47% and 66% of the  $S_{ut}$  were applied to obtain the stress life curve (S–N) shown in Fig. 3. A cycle frequency of 5 Hz has been selected to prevent overheating. The fatigue tests have been interrupted periodically before failure in order to perform the measurement of the surface parameters.

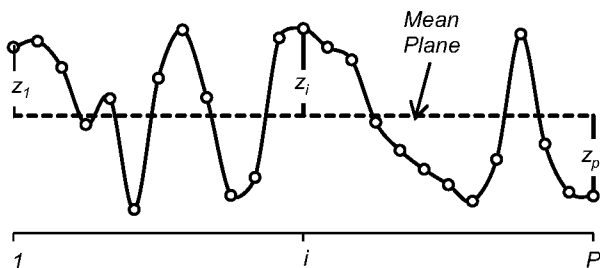
Fig. 4. Bi-dimensional scheme to represent the data measured by the confocal microscope, where “ $z_i$ ” is the value of the height of the measured point “ $i$ ” respect to the mean plane of the surface, and “ $P$ ” is the total number of measured points.

Four parameters were determined from the topography. Those parameters are commonly used to characterize surface roughness based on height magnitudes respect to the mean plane of the surface [24,25]. (1) The arithmetic average of absolute values,  $Ra$ . (2) The root mean square (rms or standard deviation),  $Rq$  or  $\sigma$ . (3) The third moment, also known as skewness, represents the symmetry of the statistical distribution function,  $Rsk$ . (4) The fourth moment, also known as kurtosis, represents the peakedness of the statistical distribution,  $Rku$ . These parameters are determined with Eqs. (1)–(4) [25], where  $z_i$  is the value of the height of the measured point  $i$  respect to the mean plane of the surface, and  $P$  is the total number of measured points (pixels) per surface. (See Fig. 4 for a bi-dimensional scheme.)

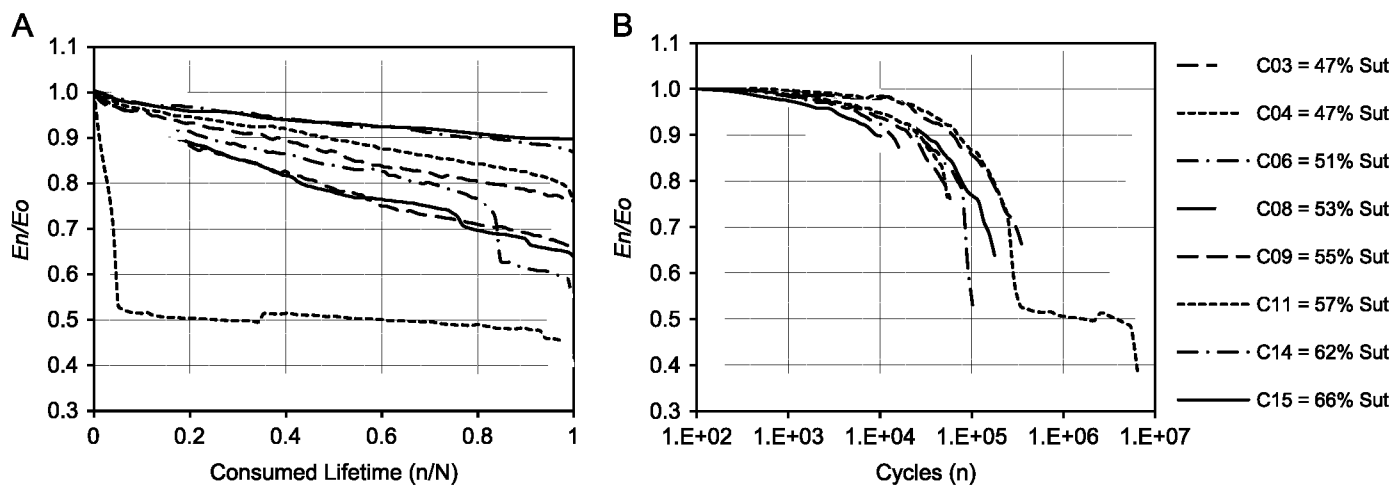
Fig. 5. Stiffness evolution under different levels of maximum load of eight representative coupons. (A) Relation of the stiffness degradation versus the consumed lifetime. (B) Relation of the stiffness degradation versus the number of cycles in a semi-logarithmic graph.

Fig. 5 shows the variation of the stiffness due to fatigue loads of some representative coupons. The graph A of Fig. 5, shows the evolution of the stiffness variation versus the consumed lifetime ( $n/N$ ), where  $n$  is the applied number of cycles, and  $N$  is the number of cycles to failure. The graph B of Fig. 5 shows the stiffness variation versus the cycles applied to each coupon. The stiffness degradation shows a direct relation with the structural damage. One of the observed relation is that the higher the applied load, the faster the degradation of the stiffness; this relation is observed in the graph B of Fig. 5, where higher loads produce curves with higher slopes of stiffness degradation. A second relation is that to fail at lower loads, a higher damage of the structure and in consequence a higher stiffness degradation is required; this relation is observed in the graph A of Fig. 5, where the final value of the stiffness degradation is higher for lower loads.

The coupon C04 which fails at  $N=6.42E6$  cycles (longer life than expected), presents almost the same stiffness degradation compared to the other coupon tested at similar load level (C03) during the first 350E3 cycles. From this number of cycles the ratio of stiffness degradation of coupon C04 becomes appreciably lower until failure in such a way that the curve on the graph A of Fig. 5 presents two slopes. Visual inspections show large delaminations and high density of matrix cracks from  $n=350E3$  cycles until failure, which suggest a change of the damage mechanism that modify the ratio of stiffness degradation, where the load begins to be supported only by the fibers oriented at  $0^\circ$  (load direction) because of the deterioration of the polymeric matrix.

The stiffness variation and its relation with structural damage, is far away from being in agreement with linear damage accumulation rules. The graph A of the Fig. 5, shows that at the same level of stiffness degradation, the percentage of life consumed is different depending on the level of load, while the linear damage accumulation rule requires that all the curves for the different coupons tested at different loads would have coincident slopes. As an example, at 90% of the initial stiffness, the percentage of consumed life for the C03 tested at  $0.47 S_{ut}$  is near to 20% versus 80% for the coupon C14 tested at  $0.62 S_{ut}$ .
