FREE-EDGE DELAMINATION LOCATION AND GROWTH MONITORING WITH AN EMBEDDED DISTRIBUTED FIBER OPTIC NETWORK

Key words: Fiber Optic, Distributed sensing, Aerospace SHM applications, Delamination, Rayleigh scatter, OBR.

Abstract

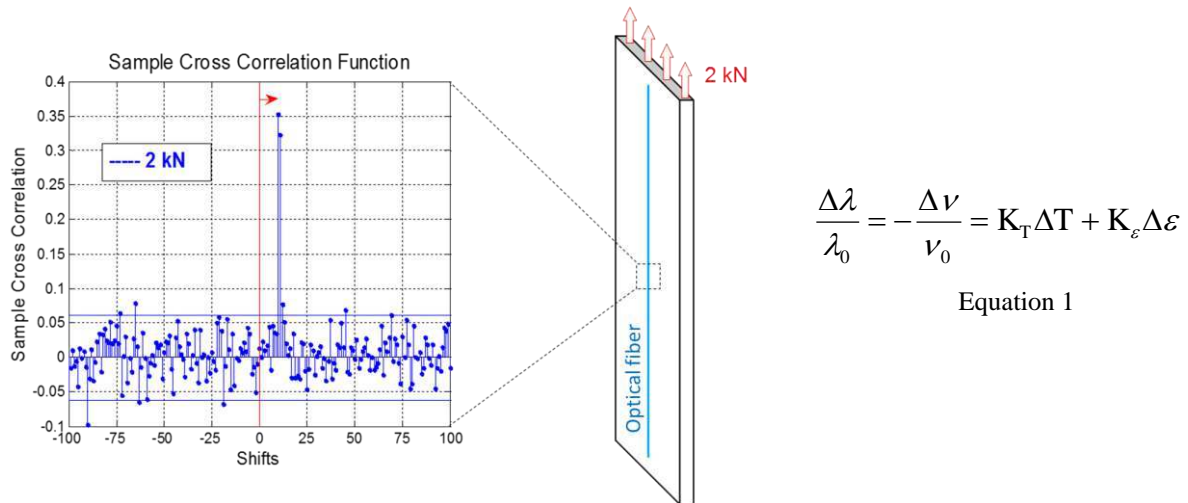
Figure 2: An aluminium sample under tensile test. A cross-correlation function is performed between the reference and the strained measurement (under 2 kN load) in order to calculate the amount of spectral shifts. Through the Equation 1 strain and temperature changes can be obtained for one sensor which belongs to optical fiber bonded on plate surface.

Total reflectivity is calculated by the vector sum of two orthogonal polarization states ('s' and 'p'). Once the complex reflection coefficient is obtained in the frequency domain, the reflectivity as a function of the fiber length is obtained via a Fast Fourier Transform [10]. Then, the reflected spectrum experiences a shift when a segment of DUT is strained or heated. In order to determine this spectral shift, a cross-correlation has to be performed between the two fiber states, the reference and the loaded. The spectral shift is linearly dependant on temperature and strain changes at each segment as shown in Equation 1.

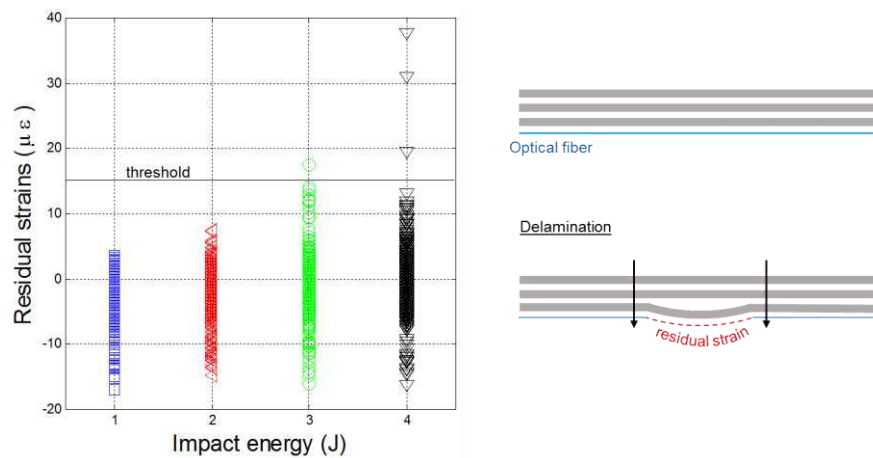
Figure 3: Measurement of residual strains after impact. (Right) Optical fiber behaviour when delamination turns up.

Distributed fiber sensors act as a strain sensor that can provide a full coverage at the region of interest by bonding one optical fiber. When a delamination occurs inside the laminate the fiber bonded on the surface undergoes compression and tension stresses. These stresses become residual strains which are used as an indicative of delamination onset. For that reason, after each impact a measurement of the strain field is recorded in order to detect small strain changes between the last structure states. Figure 3 shows the residual strains of each fiber sensors after different impacts.

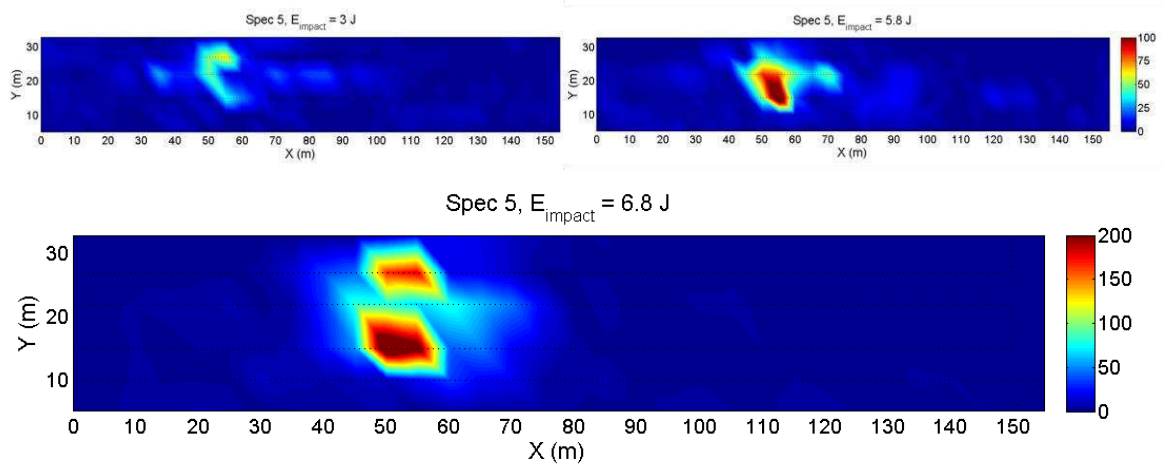
Figure 10: Upper Left: Strain map after impact of 3 J. Upper right: Strain map after impact of 5.8 J. Lower: Strain map after impact of 6.8 J.

Distributed strain measurements collected by the OBR were taken after impacts. Each measurement has been compared to the last one in order to obtain the residual strains for each impact step. The crack growth of the delamination can be monitored with a strain mapping performed at every step. After 5.8 Joules impact it should be pointed out how delamination grew close to the first local strained area. Last impact recorded the strain field changes around $200 \mu\epsilon$ at the same position of ultrasonic results which demonstrated the reliability of the results.
