Article

Temporal Acoustic Emission Index for Damage Monitoring of RC Structures Subjected to Bidirectional Seismic Loadings

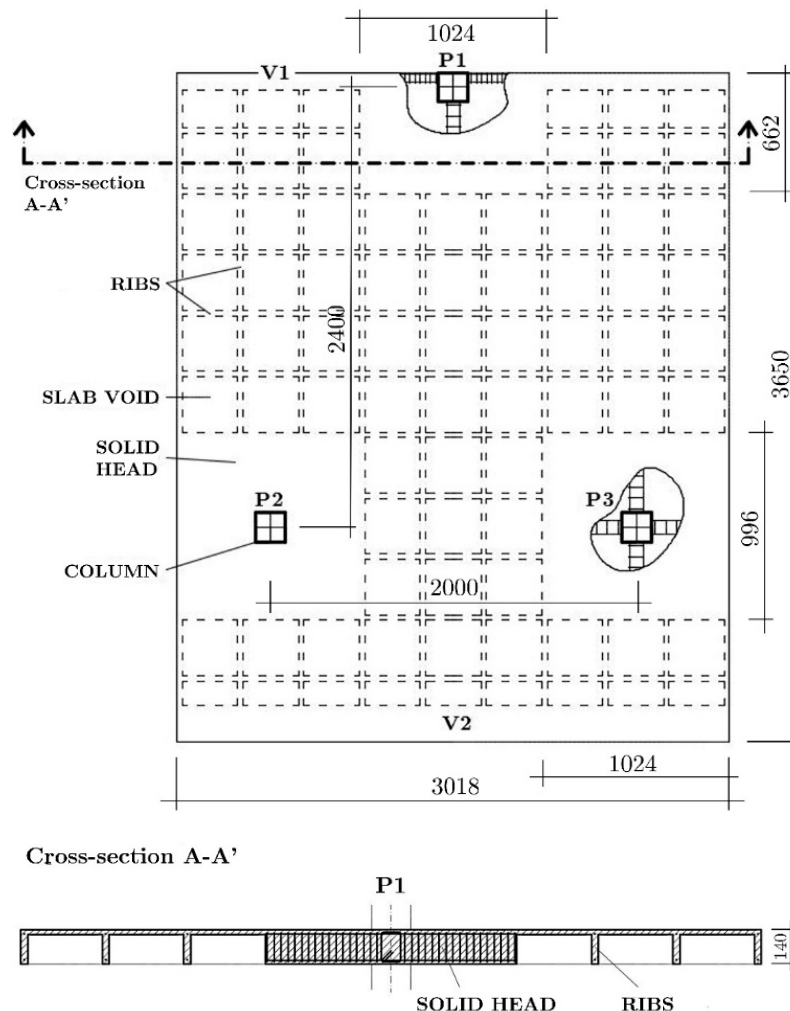
Figure 1. Floor plan and waffle plate section of BS1 and BS2 specimens. Dimensions in mm.

First, a prototype of the RC structure having three floors and constituted of waffle flat plates supported on isolated square columns was designed. The depth of the plate was 0.35 m and had a regular pattern of voids and a solid zone around the columns. The voids formed an orthogonal grid of ribs separated by 0.83 m. From this prototype, a sub-structure of one and a half floors and one and a half span was selected. The sub-structure was scaled by the factor $\lambda_d = 2/5$ for the linear dimensions and $\lambda_\sigma = 1$ for the stress to define the characteristics of the test specimens. The two identical test specimens, referred to hereafter as BS1 and BS2, were built in the Laboratory of Structures of the University of Granada. The tests specimens consisted of a waffle plate of $3.65 \times 3.02 \times 0.14 \text{ m}^3$ supported on three columns of square Section $16 \times 16 \text{ mm}^2$, as shown in Figure 1. The dimensions of the solid zone around column P1 (see Figure 1) was $1.02 \times 0.66 \text{ m}^2$, and those around columns P2 and P3 (see Figure 1) were $1.02 \times 1.02 \text{ m}^2$. The connection of column P1 with the plate will be called hereafter, exterior connection, and the connection of column P2 or P3 with the plate, interior connections. Further details about the specimens and their elaboration can be found in [23].

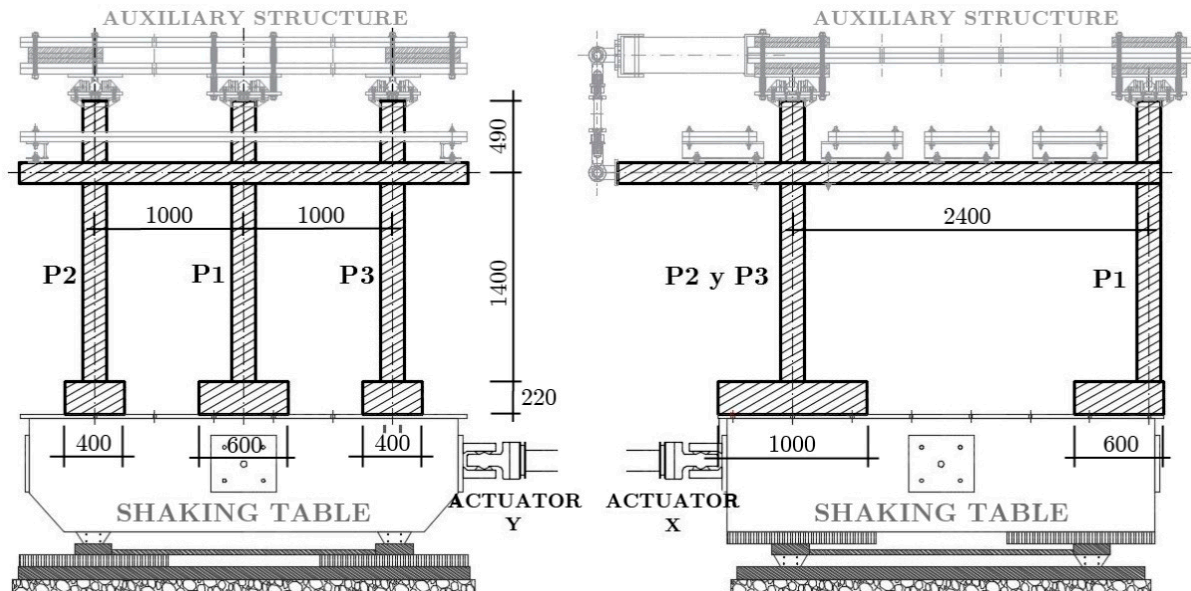
Figure 2. Elevations of the specimens installed on the shaking table. Dimensions in mm.

The specimens were placed on the shaking table of the Laboratory of Structures of the University of Granada as shown in Figures 2 and 3, and tested under dynamic loadings. One additional scaling factor of $\lambda_a = 1$ for the acceleration was used for the dynamic tests. In order to simulate the boundary

conditions of the sub-structure within the prototype, bi-articulated steel bars and pinned-joints were installed at the free ends of the upper columns and on the plate. The additional steel blocks (overloads) were attached at the top of the plate and at the top half of columns of the second story to represent the gravity loads acting on the floors and to satisfy similitude requirements.

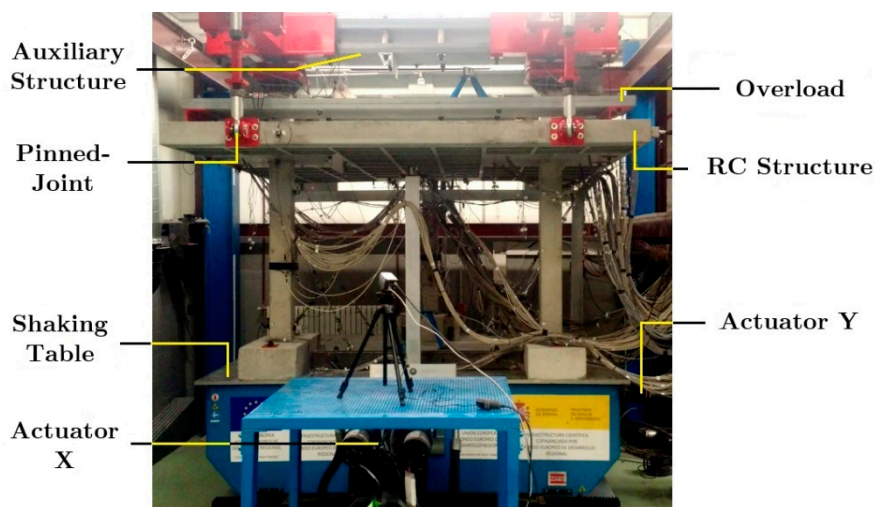
Figure 3. General setup of the seismic test: Shaking table of the Laboratory of Structures of the University of Granada (actuators X and Y), reinforced concrete (RC) main structure with overload, and auxiliary metallic structure.

Specimen BS1 was subjected to the two horizontal components of the ground motion recorded at Calitri station during the Campano-Luchano earthquake (Italy, 1980). Specimen BS2 was subjected to the two horizontal components of the ground motion recorded at Bar-Skupstina Opstine station during the Montenegro earthquake (1979). The ground accelerograms corresponding to the component with the highest peak-ground acceleration (PGA) for each earthquake are shown in Figure 4. The first earthquake (Calitri) is a far-field ground motion without pulses. The second ground motion (Bar) is an impulsive near-fault earthquake. Each specimen was subjected to successive seismic tests, referred to as seismic simulations hereafter. In each seismic simulation, the two components, north-south and east-west, of the ground motion were applied simultaneously by actuators X and Y, respectively.

(see Figure 3). In each seismic simulation, the accelerograms were scaled in amplitude to increasing values until the collapse of the specimen. Table 1 shows the PGA applied to the shake table in each seismic simulation expressed in terms of the acceleration of gravity (g). The name of each seismic simulation in Table 1 (C35, C100 etc. for specimen BS1, or B15, B5 etc. for specimen BS2) was formed with the first letter of the name of the acceleration record, and a number that indicated the percentage of the original PGA applied to the shake table during the seismic simulation. Thus, C200 for example, identifies a seismic simulation with Calitri record whose peak acceleration is 2 times that of the original (unscaled) record. Note that in the simulations, C200 and C200b in the case of specimen BS1, and in simulations B130 and B130b in case of specimen BS2, the peak acceleration was kept the same.

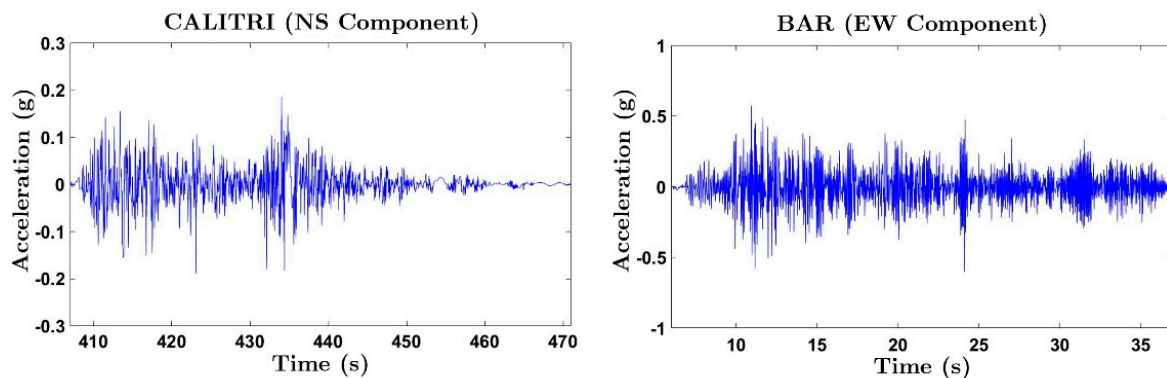
Figure 4. Original accelerogram of the earthquake recorded in the seismic station. Left: Calitri. Right: Bar-Skupstina Opstine.

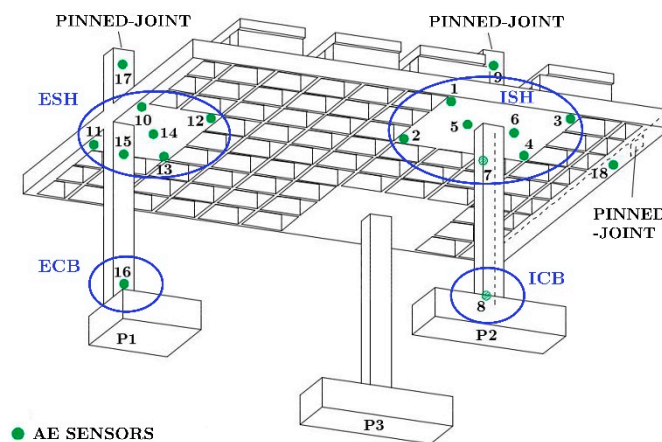
Figure 6. Sensitivity curve of sensor VS30-V.

The VS30-V sensors were manufactured by Vallen System (Icking, Germany). This type of sensor exhibits high and uniform response in the low frequency range (i.e., 25–80 kHz). Figure 6 shows the sensitivity curve of this type of sensor. The preamplifiers (model AEP4) and the acquisition system (AMSY-5) were manufactured also by Vallen System. The acquisition system, AMSY-5, has 18 channels for the AE sensors and two additional parametric entries that were used to record the shake table accelerations in the X and Y directions. Further details can be found in [24].

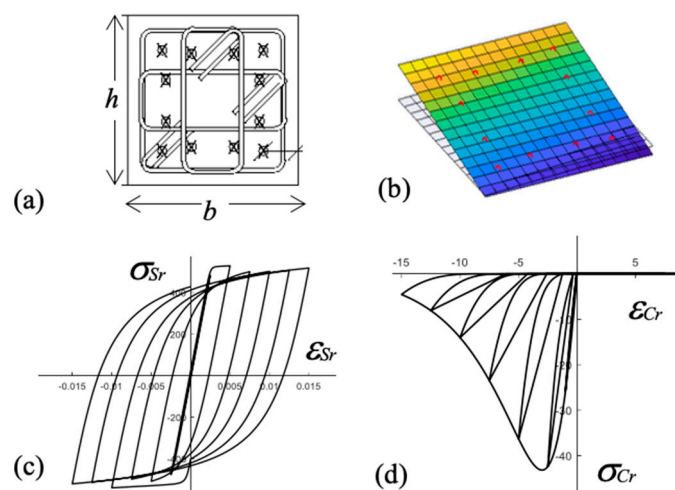
Figure 7. Column P1: (a) base cross section; (b) discretization of the cross section in fibers; (c) constitutive model for steel; (d) constitutive model for concrete.

Plastic deformations occurred at both ends of each column. The central part remained basically elastic (i.e., without cracks). The region of the plastic deformations at each end of the column is commonly referred to as plastic hinge and it is delimited by two parallel planes perpendicular to the column axis spaced a distance l_p measured from the point where the column axis contacts the plate. Past studies showed that l_p can be taken equal to the depth of the column. The elastic strain energy stored and the plastic strain energy dissipated in a given plastic hinge k from instant $t = 0$ to $t = t_t$, $W_{PH,k}$, is the sum of the energy stored/dissipated by concrete, $W_{C,k}$, and the energy stored/dissipated by steel rebars, $W_{S,k}$. In this study $W_{C,k}$ and $W_{S,k}$ are estimated as follows. Figure 7a shows the typical cross section of a column at the plastic hinge region. The rebars instrumented with strain gauges are indicated with the symbol \times . The cross section of the plastic hinge, of depth h and width b , is divided in $N \times N$ fibers as shown in Figure 7b, where $N = 14$. The depth of each fiber is h/N and the width b/N . A different material (steel or concrete) is assigned to each fiber, depending on the position of the rebars in the RC section. As usual in RC members subjected to flexural deformations, it is assumed that plane

sections remain plane after bending. This is commonly called in the literature, the plane remaining plane assumption and it is shown in Figure 7b, where the colored part represents the cross section after bending and the part without coloring, the cross section before bending. Based on this assumption, the strain at any instant t , $\varepsilon_{sr}(t)$, of any rebar r of the cross section of the plastic hinge is obtained from the strains measured by the gauges adhered to the longitudinal reinforcement by plane interpolation. The stress $\sigma_{sr}(t)$ associated with $\varepsilon_{sr}(t)$ is estimated using the Pinto-Menegoto [23] constitutive model for steel shown in Figure 7c. Naming A_{sr} the area of a rebar r and assuming that plastification develops uniformly in the length l_p , $W_{S,k}$ at a given instant t is calculated as follows:

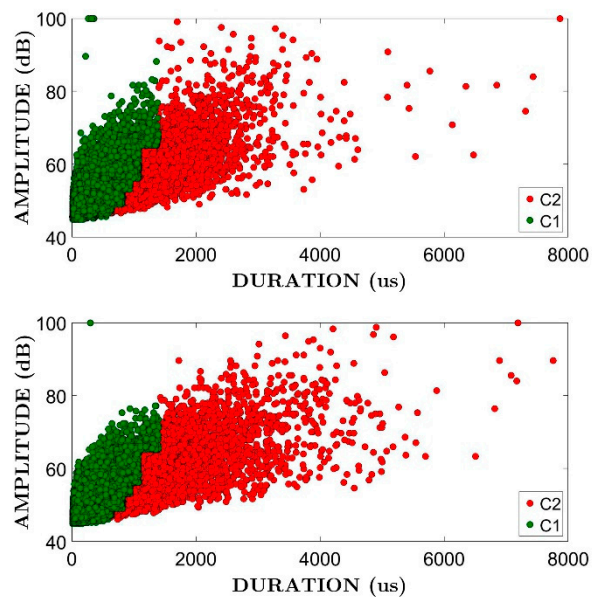
Figure 8. Amplitude-Duration plots for AE signals. Zone solid head of the exterior connection (ESH) of specimens BS1 (**top**) and BS2 (**bottom**). Green: passing the Swansong filter: Red: No passing the Swansong filter.

Firstly, the AE signals were filtered by a Swansong filter in order to avoid those of long duration and low amplitude, usually coming from the secondary mechanisms as mechanical friction. Table 2 lists the limit values previously proposed by Soltangharai et al. [22] for the RC structures with dimensions comparable to BS1 and BS2 for the Swansong filter. Basically, the filter eliminates the AE signals with a duration higher than DL, with DL depending on its amplitude as shown in Table 2. As an example, Figure 8 shows the AE signals passing the filter (in green) and those not passing the filter (in red), for the whole seismic simulations in a particular area of both BS1 and BS2 specimens. It was noted that 100 dBAE is the maximum amplitude range of the measuring system. No passing signals (filtered out) were 11%, 11%, 4% and 3% for IHS, EHS, ICB and ECB zones, respectively for specimen BS1, and were 13%, 15%, 6% and 4% for IHS, EHS, ICB and ECB zones, respectively for specimen BS2.

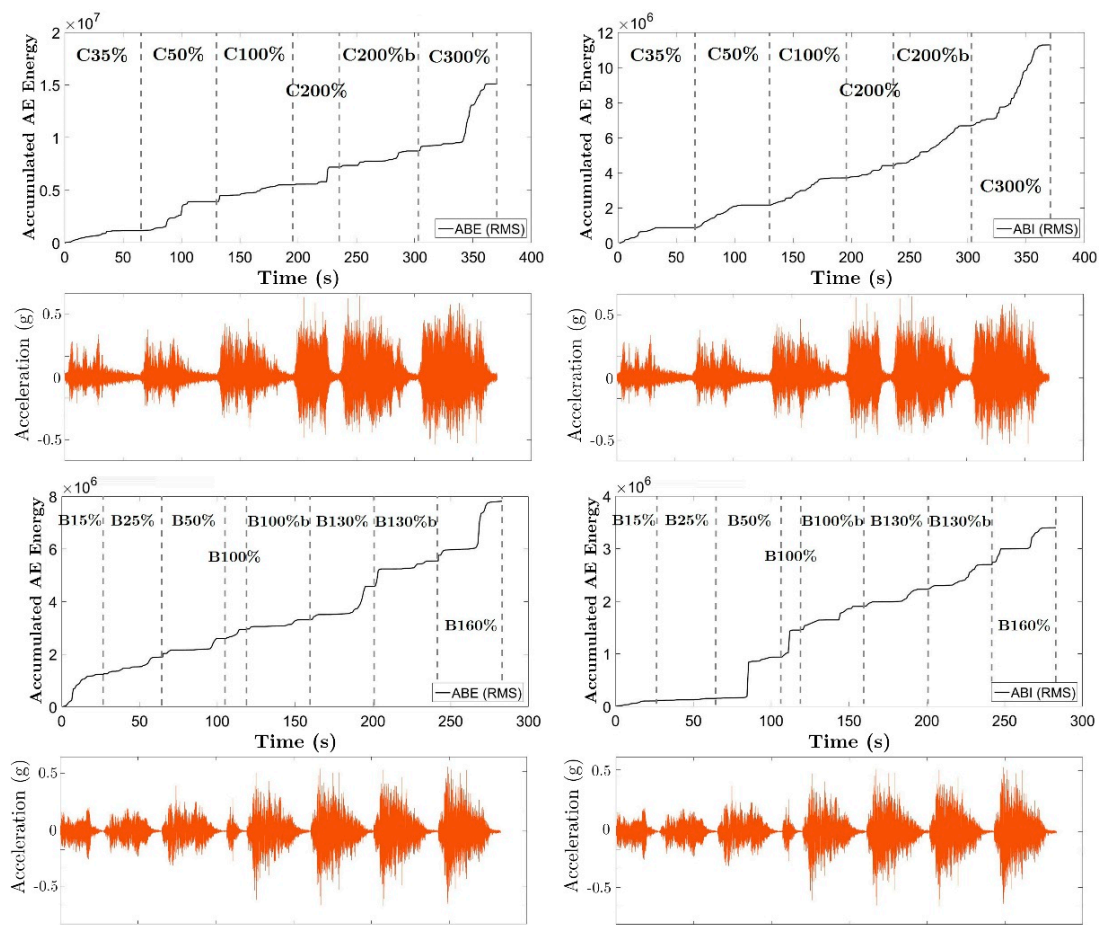
Figure 9. The accumulated AE energy in the ESH and ISH zones for BS1 (top) and BS2 (bottom) specimens. Bottom of the figures: Ground acceleration as a function of time.

Figure 9 shows the history of accumulated AE energy released in the ESH and ISH zones for each specimen. Below each history of the accumulated AE energy, the history of the acceleration applied to the shake table in one of the directions (the one of maximum PGA) were also plotted.

The plots in Figure 9 reveal a greater accumulation of AE energy in the exterior connection—column P1 (ESH area)—compared to the interior connection—column P2 (ISH). The difference is even greater if it is taken into account that the volume of the solid zone of the slab in the exterior connection (ESH) is smaller than that of the interior connection (ISH). Further, a clear increasing of the released AE is observed as the acceleration applied to the shake table increases.

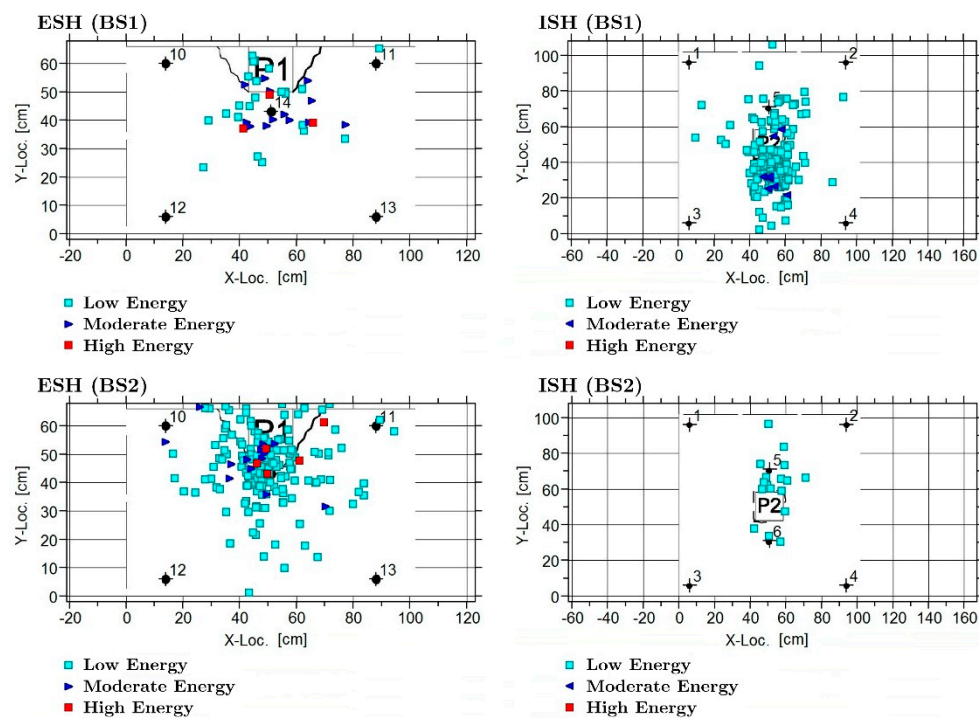
Figure 10. Planar location of the AE events at ESH and ISH zones for specimens BS1 and BS2.

Figure 10 shows the results of the AE planar location (2D) analysis performed in both the interior (ISH) and exterior (ESH) connections. A clear concentration of events can be observed around the top of the columns of the first story in both cases. The localized events were tentatively classified in three intensity levels: Low energy (light blue), moderate energy (blue) and high energy (red). It can be observed that some events of high energy were located at the exterior connection. In contrast, weaker events were recorded in the interior connection. The post-test visual inspection confirmed this result, since large cracks were observed in ESH and only small detachments in ISH. In both cases, damage occurred in the top of the column (see Figure 11).

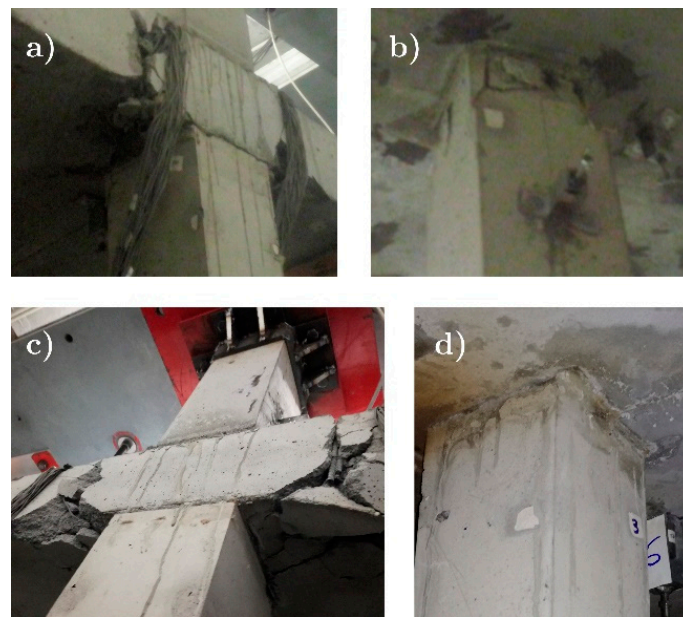
Figure 11. Final damage at the column-plate connections: a) ESH (BS1), b) ISH (BS1), c) ESH (BS2) and d) ISH (BS2).

Most of the energy absorbed by the plate was dissipated at the exterior plate-column connection, and more precisely, around the region where column P1 intersected the solid zone. This caused severe damage as shown later in Figure 11a,d that shows the state of the exterior connection at the end of the tests.

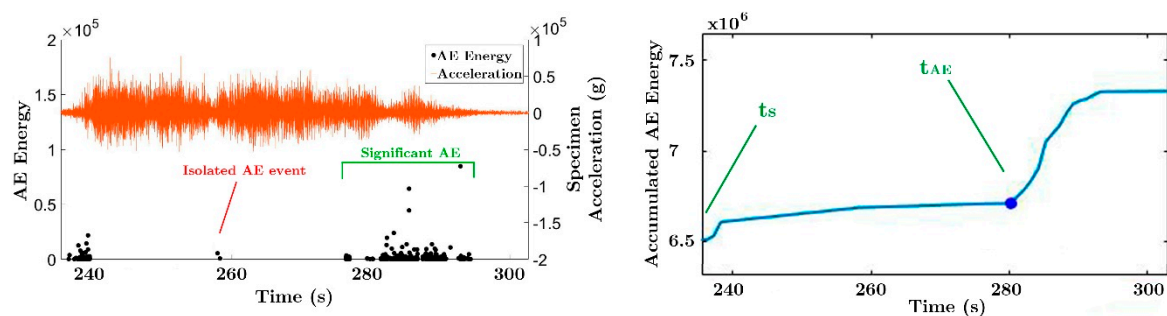
Figure 12. AE_{SIGN} (left) and the accumulated AE energy (right) during the C200b. ECB, specimen BS1.

A deeper analysis of the AE energy of the events for each seismic simulation, as represented in Figure 12 and demonstrated in plots of Figure 13, shows that the significant acoustic emission (AE_{SIGN}) arrives with a relevant delay with respect to the beginning of the seismic simulation. Moreover, this delay increases as the damage of the specimen increases, i.e., along the successive seismic simulations. The AE_{SIGN} for a particular seismic simulation is defined as an uninterrupted succession of AE events, without considering the previous isolated events (Figure 12). This behavior was observed for all the seismic simulations in both specimens. The TDI phenomenon can be attributed to several sources and to fully identify and understand all of them, additional studies are needed. One reason that can explain the delay of the AE energy onset as the acceleration increases is that in the first cycles, the steel receives the load dissipating plastic strain energy without much AE. After many cycles, different degradation phenomena happen (one of them being the deterioration of bond conditions between the steel and surrounding concrete) and the concrete starts to further crack.

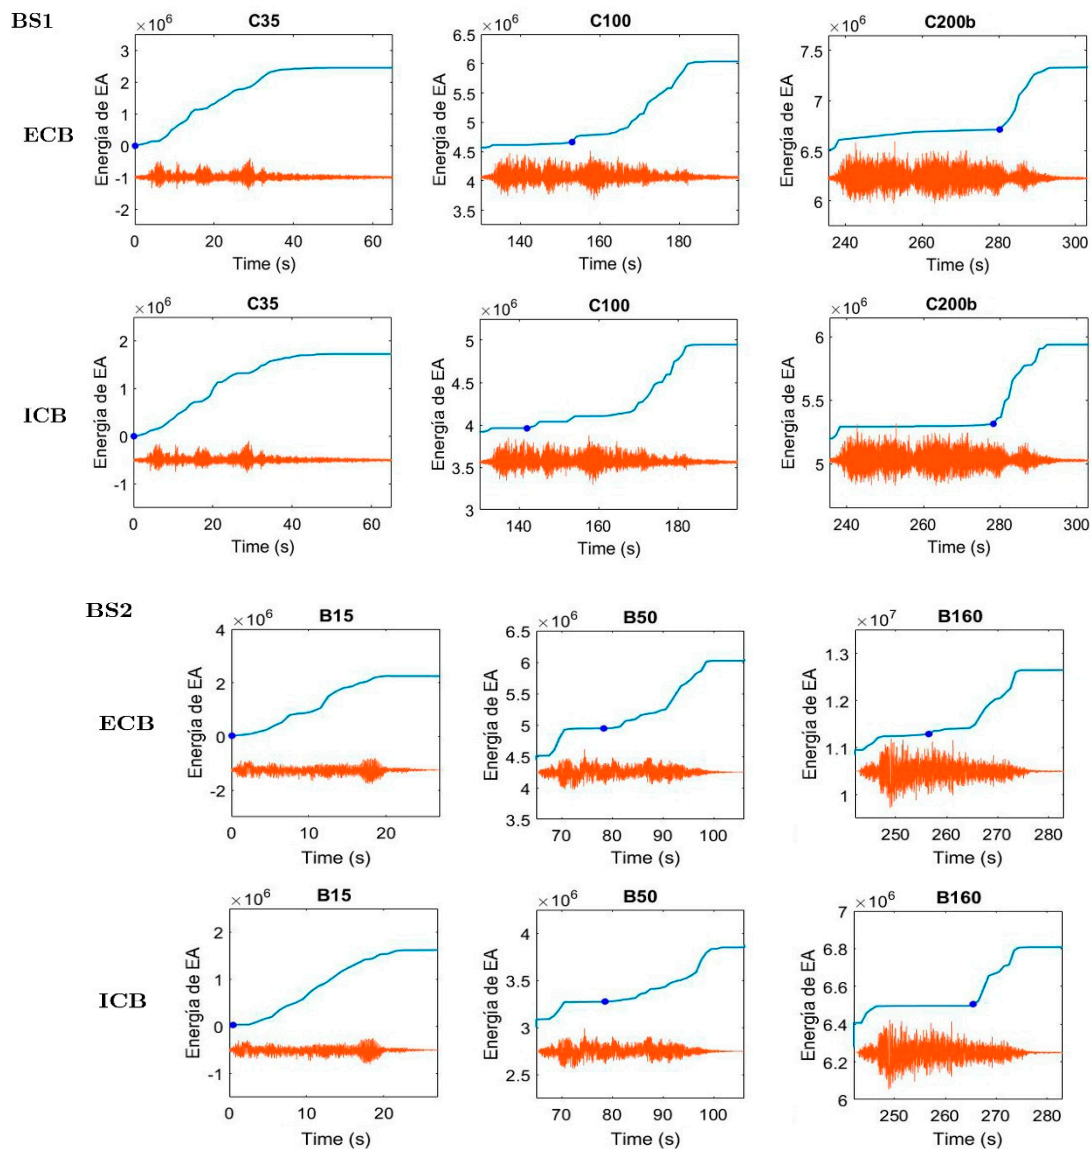
Figure 13. The accumulated AE energy on 3 different seismic simulations with the beginning of the AE_{SIGN} , t_{AE} .

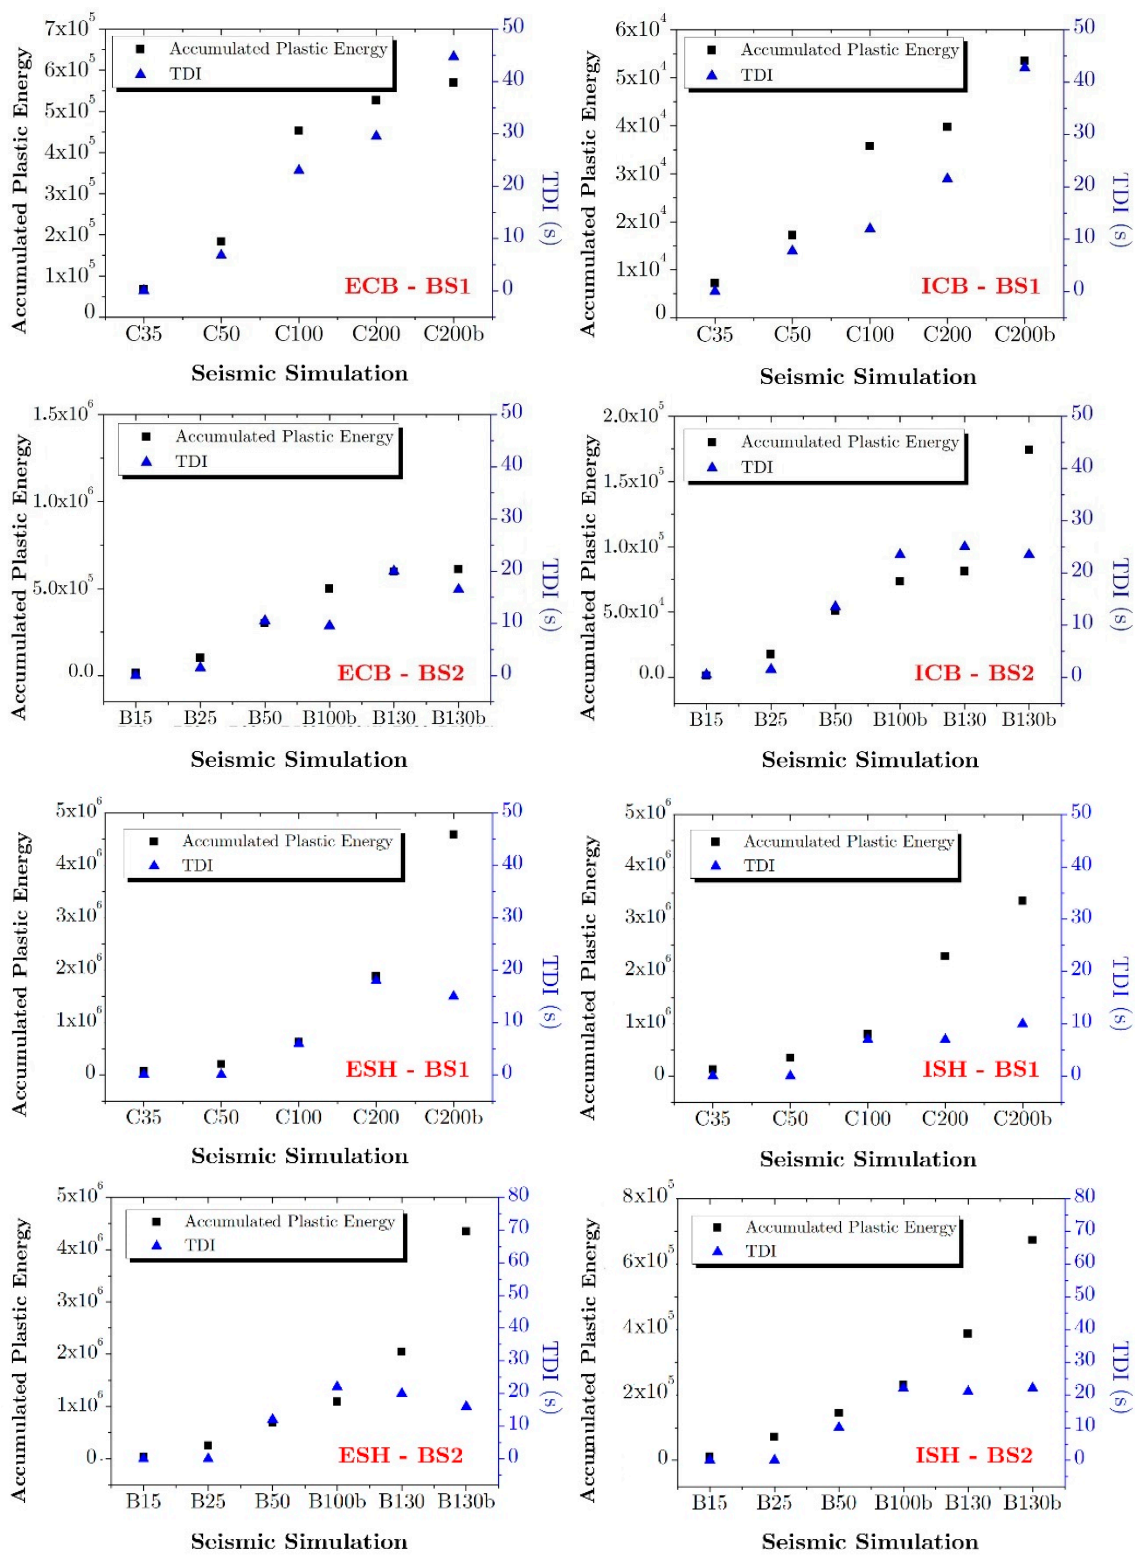
Figure 14. Correlation between the accumulated plastic energy $W_{C,p}$ and the temporal damage index (TDI).

Figure 14 compares the TDI index with the plastic strain energy released by the concrete accumulated at the end of each simulation, for zones ESH, ISH, ECB and ICB from both specimens, where the onset of the significant AE (TDI definition) has been picked by eye examination. In general, there is a progressive growing of both damage parameters as the peak acceleration increases. The agreement between both damage parameters is particularly good at the base of columns, where the amount of absorbed energy is directly and more reliably estimated as explained in Section 2.3.1. However, in the solid head connections, such agreement is only good up to simulations C100 and B100b, for which the most energy is dissipated by the columns. Beyond simulations C200 and B130, the amount of energy dissipated by the solid head is significant in comparison with the energy absorbed

by the columns, and the fact that the energy dissipated by the plate is indirectly and roughly evaluated (see Section 2.3.2) could explain the worse agreement.
